Proposed early warning system of slope failure by monitoring inclination changes in multi-point tilt sensors

Lin Wang, Shunsaku Nishie, Ling Su

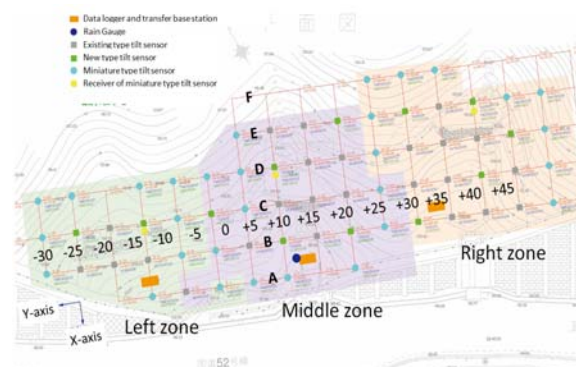
Figure 11. Arrangement of the multi-point tilt sensors

Figure 10 shows the scale of Manzawa slope failure site, and Figure 11 shows the arrangement of the multi-point tilt sensors and locations, where two types of tilt sensor were used. The arrangement interval of the sensor is designed to five meters. A total of 66 sets of sensors were deployed.

The 66 sensor units are divided into three groups, left/middle/right zone, and one data receiver unit and one logger/gateway unit for internet collect all the data from respective group as shown in Figure 11. There were eight heavy rainfall event during summer of 2015 shown in Figure 12, and the tilt angles accumulated distribution due to each rain are summarized as Figure 13. The tilting rate averaged during each rainfall event is shown in Figure 14. Distribution of tilting behaviors is figured out by multi-point monitoring.

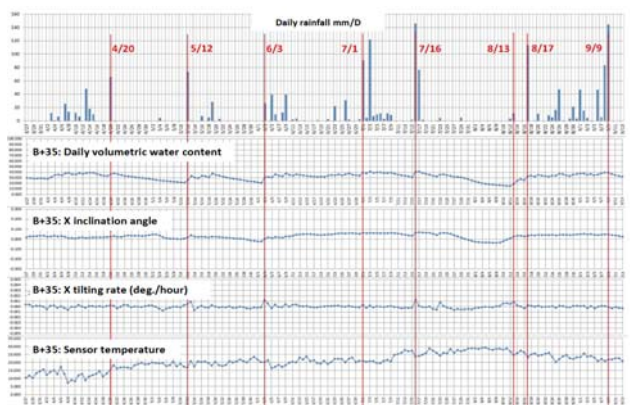
Figure 12. Time histories of movements in rainy days

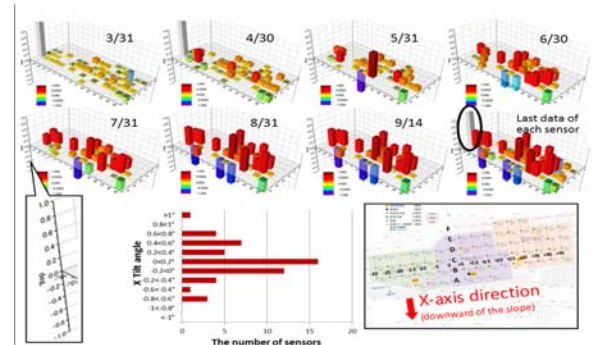
Figure 13. Distribution of accumulated inclination angle
