Satellite and UAV-enabled mapping of landslides caused by the November 17th 2015 M_w 6.5 Lefkada earthquake

Dimitrios Zekkos

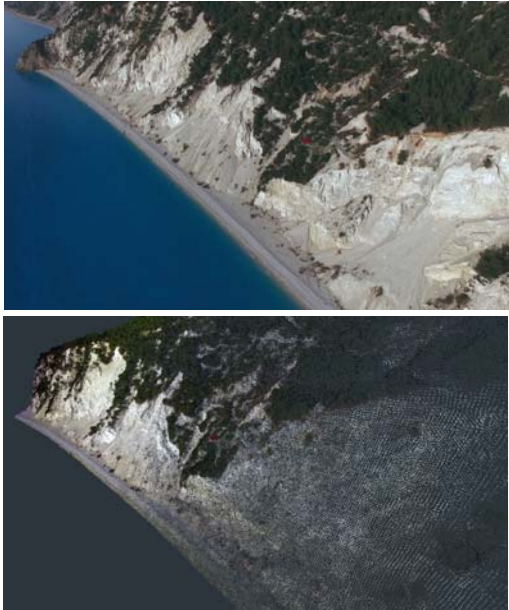
Figure 7. UAV-based 2D imagery (top) and 3D point cloud geometry (bottom) for an example site in Lefkada

The UAV provided the opportunity to map in three dimensions large portions of the landslide affected areas at a much higher resolution than is possible from the satellite data. In addition, structure-From-Motion (SFM) photogrammetry was used to develop 3-D point cloud models of landslide sites using the imagery collected by the UAV (Westoby et al., 2012, Greenwood et al. 2016, Manousakis et al. 2016). Sufficient overlap, of at least 60%, between successive images is required for 3-D model generation. Ground control point (GCP) targets were used, when possible, to develop reliable digital elevation models (DEM) at cm-level resolution. Specifically, the average point cloud density of the various 3D models was 20-70 points/m². An example of the data generated is shown in Fig. 7. Fig. 7 shows an oblique view of the Egremnoi beach in 2D, and as a 3D point-cloud that can be used for such analysis. Point cloud data enables identification of individual landslides within larger landslide complexes, which cannot be easily recognized from satellite imagery alone, mostly because the imagery lacks resolution in 3D. Segregation of landslide complexes into their component parts is expected to significantly affect commonly used frequency area statistics such as shown in Figure 6. Such segregation is expected to be achieved using the higher resolution UAV imagery.
