Permeability, groutability and protected clayey blanket appraisal of the Qadrony Zarand dam site in Iran

Mehdi Momeni

ABSTRACT: Seepage from the body and foundations of dams is one of the most important design parameters highly influenced by permeability. Also, permeability is one of the basic parameters for designing grout curtains, preventing water from escaping from the foundation and avoiding negative seepage pressures in borrow materials used for grouting. In this work, rock mass classification of a rock foundation dam site was carried out using the rock mass rating (RMR) and geological strength index (GSI) systems. This study was mainly conducted to evaluate permeability and groutability at the left side of Qadroni Zarand dam in Iran using Lugeon tests and insitu grouting. Also, the dam foundation was evaluated by pressure tests (WPTs) that indicated the need for a grout curtain below the dam foundation. The rock mass quality of the samples obtained via the SPI in conjunction with the drill core jointing degree acts as a useful reference for ground treatment design. The dam foundation groutability was zoned according to an SPI classification point view. At the left side zon

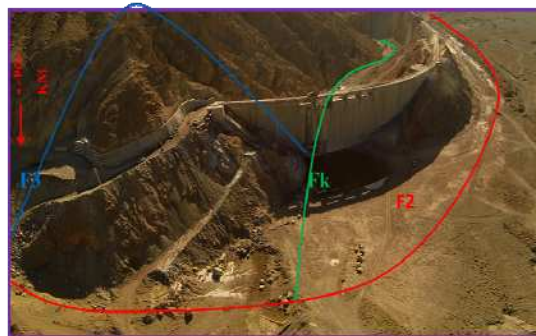
Figure 4. faults in the site of Qadrony dam

Whole fault, F-3, F-2 F-K's in the middle part of the three fault, a wedge is being raised by fragmentation (Figure 4).

Fault F-3 and F-3, which plugs F'-3 intake system downstream of range passes. Between the two branches of the F-3 is also a sharp stone fragmentation.

The performance of the fault that has caused the left, between Taft limestone and marl and stones Sangestan Fvrsh remain as a pop-up and That the cutoff for the implementation of this water will escape The necessity of the measures to close it came to normal level of action taken.

This is the fault of the downstream dam axis perpendicular to the slope 65 to 70 F-2 goes into the tank to fault. Due to the absence of groundwater level in the range mentioned, and because of steep faults that extends deep into the earth and As well as extending them into the tank, the seepage of shear zone between faults outside of the cutoff was inevitable. Field surveys conducted in rock cavities left in the tank and the tank showed that there are several tectonic fractures and To check the hydraulic conductivity of the Left Bank close the bottom outlet valve to collect flood to 1685 levels (about 450 thousand cubic meters of tank volume) were measured. The hydraulic conductivity of about 440 liters per second from the left that the tests need to run the Surface coatings on the left to be more visible (Figure 1).

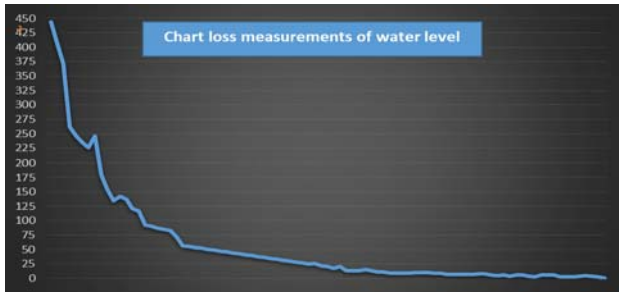
Figure 5. Grout curtain proof test for right hand sealing technic (water level decline from 2015/02/22 to 2015/05/21)

In comparing the two methods technically, stepped concrete method is easier and safer and from an economic standpoint stepped concrete implementation cost estimate was about 20% cheaper then was used to cover the left bank of reinforced concrete staircase (Figure 5).

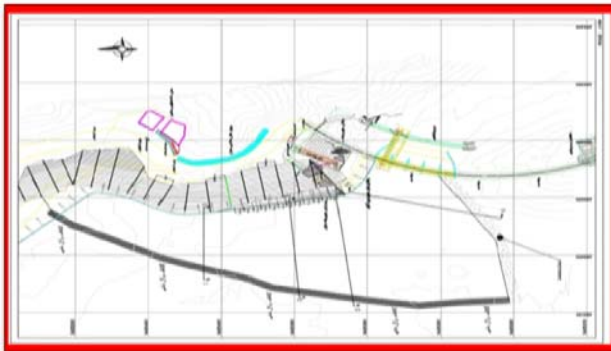
Figure 6. Bottom of the reservoir improvement and concrete lining for walls of the left side.

Technic for sealing of the bottom of the reservoir is shown in Figure 6 and 7. For sealing the area at the bottom of the tank, a cover seal surrounded by a protective layer was used. The sealing covers at the bottom of the trench inflow, on the one hand by the seal into impermeable layers sewn Sangestan and the other at the foot of the dam has been connected to the concrete body. The seal between the cover and the concrete dam of the water stop bentonite was used.

- In the bottom of the reservoir of dam foundation, "sandwich blanket" is the best choice and will be connected to natural deep layer of clayey soil.
- In the right abutment, grout curtain is the best choice.
- In the left abutment, concrete lining for walls which is connected to deep layer of clayey soil at the base is the best choice.

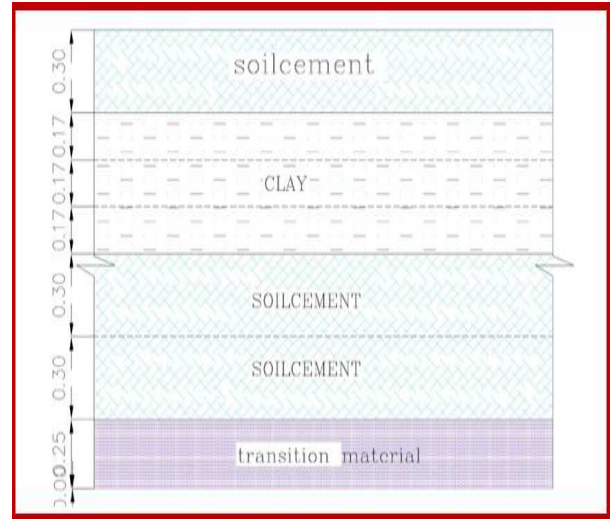
Figure 8 – sandwich blanket for bottom of the reservoir sealing

4. Contains two layers of materials river transport materials to the thickness of each layer and dual-layer 25 cm of soil and cement thickness of each layer 30 cm and Three layers of clay seal each 17 cm thick and 30 cm thick layer of cement dust and moisture protection for hydraulic and clay (figure 8).

In this type of combination of clay and cement is used as a sandwich filling. This approach has technical advantages clay soil and cement, and placed them side by side, reduces the disadvantages of each of them separately and and between a layer of clay soil and cement to repair cracks might be more effective (Table 1).
