Identifying Defects in Deep Bored Piles - Case Studies from India

Sanjay Gupta (Managing Director), *Cengrs Geotechnica Pvt. Ltd., India, sanjay@cengrs.com*

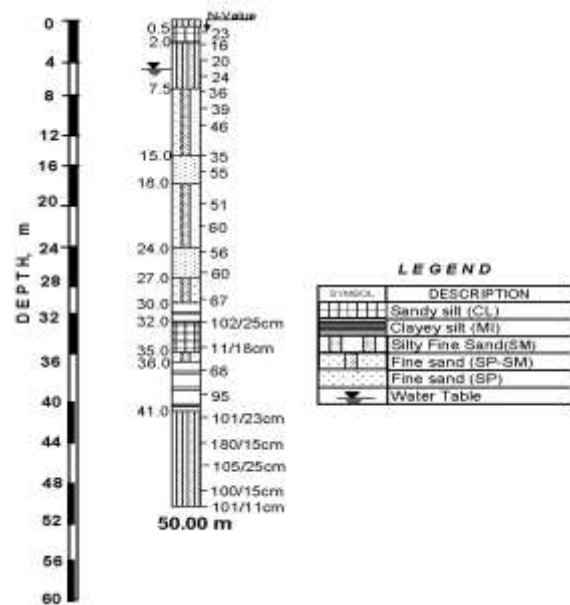
Figure 2. Typical borehole logs

Geotechnical investigations indicate the presence of medium dense to very dense alluvial sand to 32 m depth, underlain by a hard clay stratum to 41 m depth and very dense (N>100) sand below it to 50 m depth. Water table was met at 4.5 m depth. Figure 2 presents typical borehole logs. Figure 3 summarizes the pressuremeter and cross-hole seismic test results, along with the selected design values.

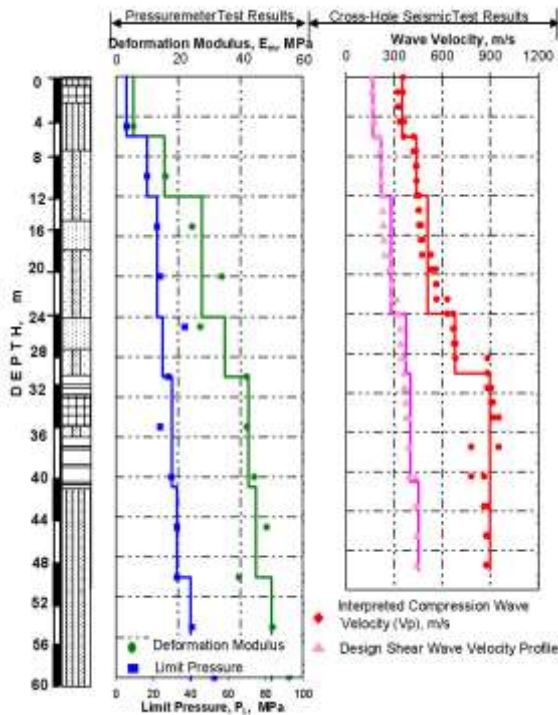
Figure 3. Pressuremeter and cross-hole seismic test results

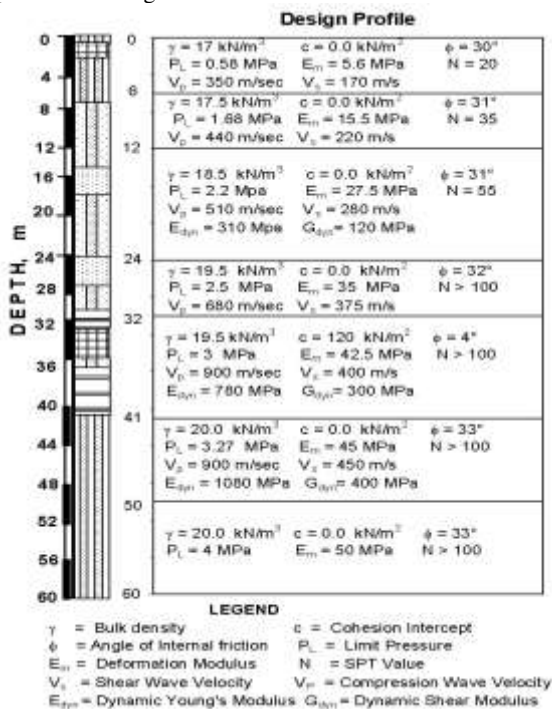
Figure 4. Design Profile

Engineering parameters selected for foundation analysis are presented on Fig. 4.

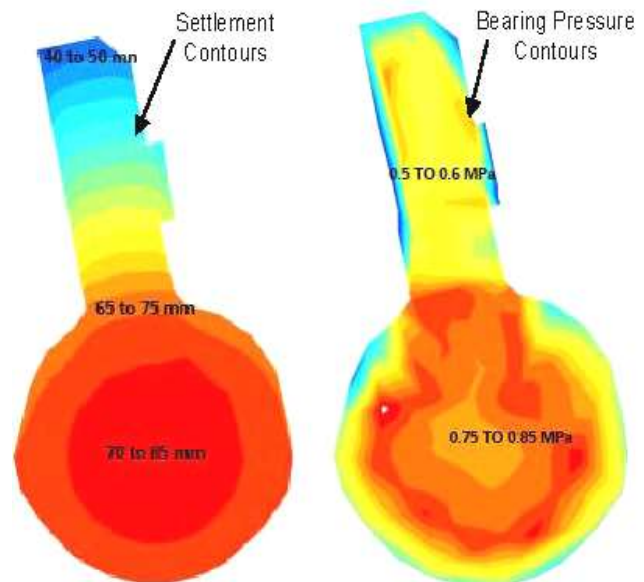
Settlements estimated using Plaxis 3D varied from about 40 to 50 mm at the edges of the central tower, increasing to about 70 to 85 mm at the center. The corresponding angular distortion is estimated at about 1/1500 or better. The maximum bearing pressure at the base of the raft is estimated at about 0.75 to 0.85 MPa and is below the center of the tower. The results of the FE analysis are presented on Fig. 5.

Figure 5. FE Analysis

The results of the FE analysis, as well as preliminary results of the structural analysis, showed that about 75 percent of the superstructure load is transferred to the piles, and about 25 percent is taken by the soil subgrade. The equivalent pile springs were determined from the load applied to each pile and the associated settlement at the pile head.

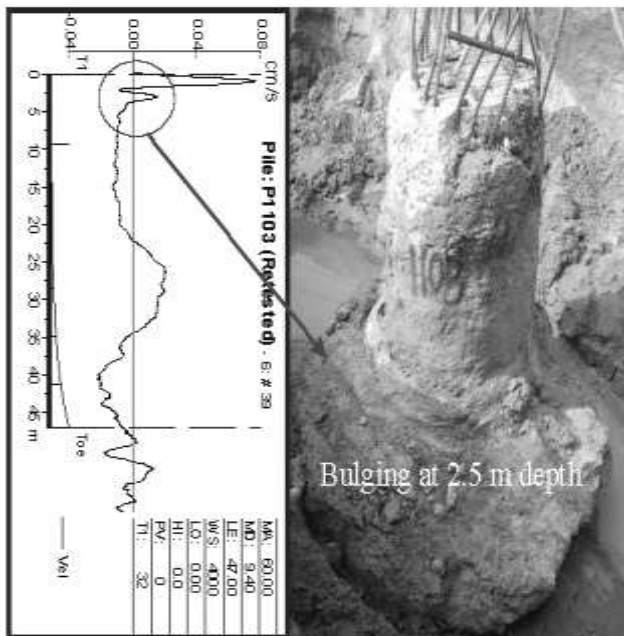
Low-strain pile integrity tests (PIT) were performed on all the piles installed at the site using a special hand-held hammer (8 lbs) struck on the pile head. An accelerometer placed on the pile records the sonic response (Gupta, Sundar & Gupta 2008). The PIT results indicated significant impedance changes along the pile shaft, particularly at shallow depths of about 2.5-4.5 m. This was confirmed by excavating and exposing a few piles to about 5 m depth (Fig. 6). Further, most of the PIT results showed a weak toe response, which was attributed to low pile end-bearing.

Figure 6. PIT results confirmed by excavation (Pile No. 1103)

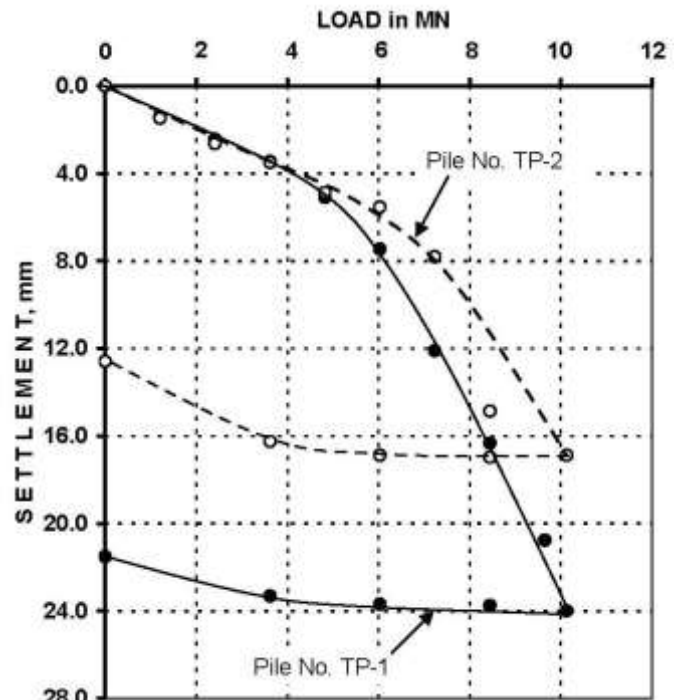
Initial (static) load tests on 1 m diameter, 25 m long test piles installed at the project site indicated a total pile settlement of less than 25 mm at the test load of 10 MN (Fig. 7).

Figure 7. Initial (static) load tests on 25 m long, 1m diameter piles

Based on the static / dynamic load test results, it is observed that the total settlement of the 48 m long production piles under a test load of 10 MN is typically about 40-60 mm, which is twice the settlement of the 25 m long initial piles (Fig. 7). Based on the PIT and load test results, as well as pour card information, the authors concluded that the poor pile performance was due to structural defects and variations in the pile concrete, as well as “soft toe condition” owing to poor bottom cleaning.

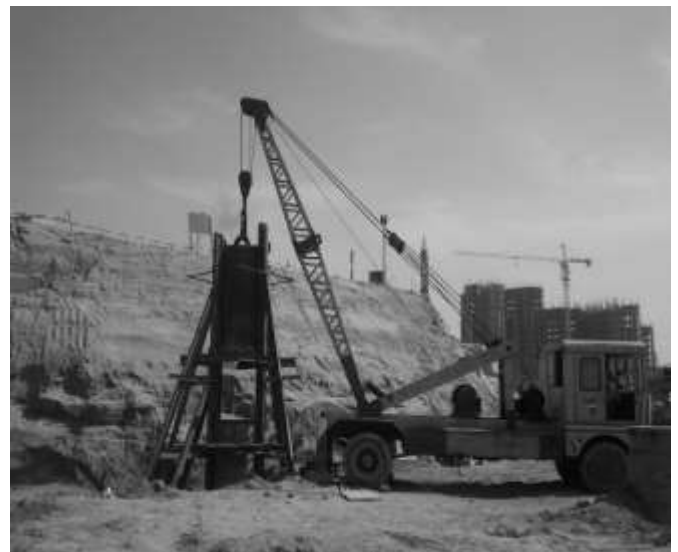
Static load tests were also carried out on 3 Nos. production piles (48 m length) by kentledge method. Further, 6 Nos. high-strain dynamic load tests (ASTM D4945-08) were also carried out using a 200 kN, guided weight free-falling from 0.5-3 m height and 16-channel Pile Driving Analyzer (PDA) equipment. A photograph showing the test setup is presented on Fig. 8.

Figure 8. Dynamic Pile Load Test Setup

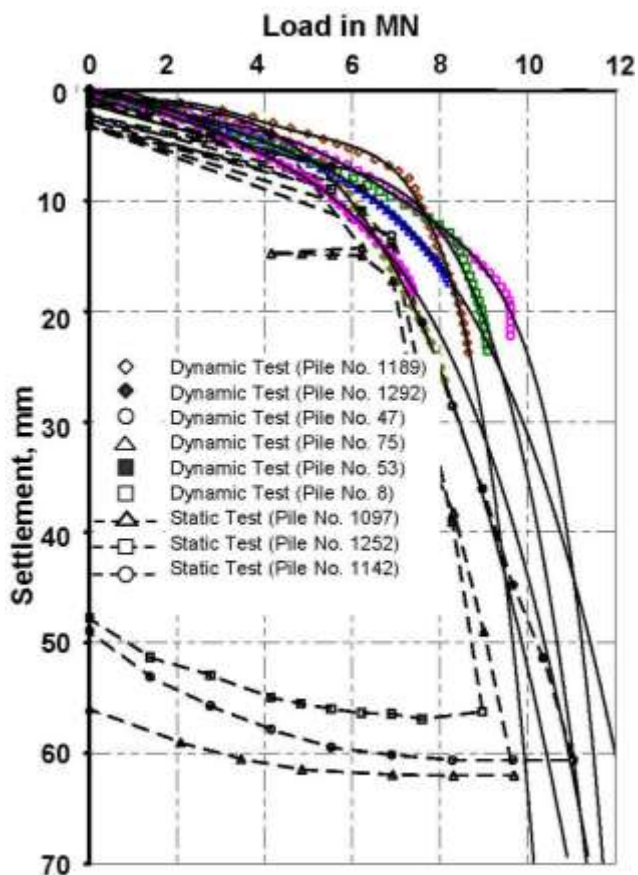
The data from the dynamic tests was analyzed using CAPWAP® software to assess the equivalent load-settlement curves. Figure 9 presents the interpreted static load-settlement behaviour of the piles from the high strain dynamic tests, along with load settlement curves from static load tests.

Figure 9. Load-Settlement Curves-Static and Dynamic

The quality assurance program proved that the piles construction at the site were unlikely to behave as per design. The foundation analysis was repeated considering lowered pile stiffness (corresponding to nil end-bearing). Additional piles were constructed under the raft to compensate for the loss in the foundation bearing capacity.

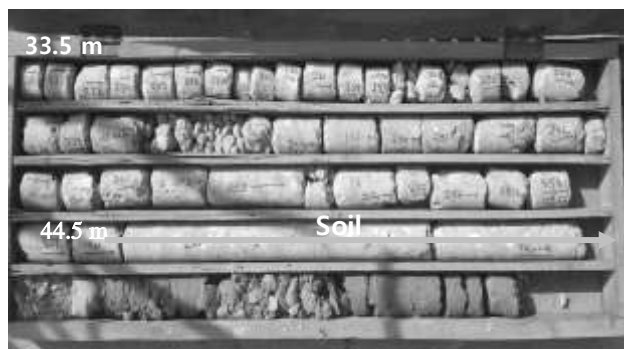
The PIT and PDA tests indicated that the quality of concrete in some of the piles may be suspect. To confirm the concrete quality, the coring of NX size was done using a hydraulic rotary drilling rig. Figure 10 presents typical concrete core for Pile 1079 at the terminal depth.

Figure 10. Concrete Core – Pile No. 1097 (Note the discontinuities and soft zones)
