Long-term behavior of friction piled raft with grid-form DMWs in loose sand underlain by thick clay layers in reclaimed land

Kiyoshi Yamashita, Akihiko Uchida, Tomohiro Tanikawa

Takenaka R&D Institute, Takenaka Corporation, Japan, yamashita.kiyoshi@takenaka.co.jp

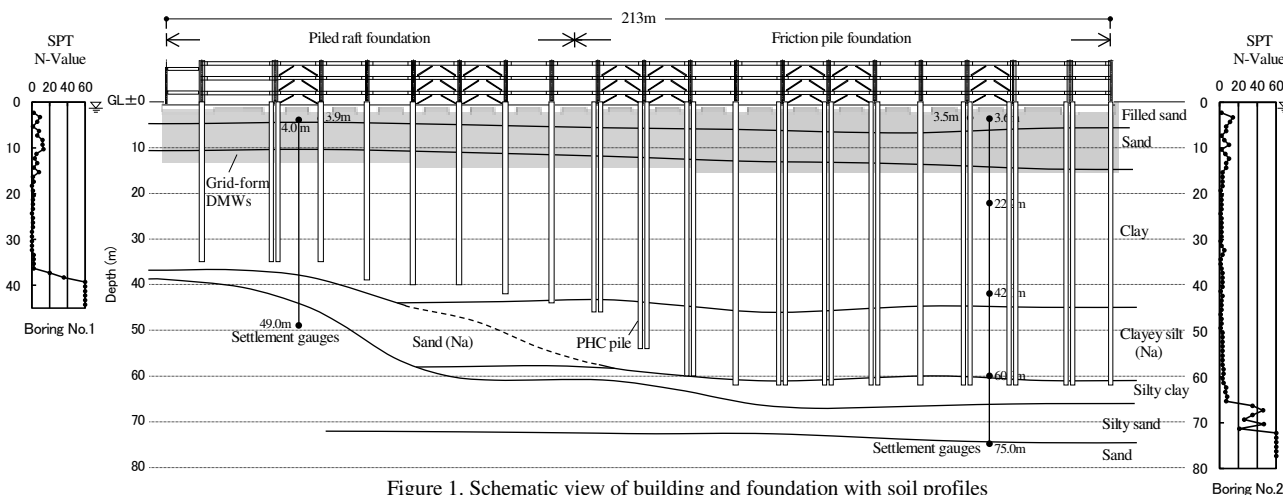
A four-story parking garage is located in Urayasu City, Chiba Prefecture (Uchida et al., 2012). Figure 1 shows a schematic view of the building and the foundation with soil stratification in the site. The site is in reclaimed land where the reclamation work was ended in 1975 (Tokimatsu et al., 2012). The soil stratification was estimated using totally 14 soil boring logs in the site. The soil profile down to a depth of 10-15 m from the ground surface consists of filled sand and alluvial loose sand. The ground water table appears around 1.5 m below the ground surface. Below the depth of 16 m, there are very-soft to medium alluvial clay layers which are normally consolidated or underconsolidated. The depth of the alluvial clay layers changes markedly in the north-south direction near the center of the site since buried valleys exist below the site. The diluvial dense sandy layers appear at a depth of about 39 m in the northern part and about 66 m in the southern part.

Figure 1. Schematic view of building and foundation with soil profiles

2006). The locations of the monitoring devices are shown in Figs. 1 and 2. Pile 3C (35 m long, 1.0 m in diameter) and Pile 17C (60 m long, 0.8 m in diameter), were installed with a couple of LVDT-type strain gauge at the pile head, at a depth of 3.9 and 3.5 m, respectively. A pair of earth pressure cell together with a piezometer was installed in unimproved soil beneath the mat slab in the tributary area of columns 3C and 17C, as shown in Fig. 2. The vertical ground displacements, at a depth of 4.0 m near 3C and at four depths of 3.6, 22.2, 42.0 and 60.0 m near 17C, were measured using differential settlement gauges as shown in Fig. 1. The reference points were set in the very dense sand, at depths of 49.0 m and 75.0 m. These measurements began in March 2006. The settlements of the first floor were also measured at selected column points using an optical level. The optical level measurements started in May 2006.

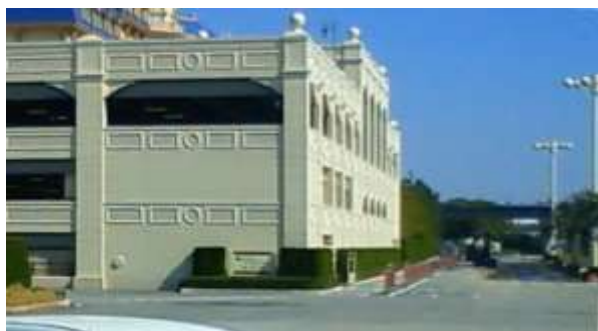
Photo 1. View of ground around the building (March 13, 2011)

Photo 1 shows a view of the building two days after the earthquake. Liquefaction induced settlement is seen in ground surface adjacent to the building, though the ground surface around the building had been temporally restored when Photo 1 was taken.

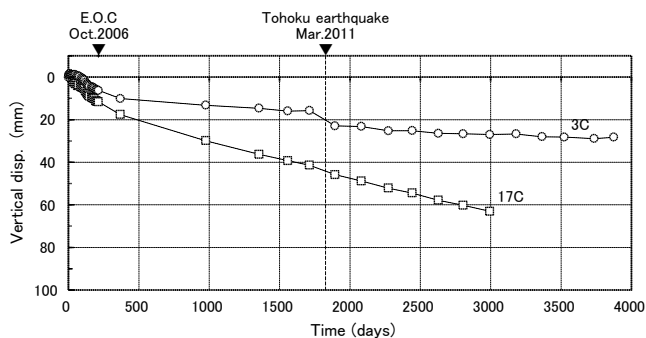
Figure 3 shows the development of the measured vertical ground displacements just below the mat slab. The ground displacement near 3C was 16 mm in November, 2010, and increased notably to 23 mm in May, 2011. It is likely that the incremental settlement of 7 mm was caused primarily by settlement of the friction piles in piled raft system due to the rotational moment of the superstructure during the earthquake. Thereafter, the settlement was almost stable. On the other hand, the ground displacement near 17C increased gradually after E.O.C. due to the consolidation settlement of the reclaimed ground. The settlement was 41 mm before the event, and increased to 63 mm in May, 2014. Unfortunately, no data were obtained from the settlement gauges near 17C after that time. In contrast to the settlement near 3C, almost no increase in settlement was observed after the event.

Figure 3. Measured vertical ground displacements just below mat slab vs. time

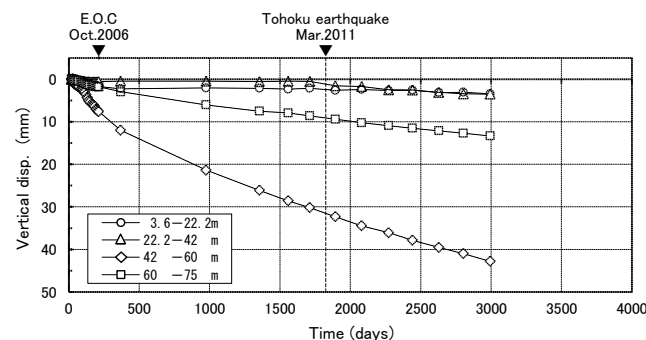
Figure 4 shows the measured vertical ground displacement of each soil layer versus time near 17C. The largest vertical displacement of 43 mm occurred in a soil layer between depths of 42 and 60 m in May, 2014. This alluvial soil layer is called the Nanagochi layer (Na) which was deposited 10000-20000 years ago (Yasuda et al, 2012). The ground displacement of 13 mm occurred in the diluvial soil layers between depths of 60 and 75 m. In contrast, the ground displacement of the filled sand and alluvial layers between depths of 3.6 and 42 m was relatively small, 7 mm.

Figure 4. Measured vertical ground displacements of each soil layer vs. time (near 17C)

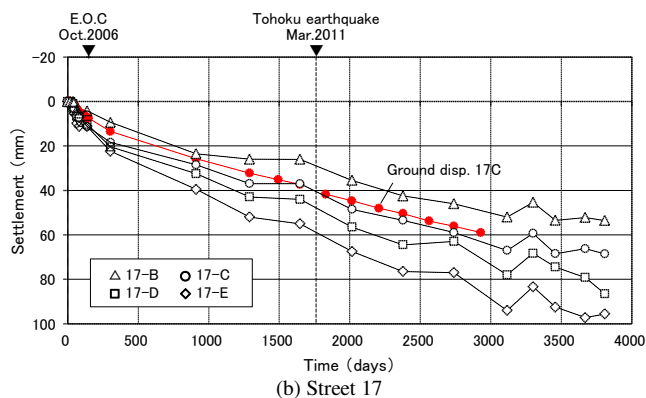
Figure 5 shows the development of the measured settlements of the first floor at the selected column points. A benchmark for the optical level measurement was set to column 3C, at which the settlement was assumed to be equal to the vertical ground displacement at the depth of 4.0 m near 3C after the casting of the mat slab (indicated by a red line in Fig. 5 (a)). The settlement of the first floor at 17C was almost consistent with the vertical ground displacement near 17C shown in Fig. 5(b) before and after the 2011 earthquake. This suggests that almost no increase in settlement of the first floor in the southern part occurred due to the seismic load. It is seen that the rate of the measured settlements on Street 17 decreased in recent years. Hence, the residual settlements were calculated using Asaoka method (Asaoka, 1978), and estimated to be less than 60 mm.

(a) Street 3

(b) Street 17

Figure 5. Measured settlements of the 1st floor vs. time

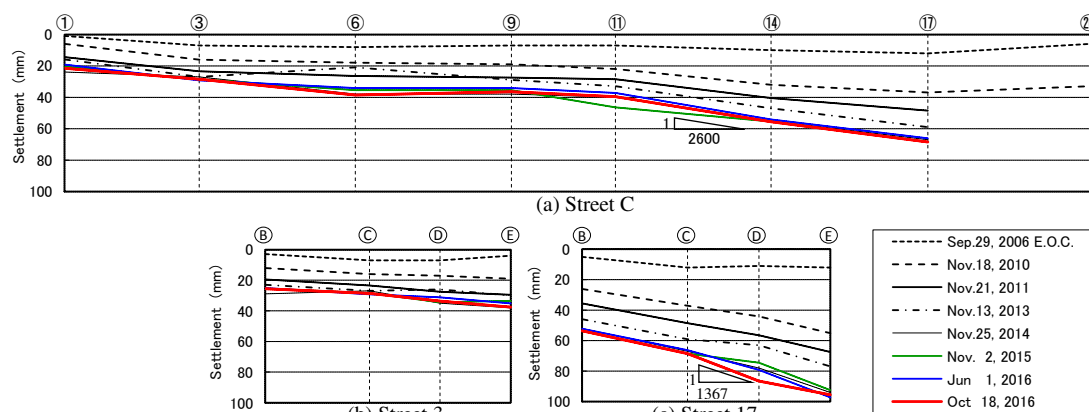
Figure 6 shows the settlement profiles of the first floor after E.O.C. The settlements of the first floor reached 22 mm (at 1C) to 96 mm (at 17E) in October, 2016. At that time, the maximum angular rotation was 1/1367 radian in the east-west direction (B-E along Street 17) and about 1/2600 radian in the north-south direction (9-17 along Street C), which were less than an acceptable value of 1/500 radian in Figure 7 shows the average contact pressure from a pair of earth pressure cell and the porewater pressure beneath the mat slab. The contact pressure after E.O.C. was seen clearly, 5-14 kPa, from both earth pressure cells. The porewater pressure beneath the mat slab near 17C was varied from 2 to 6 kPa. Note that no data were obtained from the piezometer near 3C. At the time of the 2011 earthquake, no significant change in contact pressure between the raft and the unimproved soil was observed after the event. This confirms that the effectiveness of the grid-form DMWs as a countermeasure of soil liquefaction against seismic motion

Figure 6. Time dependent settlement profiles of the 1st floor
