Typology of landslides, investigation and monitoring in flysch deposits in Albania

Skender Allkja, Ardita Malaj

ABSTRACT: The development of infrastructure, energy and tourism in recent years in Albania has brought the necessity of geotechnical studies to a higher technical level. Most of these buildings (hydropower, motorway, pipeline) are built in mountainous areas with complicated geological conditions. The most complicated obstacles seem to be huge landslides, especially for those situated on flysch deposits. Most of the huge landslides were innate and active by the end of Pleistocene; however, some of them, especially those in flysch areas, are activated due to recent changes of climate and intensive man activities. Examples of re-activation of old landslides are encountered on Qukes-Qafe Plloçe road, on Devoll river valley where are being built several hydropower and on Poliçan-Potom area where is built a gas line. These landslides are under design investigations using field and laboratory methods like drilling, inclinometers and piezometers measurement, geophysical probing, rock and soil testing. All slopes with flysch rocks in Albania have low stability because of the pre

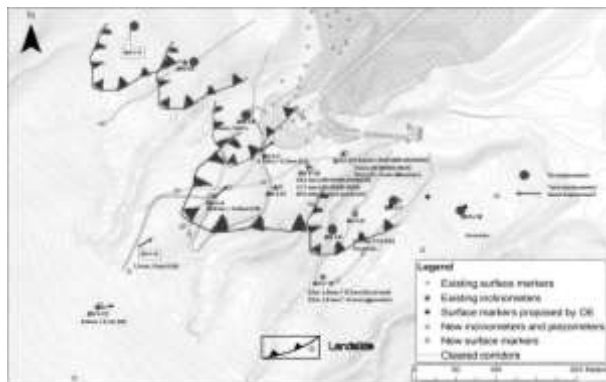
Figure 7. Landslide at Banja dam.

The landslides located near the large dams and reservoirs have big dimensions. The target in these landslide areas, is to evaluate the hazard created by movement of big soil masses, directly in the reservoir. The landslide hazards, near the dams, are evaluated and protective measures are taken. Although these measures include long time monitoring, for each movement, extra protective measures are needed, in addition to the calculations made.

No remedial works are undertaken for the stabilization of these landslides, but the potential soil mass that may slide into the reservoir is estimated, along with the released energy and the impact that they will have on the water level of the lake and this is calculated later on, during the design phase, as a safety height of the dam, over the maximal water quota in the lake. These landslides are being studied for their dynamic movement with respect to time and weather conditions.

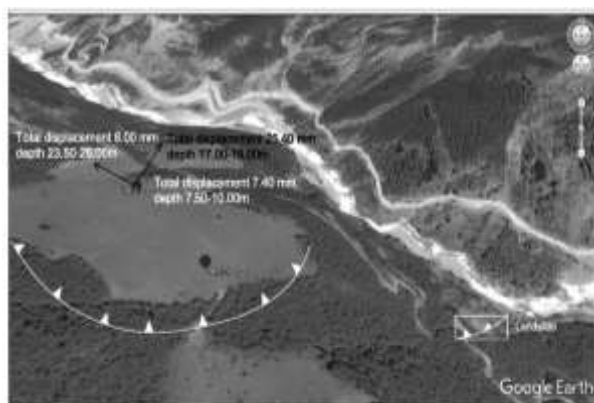
Figure 8. Landslide at Moglica dam.
