# Green system for erosion control and stabilization as an alternative to shotcrete: A case study of Bogotá - Villeta highway slope

Javier Quiroga Dionisio

PAVCO WAVIN, Orbia

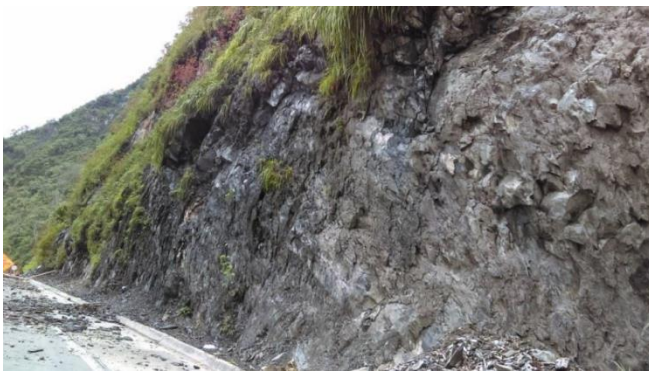
Figure 2. Debris fall.

Precipitations causes the continuous release of material from the slopes and consequently may lead to landslides, which fall to the highway generating permanent risk for the users.

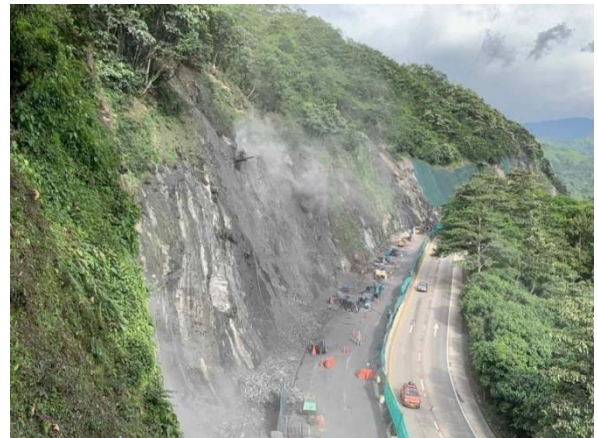
Figure 4. Slope initial condition (K60).

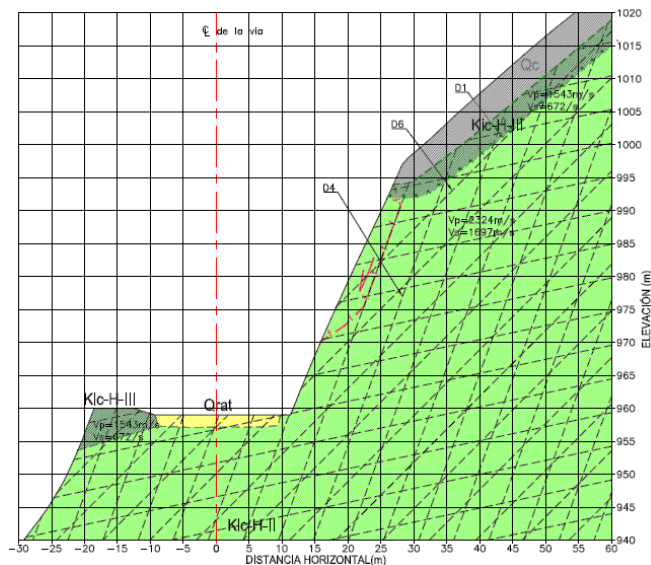
Figure 3. Slope initial condition (K60) and debris drop.

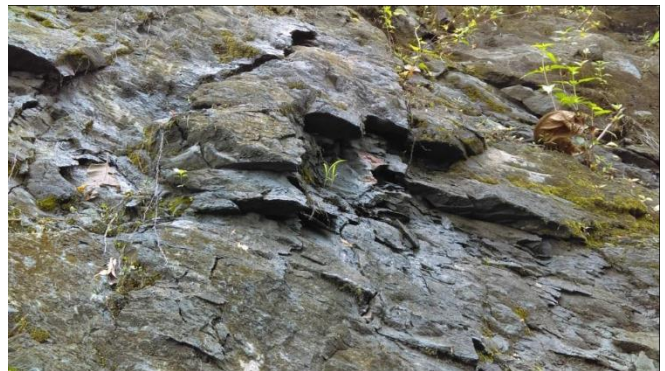
In some places, cuts in sedimentary rocks of the Capotes Formation are evident. Siltstones, mudstone and calcareous mudstones are identified. These rocks have been affected by tectonic events associated with the lifting of the Central Mountain Range throughout geological time. Consequently, they reflect a strong fracturing, high porosity and secondary permeability of the massif.

Figure 5. Very fractured calcareous mudstone.

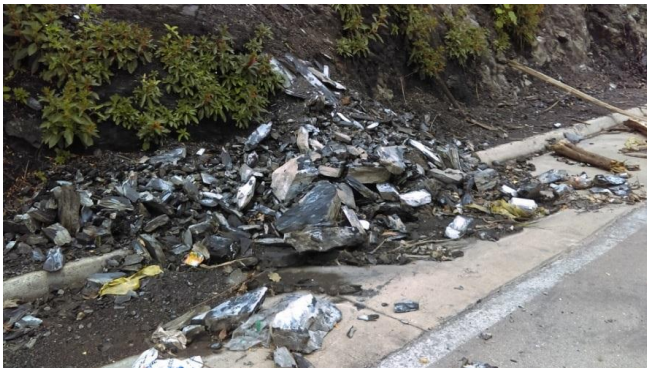
Figure 6. Rock Blocks fall to the road.

From the previous conditions that generate instability in the sector, some predominant typologies are identified, which correspond to blocks detachment associated with the discontinuities arrangement of the rock mass.

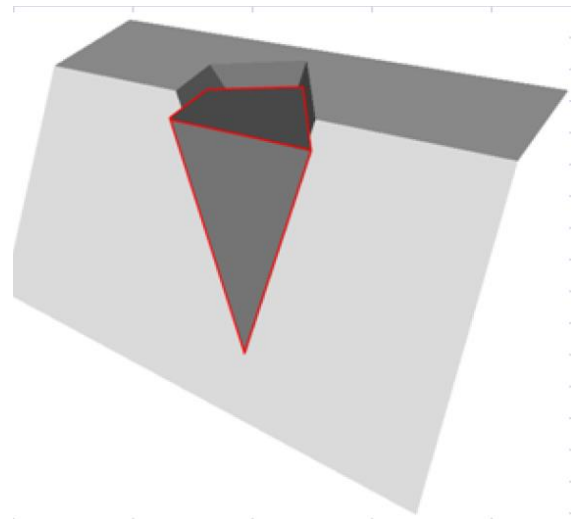
The analysis indicates that the wedge failure is the critical condition, even more than the planar failure, because a greater bolts capacity is required.

Figure 7. Wedges Modelling by using specialized software.

Several methods of calculating slope stability based on the balance of forces, moments or energy are used. Most often, the methods based on the assumption that failure occurs towards slip surface. The shape of slip surface depends mainly on the physical and mechanical properties of soils or their arrangement in the profile. The stability analysis in question takes into account the families of discontinuities that predominate in the sector and the cutting slopes directions. This structural data was analyzed using the DIPS V5.1 software to determine the failures associated with each of these slopes.

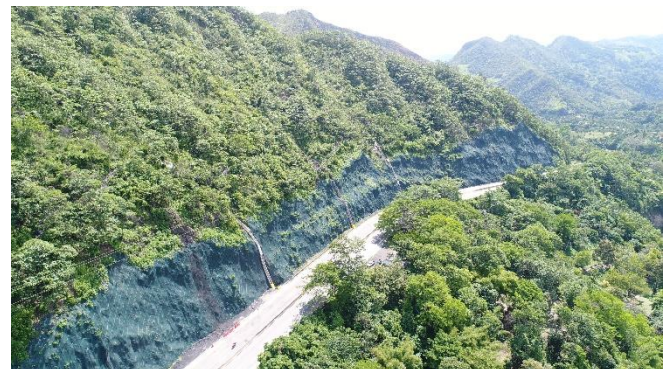
Figure 8. General view of the slope intervened by green system

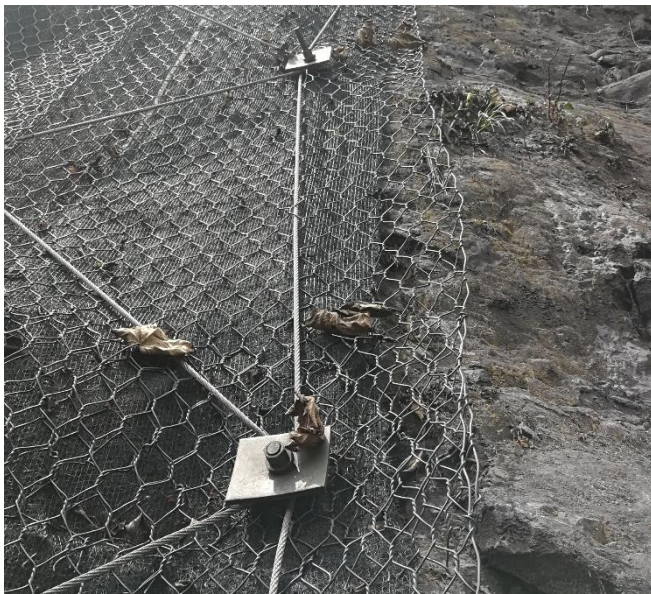
Figure 10. 15cm x 15cm steel plate and hexagonal nut

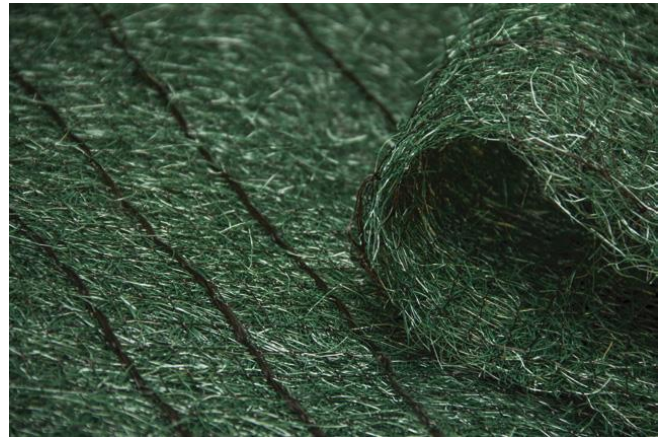
Figure 11. Permanent and 100% UV stabilized fibers mat

These types of mats are suitable when natural vegetation, by itself, is not able to withstand flow conditions, and provide sufficient protection for long-term erosion neither.

Considering the erosion potential of the analyzed slope that is determined by four basic factors: soil characteristics, vegetative cover, topography, and climate. A geosynthetic mat was specified for control erosion in the slope surface.

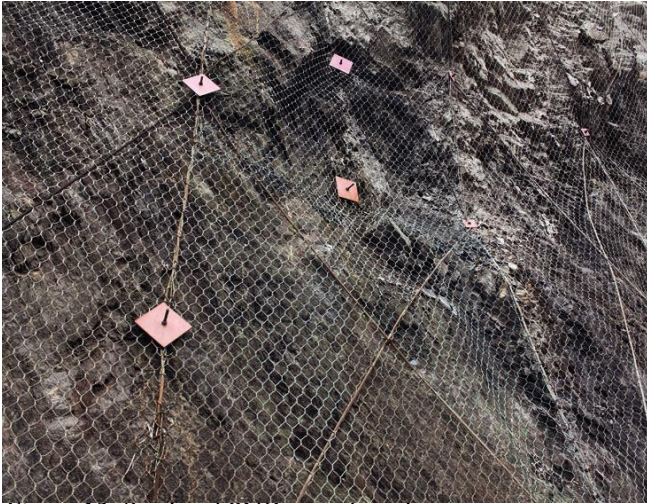
The mesh is a two-dimensional element, composed of high resistance wires arranged in a hexagonal configuration, whose flexibility allows easy adaptation to the slope morphology. It is a retention element used in slopes formed by residual soil, with a high presence of blocks from weathered rock and with frequent fall of debris and landslides of medium-sized material.

Figure 13. Steel and PVC coated mesh

The mesh used for this specific slope consist in a galvanized steel triple torsion and PVC coated mesh. The element is responsible for keeping soil particles in place and preventing mats damage due to strengths caused by surface detachments.

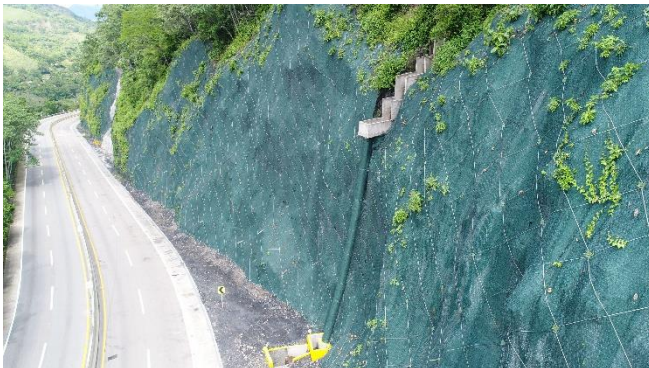
Additionally, wires were used among the bolts, allowing load transferring from the mesh towards the bolts around.

Figure 14. Steel and PVC coated mesh.

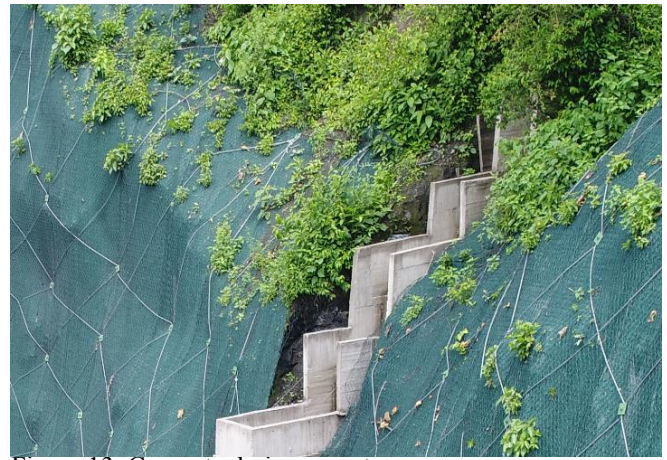
Two specific structures were design for that purpose. A concrete dissipation structure and a flexible waterproofed ditch with 0.75mm geomembrane at the crest of the slope.

Figure 13. Concrete drainage system.

It is fundamental to guarantee optimal drainage conditions over the entire slope. Free water flow is the optimal condition in the slope surface for avoiding hydrostatic pressures. At the top, flow must be control and driven carefully.

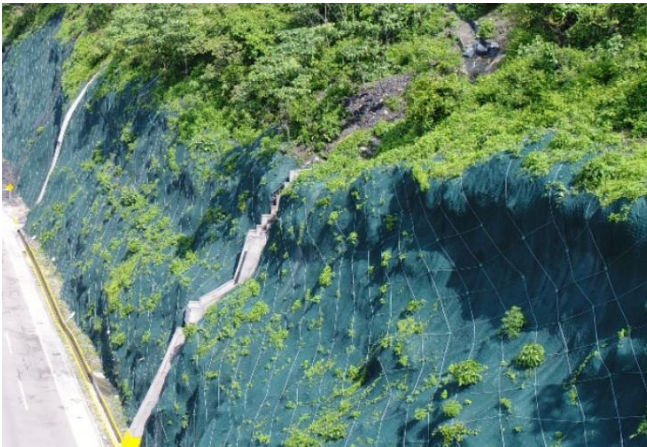
Four months after de system implementation, 25% of the slope surface was cover with vegetation. It is expected to continue growing in the near future.

Figure 14. Re-vegetation process
