Possibility of landslide damming in the Vakhsh River catchment and its effect on the hydraulic schemes and population

Abstract

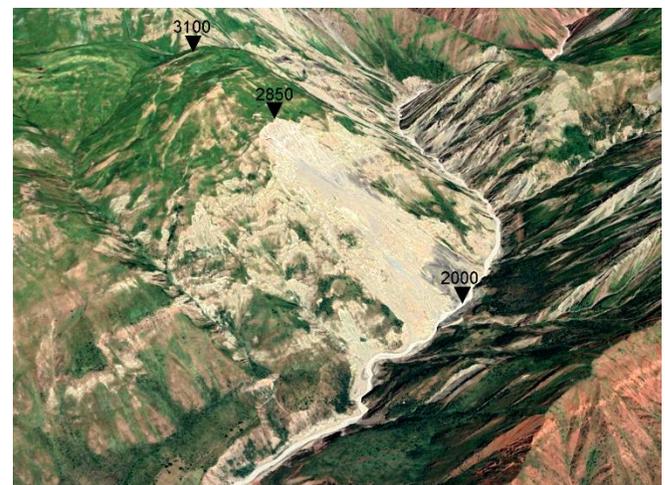
Figure 2. Google Earth image of the valley slope with well visible evidence of deformations.

Results of these modeling demonstrate rather good spatial convergence of the boundaries of the unstable rock mass revealed by simulation with arcuate scarps visible on space images and formed by earlier slope deformations (compare Figs. 2 and 5). They show that at present, even without seismic shaking, this slope is close to the limited equilibrium state – the calculated factor of safety value just slightly exceeds 1.0. In such conditions, maximal distance between sliding surface and

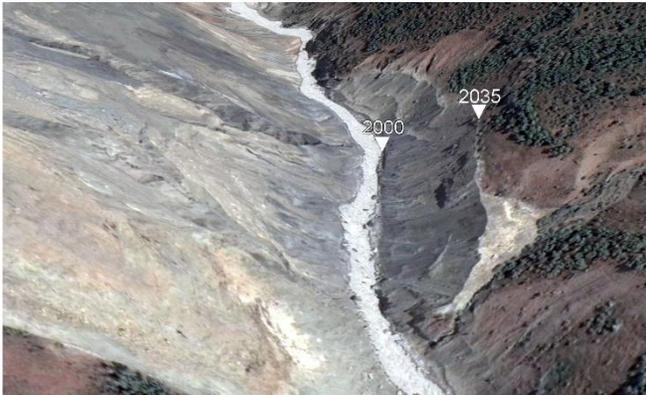
Figure 3. Remnant of the completely eroded dam in the Ragnow River valley. 3D Google Earth image.

Comparison of the available aerial images of 1956 and of the space images made in late 70's – early 80's show that the frontal face of this slope had collapsed first time within this period (Strom and Abdrakhmatov, 2018). There is also an unpublished report of the Geological Survey of Tajikistan that similar failure occurred in August 1983 (N. Ischuk, personal communication) and that river damming lasted for 3 days before the dam was breached. Most likely that just its remnants can be seen on modern space images (Figure 3).

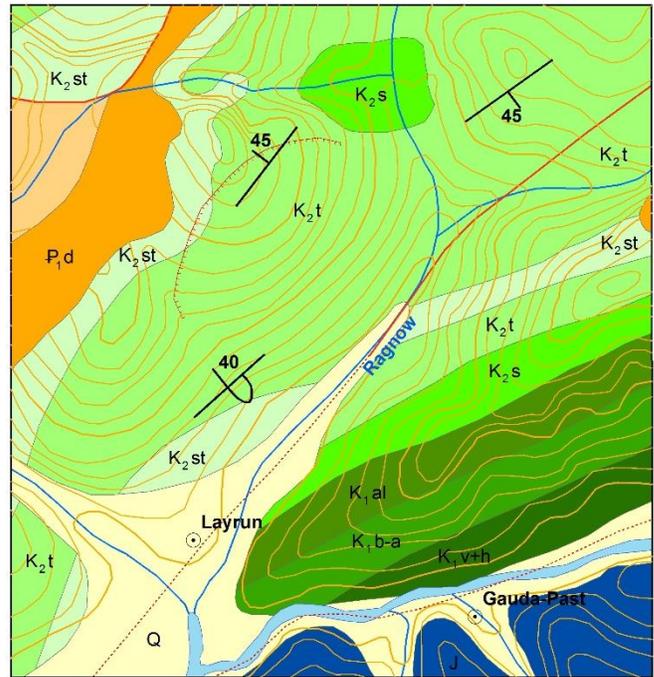
Figure 4. Geological map of the site based on the 1:200000 State geological map of the USSR, Sheet J-42-XI (1962). P_{1d} – gypsum and clay with marl and sandstone interbeds; K_{2sn} – limestone, marl, clay, sandstone, gypsum; K_{2t} – limestone, clay, sandstone, gypsum, mudstone; K_{2cm} – clay, sandstone, conglomerate, limestone, gypsum; K_{1v+h} – K_{1al} – sandstone, clay, gravelly conglomerate; bold red lines – faults; dotted red lines – assumed faults; thin comb red line marks the most distant arcuate scarp (assumed headscarp crown).

Rockslides represent a specific group of slope processes (Zerkal, Fomenko, 2016). Their numerical modeling is complicated since compilation of the correct geomechanical model requires consideration of numerous factors such as bedding, density and orientation of fracture systems, anisotropy of rock properties, etc. We performed the numerical simulation based on the simplified geomechanical model that takes into account just general geology of the slope that can be revealed from the 1:200 000 State geological map (Figure 4), and averaged mechanical properties of the affected rock types.

Taking into account poor mechanical properties of the material that would form a dam (see legend in Figure 4), its catastrophic breach and almost complete emptying of the dammed lake cannot be excluded. Such outburst flood would devastate the entire Obi-Khingou River valley downstream the Ragnow River mouth and all the released water will finally reach the Rogun reservoir with an area at its full level of about 180 km^2 .

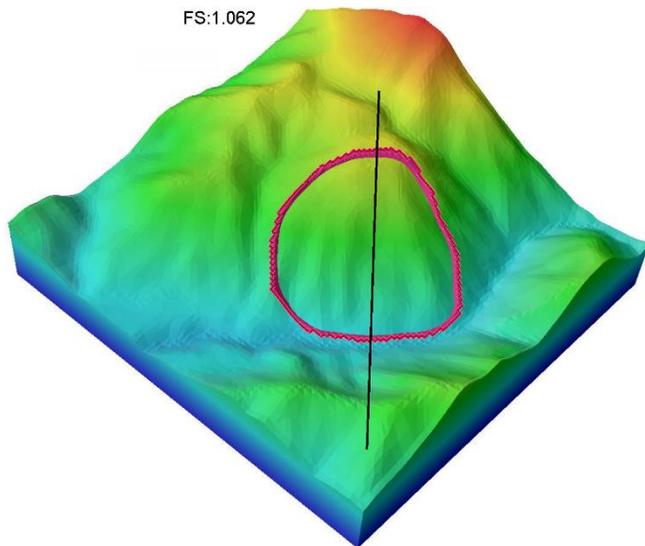
Figure 5. Boundary of the potentially unstable rock massif (red line) derived by numerical modeling in 'static' conditions (without applying seismic load). Calculated FS=1.062. Black line – profile shown in Figure 6.

The numerical modeling was carried out in two stages. The static slope stability analysis was performed, first, to estimate factor of safety and volume of the potentially unstable massif (Figure 5). At the second stage we analyzed effect of strong motion of earthquakes with anticipated intensity of 7.0, 7.5, and 8.0 points of the MSK-64 scale (corresponding seismic accelerations 0.1g; 0.15g; 0.2 g) on the area and volume of slope failure.

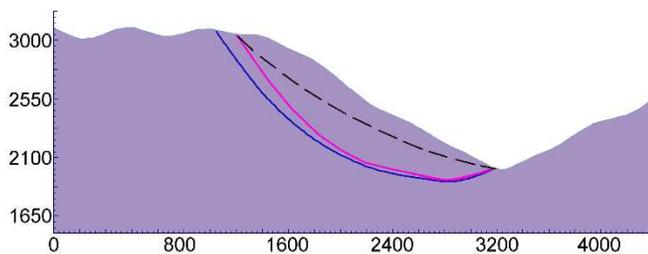
Figure 6. Cross-section of the potentially unstable slope (see Figure 5) with assumed sliding surfaces derived from numerical modeling. Red line – without seismic loading; blue line – with PGA = 0.2 g; black dashed line – previous expert judgement (Strom, et al., 2019).

daylight surface could reach 400 m and volume of the potentially unstable rock mass is about 980 million m³ – 3 times more than volume revealed previously by expert's judgement (see Table 1 and Figure 6).

The very rough, preliminary numerical modeling of the stability of the slope affected by strong earthquake shows that if its intensity will be just 7 points of the MSK-64 scale it could destabilize rock massif creating large-scale rockslide. Further increase of strong motion intensity results in gradual widening of the slope area that might be involved in failure, and with rather small increase of the sliding surface depth. It could result in increase of rockslide volume that might reach ca. 1.3 km³ if PGA will increase up to 0.2 g (Figures 6 and 7).

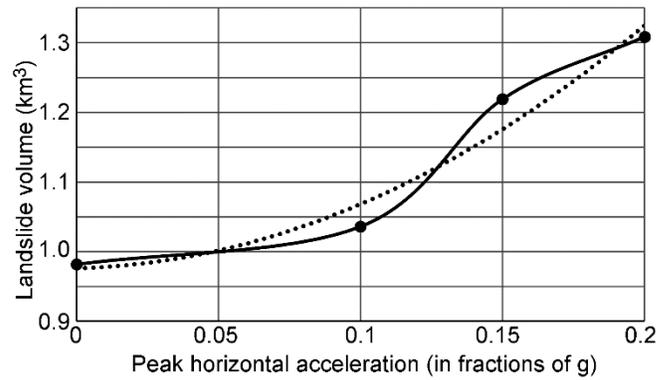
Figure 7. General dependence of the potentially unstable massif volume on horizontal PGA value. Solid line fits to calculated values (dots); dotted line – approximation.

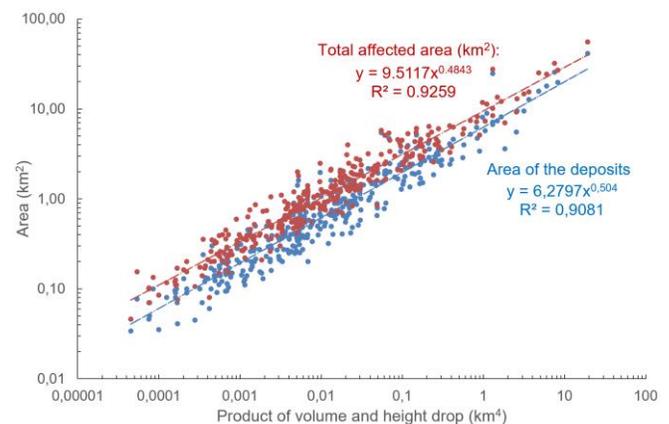
Figure 8. Relationships between total affected area (A – red dots) and area of the deposits (A_{dep} – blue dots) and the product of landslide volume and height drop for rockslides and rock avalanches with frontal confinement in the Central Asia region (331 cases)

The potential Ragnow-mouth dam's height was estimated as follows. First, the total landside affected area (A) and area of the deposits (A_{dep}) were estimated according to the statistical relationships between these parameters and the product of landside volume (V) and height drop (H) (Strom and Abdrakhmatov, 2018; Strom et al., 2019) (see Table 1 and Figure 8).

We calculated total landslide affected area (A) and then subtracted 2 km^2 (the assumed headscarp area) to get A_{dep} value. Direct calculation of the landslide body area (Strom et al., 2019) gave smaller A_{dep} value for landslide volumes of $0.98\text{--}1.3 \text{ km}^3$ resulting in much larger dam's height – up to 520 m (see Table 1) that seems to be unrealistic in this particular case. Besides, the correlation coefficient of the relationship between A and $V \times H$ is slightly higher than between A_{dep} and $V \times H$ (see Figure 8).

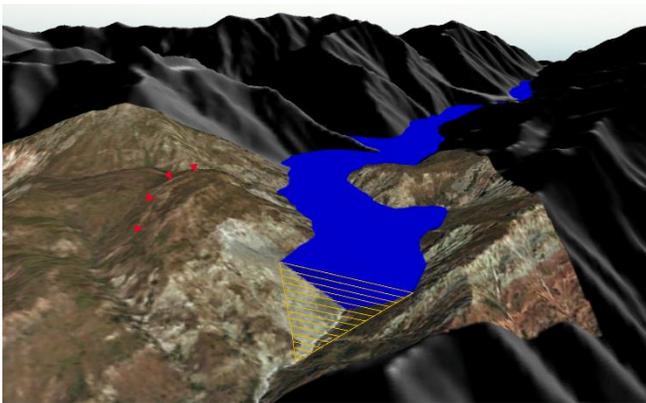
Figure 9. Impounded lake formed by assumed 400 m high landslide dam (its' quite schematic downstream slope is marked by hatched triangle). Red triangles mark the most distant arcuate scarp visible on space images. 3" SRTM DEM combined with space image and visualized by Global Mapper software.

Such dam could form a lake up to ca. 1.5 km^3 in volume (Figure 9) – almost 3.5 times larger than the dammed lake estimated previously (Shakirov et al., 2018).
