The paper was published in the proceedings of the 13th International Symposium on Landslides and was edited by Miguel Angel Cabrera, Luis Felipe Prada-Sarmiento and Juan Montero. The conference was originally scheduled to be held in Cartagena, Colombia in June 2020, but due to the SARS-CoV-2 pandemic, it was held online from February 22nd to February 26th 2021.

Microzonation for the management of landslide risks in natural disasters - Case Study in the Peruvian southern highlands

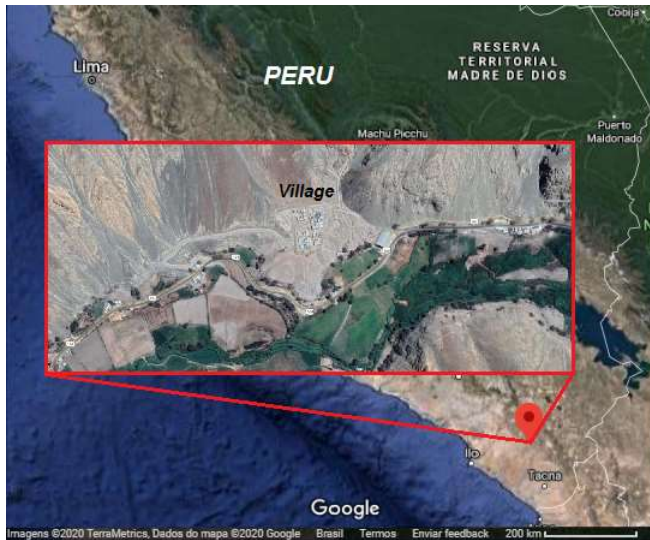
Figure 1. Satellite view of the study (Google Maps, 2020)

With different geological formations, the study area (Figure 1), mostly includes volcanic rocks, intrusive rocks on which quaternary deposits are found (Figure 2). With the presence of the Matalaque Formation that includes lithocrystalline and crystallolytic tuffs, which correspond to the lower Cretaceous, this unit is distributed along the entire right bank of the Curibaya River and the study area, being well welded and in some gap-type sections. The Paralake Formation has lithic welded tuffs, which are assigned a higher Cretaceous age. This unit is distributed along almost the entire left bank of the Curibaya River and the study area. The Quellaveco Formation has two units, of which only the Samanape Andesite is within the study area, and consists of microporphyric andesites and vitrolytic tuffs, they are assigned a Cretaceous age greater than the Eocene, they are located in both margins, on the Matalaque formation and in the case of the left bank on the Fm. For which. The Tarata Superior Formation consists of pyroclastic rocks, limonites, dark limestones, it is assigned an age of the Upper Paleogene (Oligocene), they are found in the upper parts of both sides of the valley. Alluvial Colluvial Deposits are recent unconsolidated deposits, which are of colluvium and alluvial and colluviums are those found on the slopes, detritus cones on detritic skirts. They are formed by the action of the surface flow of unchanged water, when it flows into the main valley (Curibaya). The texture of the deposits ranges from silt, sand, gravel and buttonhole, subangulous. It is at the base of the debris cones that homes are often located. In the study area they are mainly at the foot of the hills (Wilson and García, 1962).

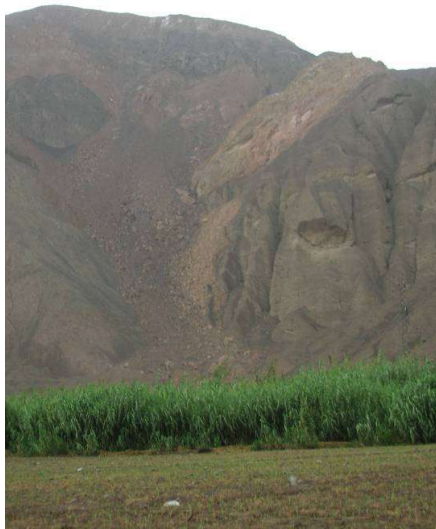
Figure 6. Geological fault, lithological contacts

The hazard assessment will be based on the analysis of the coverage formations, which are best, represented and analyzed from a geomorphological and geotechnical point of view; for which the survey on the ground of the Substrate and the Forms has been programmed (Figure 6).

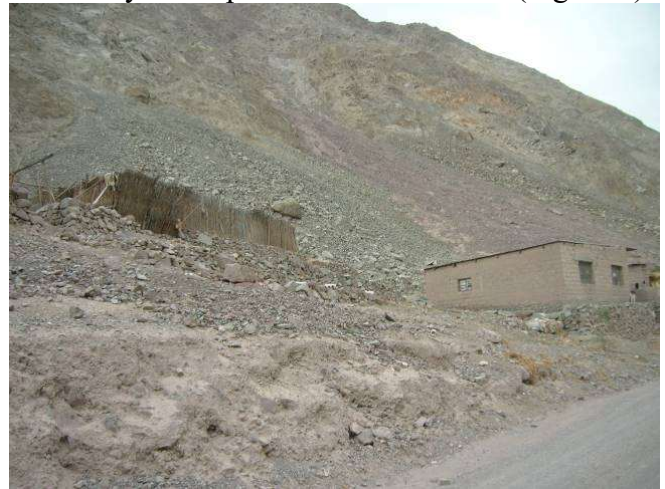
Figure 7. Detritus cone

Within which there are landslides, landslides, laundry, hillside detritus, detritus cone, detritus skirt. These geomorphological features are those of greatest interest in the hazard assessment. Detritus cone located at the foot of a detrital wash (Figure 7).

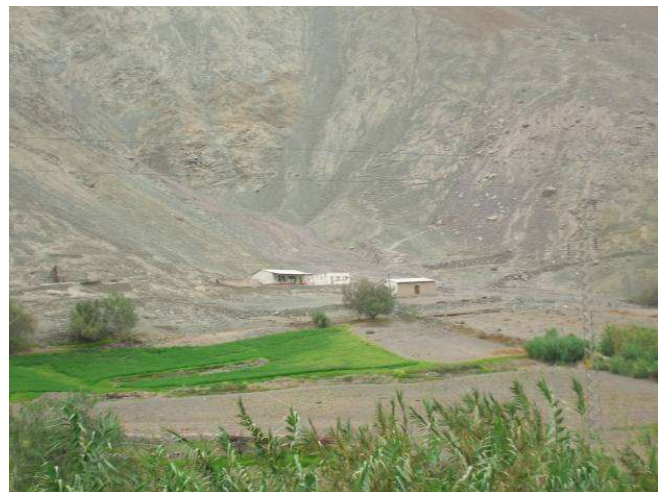
Figure 8. Alluvial cone

Within which we have the gullies, erosion escarpments or terraces, alluvial deposits, alluvial cones, colluvial deposit. Alluvial cone is that accumulation deposit, which by way of a fan, is formed by the deposition of some river (Figure 8).
