*The paper was published in the proceedings of the 13<sup>th</sup> International Symposium on Landslides and was edited by Miguel Angel Cabrera, Luis Felipe Prada-Sarmiento and Juan Montero. The conference was originally scheduled to be held in Cartagena, Colombia in June 2020, but due to the SARS-CoV-2 pandemic, it was held online from February 22<sup>nd</sup> to February 26<sup>th</sup> 2021.*

# Failure mechanisms of large volume rock avalanches in the Andes of Central Chile: a brief discussion

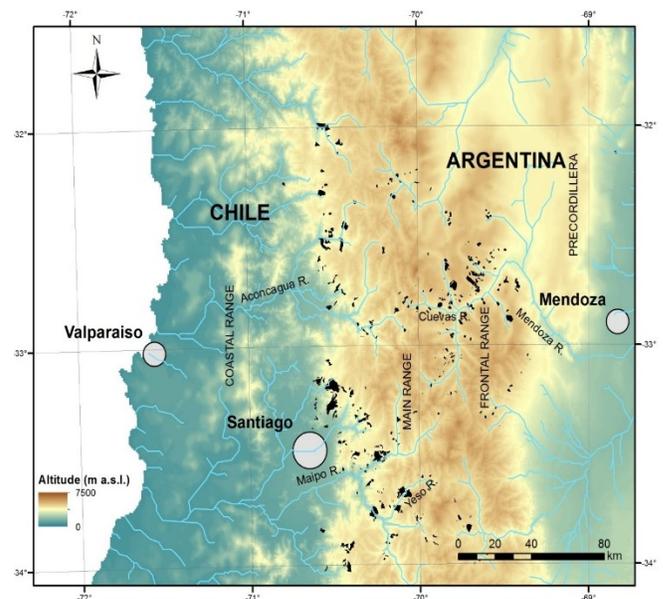
Figure 1: Large volume landslide inventory of central Chile and Argentina (modified after Sepúlveda and Moreiras, 2015)

Large volume landslide inventories in central Chile (Antinao and Gosse, 2009; Moreiras and Sepúlveda, 2015; Figure 1) have related the origin of large volume landslides (Figure 2), mainly rock slides and rock avalanches, with a likely seismic trigger. In particular, Antinao and Gosse (2009) correlate their distribution with main geologic faults, which have been mostly not studied in detail

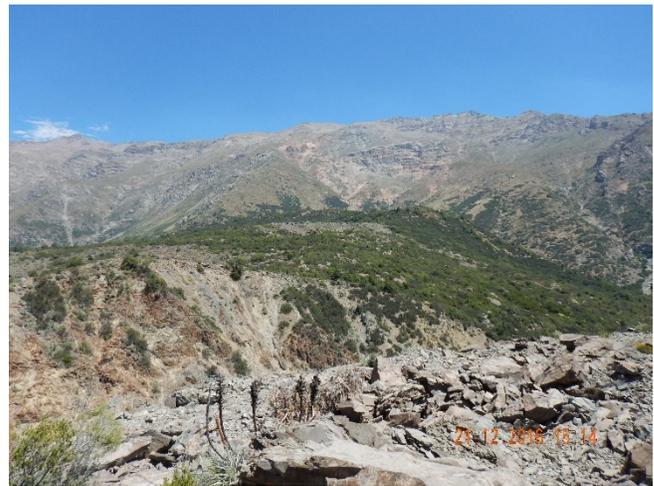
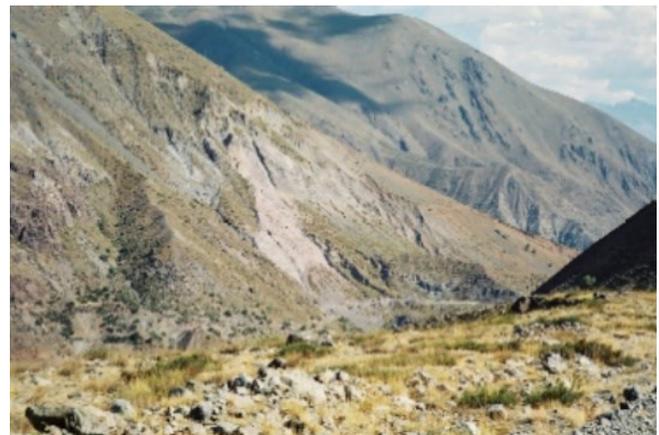
Figure 2: Examples of large volume landslides in the region: Above, prehistoric rock avalanche deposits in Pangal valley (34.2°S, Sepúlveda et al., 2019); below: Las Cortaderas landslide reactivated during the 1958 earthquake in an old, large rock collapse deposit in the Yeso valley (33.7°S; Sepúlveda et al., 2008).
