The paper was published in the proceedings of the 13th International Symposium on Landslides and was edited by Miguel Angel Cabrera, Luis Felipe Prada-Sarmiento and Juan Montero. The conference was originally scheduled to be held in Cartagena, Colombia in June 2020, but due to the SARS-CoV-2 pandemic, it was held online from February 22nd to February 26th 2021.

Landslide Risk Mapping as Risk Management Tool

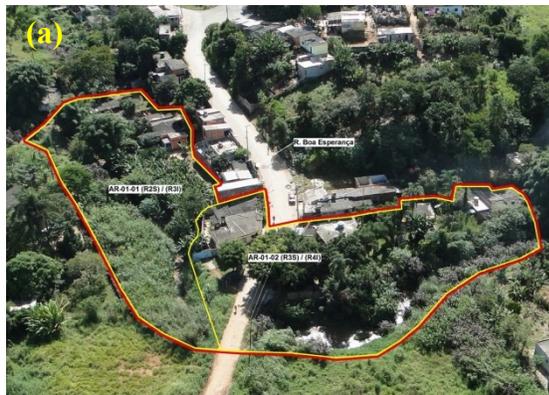
Figure 4 – (a) Area AR-01 mapped in 2012 presenting 2 risk sectors (R3) and (R4); (b) Area AR-01 mapped in 2016 presenting only one risk sector (R2).

In addition to a decrease in the number of mapped sectors in 2016, there was a reduction and/or elimination of major risks mapped when compared to 2012, as showed in Figures 2 and 3 for landslides and floods, respectively. Figure 4 presents an example of a mapped area in both 2012 and 2016 where the risk level has decreased.

In the Rosely neighborhood (AR-01), interventions were made, such as:

- cleaning services in the Taboazinho stream channel;
- Segment install under Esperança street (1,5 meters tall and 1,0 meter wide), besides 2 tubes of 0,8 meters already existent in the 2012's mapping.
- Channel's enlargement; and
- Channel's deepening.

These structural measures reduced the flooded area at the place and reduced the gravity of the process on the elements at risk.
