## The Formentor rockfall in Mallorca (Spain): new protection barriers

Joan Maria Rius, Raül Aguiló

*Departament d'Infraestructures i Mobilitat, Consell de Mallorca. General Riera, 113. 07010 Palma de Mallorca (Spain)*

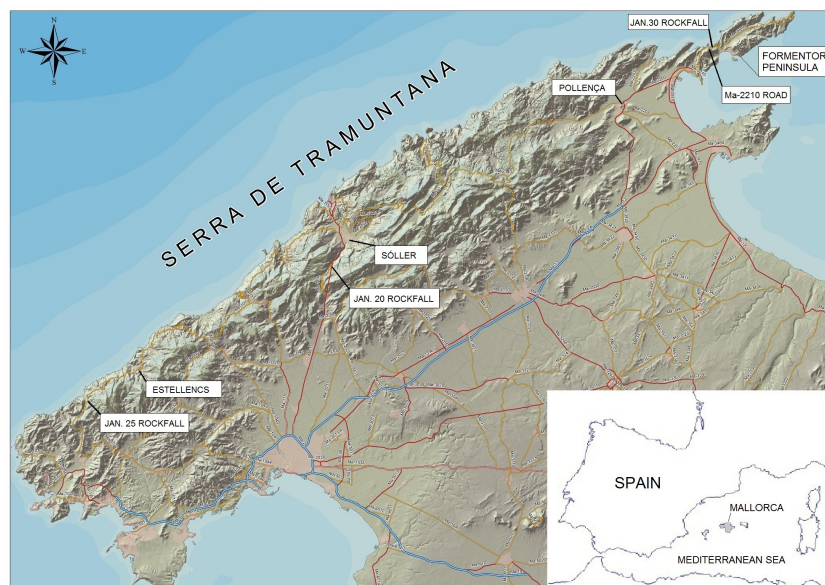
Figure 1. Location of Tramuntana Range in the northwest side of the island of Mallorca in the western Mediterranean Sea and the Formentor rockfall of January 30<sup>th</sup> 2017. Other rockfall events of winter 2017 are also located

The wet period of winter 2017 during December 2016 and January 2017 triggered several rockfall events with different rock volumes involved: January 20th at Coll de Sóller, 160 m<sup>3</sup>; January 25th at Estellencs, 20 m<sup>3</sup>; January the 30th at Formentor, 14 m<sup>3</sup> and other minor events (figure 1). All along the range rockfall events occurred and different incidents affecting main roads took place. All events triggered at the end of January 2017 were strongly related to rainfall. This relationship between rainfall and rockfall activity in Tramuntana range has been previously studied with ancient rainfall events (Mateos et al. 2012), and maximum of cumulated rainfall and previous daily rainfall were reported as triggering factors.

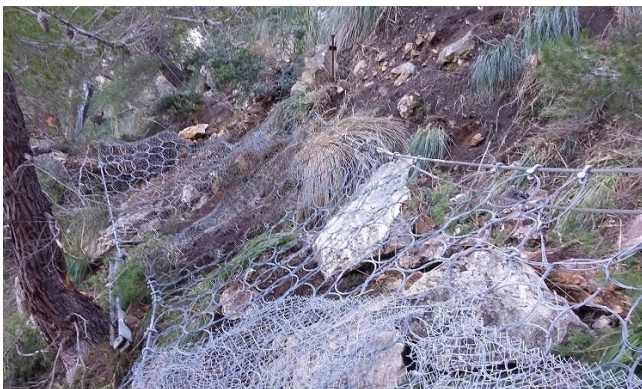
Figure 2. Pictures of Formentor rockfall event with severely damaged lying dynamic barrier and stopped rock blocks close to the Ma-2210 road.

On the evening of January 30th, 2017, the presence of rock blocks on the road that prevented circulation was reported by CIM road maintenance service due to a rockfall at km 6.2 of Ma-2210 road. They were able to restore circulation as only partial blockage of the road occurred. Afterwards, it was found that the detachment had affected a certain long of the dynamic barriers that were protecting the area of Mal Pas (Formentor). A rock mass of about  $14 \text{ m}^3$  was detached from a cliff about 45 m far from the road, moved down the slope and hit an area already protected with dynamic barriers (more than 20 years old and the first installed on the island) knocking them down along a section of 30 m wide and reaching the road (figure 2). Thus, a mass of about a total volume of almost  $14 \text{ m}^3$  in several blocks reached the surroundings of the road, having overcome the dynamic barrier being totally inclined, folded supports and lying on the ground. From recent preliminary CIM internal reports, it is interpreted a very low residual resistance capacity, due to damage in most elements, (brakes, ropes, wire nets, rock bolts) although the mass released and their probable impact energy would have overcome their theoretical capacity (1000 kJ and 3 m height) anyway (Rius & Aguiló 2017).

Therefore, it was essential to undertake an emergency action to recover the functionality of the barriers and the security of the road replacing the damaged barriers. A previous question about effectiveness of existing rockfall protection barriers arose. Recent studies show a reduction in residual capacity of barriers after previous impacts (Govoni et al. 2016) and the influence of different design parameters on their effectiveness.

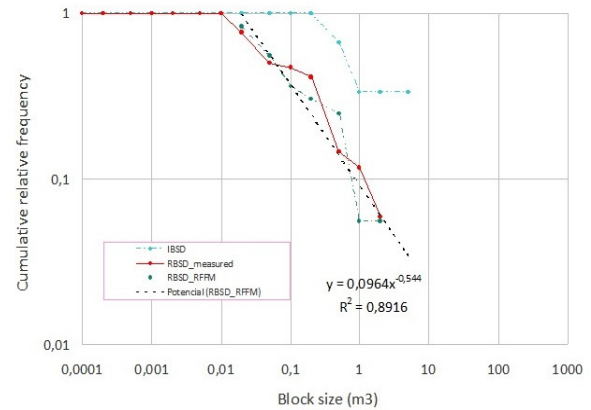
Figure 6. Formentor rockfall different cumulative relative frequency vs block size volume relationships: in-situ (cliff) block size distribution (IBSD), ground measured (RBSD\_measured), fractal model (RBSD\_RFFM) and power-law adjustment (Potencial)

risk assessment different patterns about magnitude-frequency of rockfall events have been extensively analysed with different techniques. Thus, the analysis of the Formentor rockfall event was performed taking into account rock fragmentation and impact kinetic energy from collected data. Figure 6 depicts the block size distribution and the adjustment with a fractal fragmentation model. A quite good fit with a power law with an exponent of 0.54 was achieved, value among referenced ones in this kind of events (Matas et al. 2017).

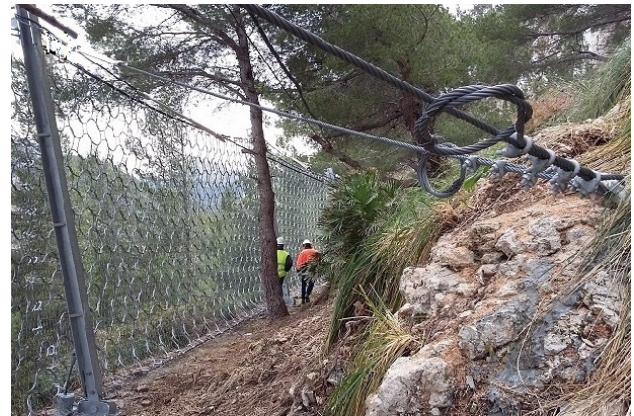
Figure 9. New dynamic barrier on Formentor rockfall area (April 2017 image)

The results of the performed analysis led to a new dimensioning for dynamic barriers with a protection capacity to be installed of 3000kJ capacity and 4m height as upper boundary design values. Therefore, in compliance with ETAG027 a barrier with MEL of 3000 kJ and SEL of 1000 kJ was selected. Reduced values of MEL and SEL energies after considering safety factor validate this design in terms of energy and height. Therefore, a uniform value of rockfall protection energy of MEL 3000 kJ (SEL 1000 kJ) and 4 m height was designed. Moreover, as it was detected after field investigations, the west side of the cliff area was not completely protected by existing barriers and in this side the length of protected area was stretched with 30 m of additional protection barrier to a rock wall, with a total length of 220 m. After an emergency project undertaken, in late April 2017 the new dynamic barriers were installed (figure 9).
