*The paper was published in the proceedings of the 13<sup>th</sup> International Symposium on Landslides and was edited by Miguel Angel Cabrera, Luis Felipe Prada-Sarmiento and Juan Montero. The conference was originally scheduled to be held in Cartagena, Colombia in June 2020, but due to the SARS-CoV-2 pandemic, it was held online from February 22<sup>nd</sup> to February 26<sup>th</sup> 2021.*

# Landslide Mitigation through Slope Reinforcement, Case Study La Colinas 2001 Landslide

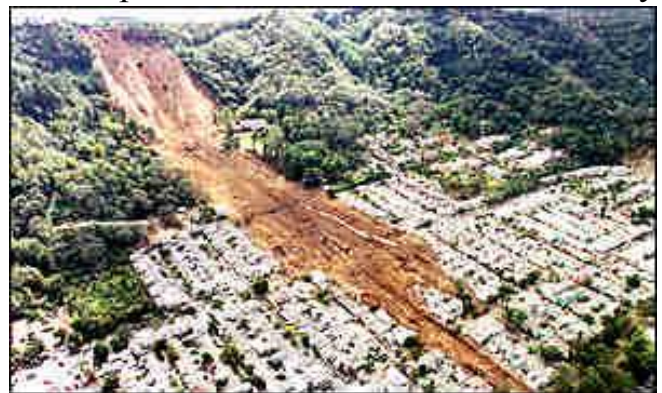
Figure 2: The Las Colinas landslide with its huge impact on the community at the foot of the slope (BBC 2001).

Hundreds of landslides were triggered across the country, after the earthquake and thousands of people were buried alive in their homes while countless were injured and left homeless (see Figure 2). The most

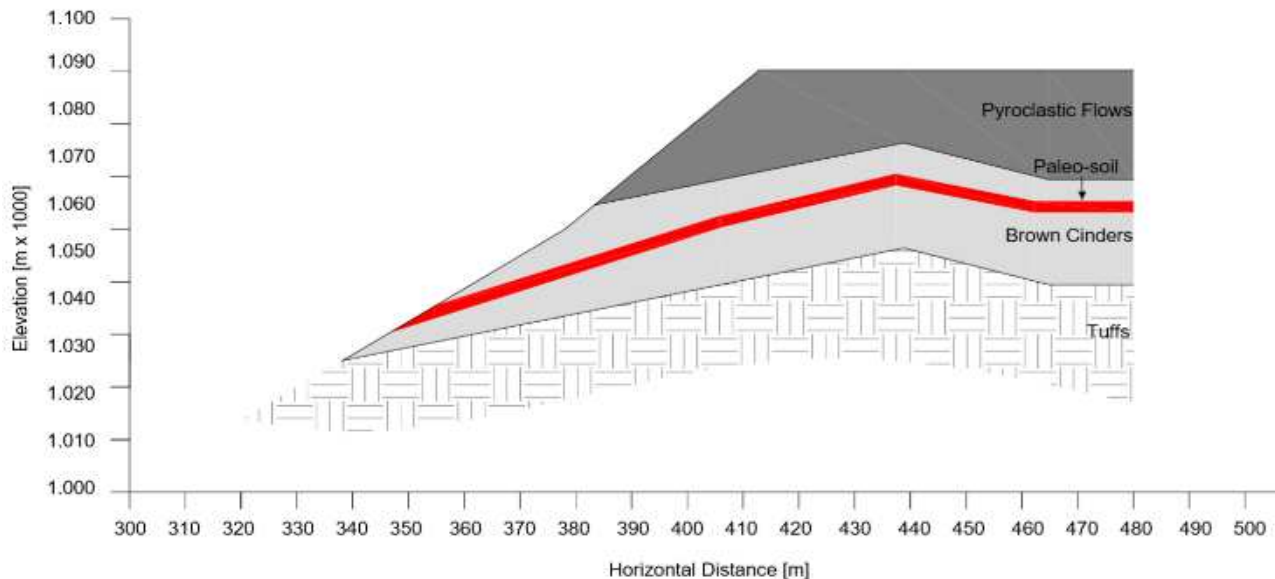
Figure 3: The geological scheme adapted from that of C. Lotti & Associati, 2001.

From these site investigations, four main layers were discovered (Figure 3): the

uppermost layer contained approximately 1m of lithoid elements. Just below this was the pyroclastic deposits comprising pumice, volcanic ash, sprouts and paleo-soil. Underlain by brown ash/ cinders followed by tuffs formation in which the SPT tests were generally rejected (C. Lotti & Associati 2001).

In this paper, a pseudo-static analysis was performed considering the geometry and soil layers presented in Figure 3 to determine a solution and the calculations will be described below. This analysis is effectively done through the application of limiting equilibrium practices that considers a force or moment of a particular soil above the potential failure surface (Akhlaghi and

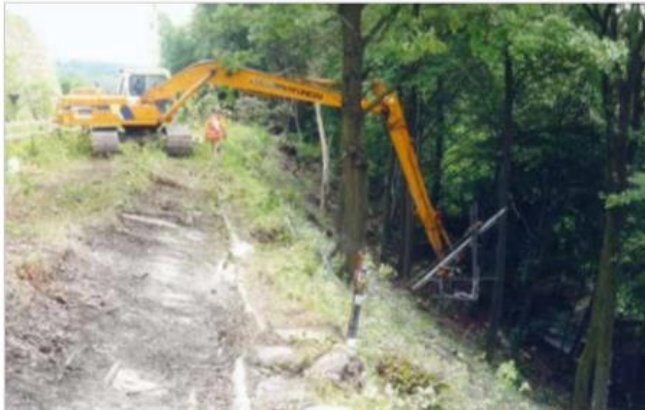
Figure 7: An example of soil nail installation in a forested area (Friedrich Ischebeck GmbH 2019).
