The paper was published in the proceedings of the 13th International Symposium on Landslides and was edited by Miguel Angel Cabrera, Luis Felipe Prada-Sarmiento and Juan Montero. The conference was originally scheduled to be held in Cartagena, Colombia in June 2020, but due to the SARS-CoV-2 pandemic, it was held online from February 22nd to February 26th 2021.

Back-analysis of slope wedge failure in residual soil and comparison with two software results

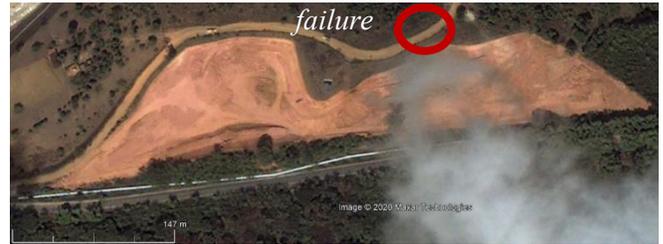
Figure 2: View of the studied area dated 11/11/2012. (Google Earth)

In 2012, the earthmoving started at the site of the project, Figure 2.

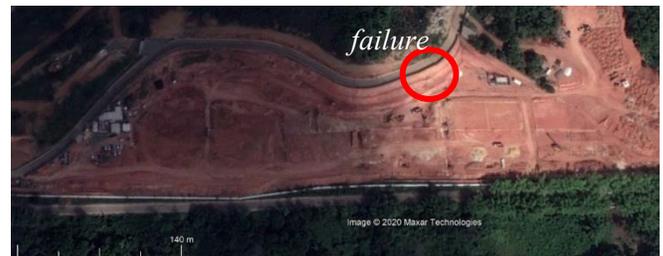
Figure 3, a satellite image dated 05/08/2016, shows the initial phase of earthworks on the internal streets of the project and the re-sloping processes, at this point, the failure had already occurred with close to 55 m³ sliding mass. The real slope inclinations, after all the earthworks in the site, were close to 47-49° (according to topographic surveys), different from the original design inclination of 45° (1:1).

Figure 3: View of the studied area dated 05/08/2016. (Google Earth)

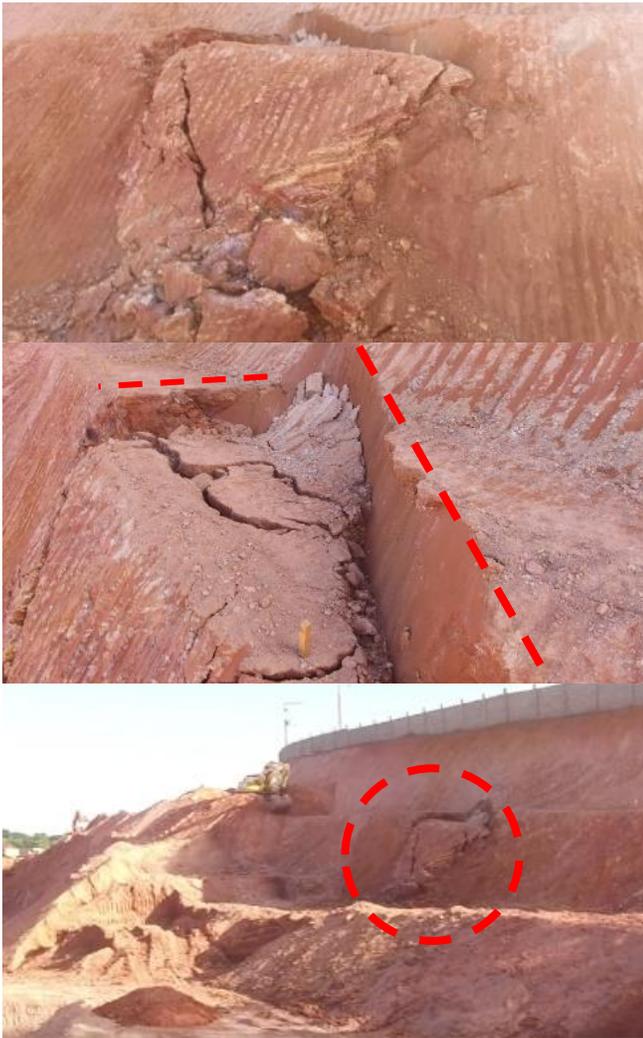
The Figure 4 shows the front, top and side view of the failure (wedge) and were taken from a drone footage on 03/17/2016.

Figure 4: Front, top and side view of the failure (Sérgio Velloso Projetos collection)

Due to this fact, it was decided to study the failure by back-analysis. Through a visual analysis of the failure, it was noted that the slope failure geometry resembles a wedge. For this reason, it was decided to use back-analysis by Swedge software in addition to the study by Slide software.

According to Rocscience, the software Swedge is an interactive analysis tool for evaluating the stability of surface wedges in rock slopes, defined by two intersecting discontinuity planes and the slope surface. The geometry of the failure that occurred in Lauro de Freitas city, Figure 4, is a wedge. So, this exact geometry was modeled in Swedge software, using topographic surveys data, to run the stability analysis.
