# Geophysical exploration for a large terrace landslide

Jorge Rodriguez, Jaime Azuaje

## Abstract

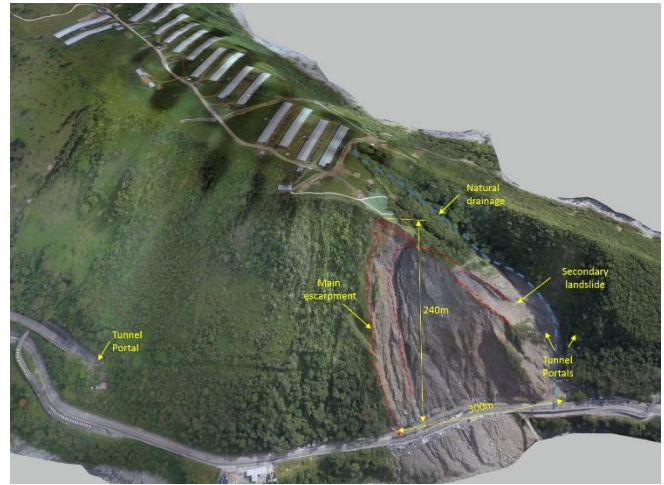
Figure 1. Overview of the study area on December 2019 (SCI, 2020)

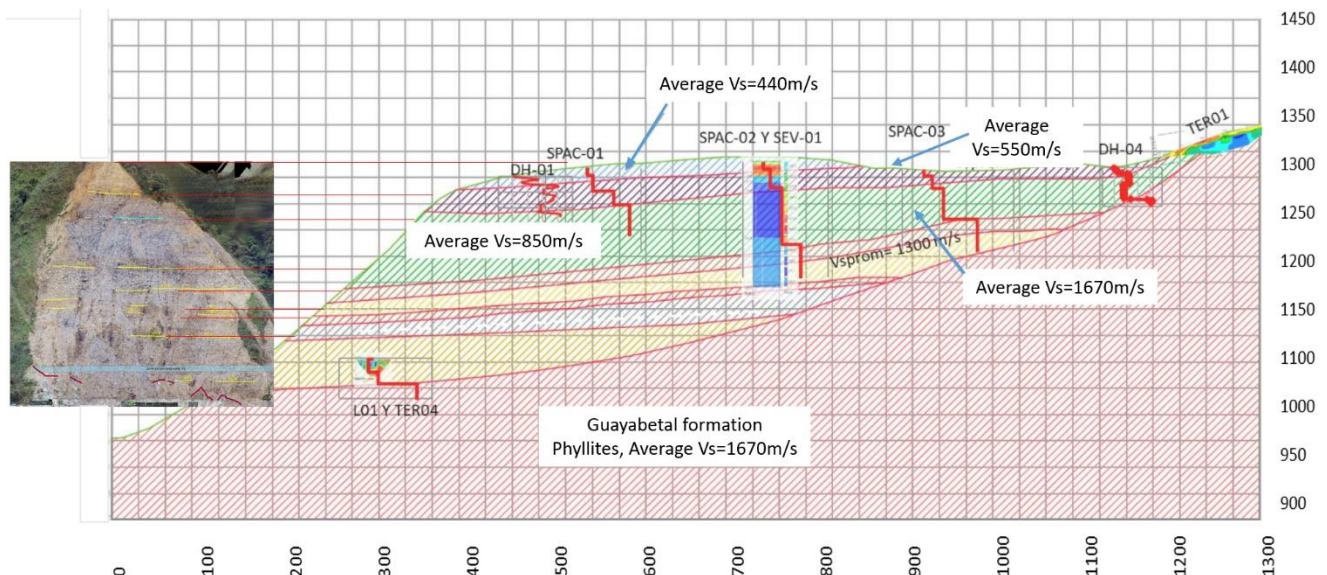
Figure 15. Results of geophysical exploration on the Mesa Grande Terrace. Succession of terrace levels over the Guayabetal formation.

Figure 14 shows an overview of the study area with the location of geophysical measurements performed. Figure 15 shows the geophysical data projected on a longitudinal section along the terrace.
