*The paper was published in the proceedings of the 13<sup>th</sup> International Symposium on Landslides and was edited by Miguel Angel Cabrera, Luis Felipe Prada-Sarmiento and Juan Montero. The conference was originally scheduled to be held in Cartagena, Colombia in June 2020, but due to the SARS-CoV-2 pandemic, it was held online from February 22<sup>nd</sup> to February 26<sup>th</sup> 2021.*

# The influence of relative density on the friction angle of iron ore tailings from the Fundão Dam

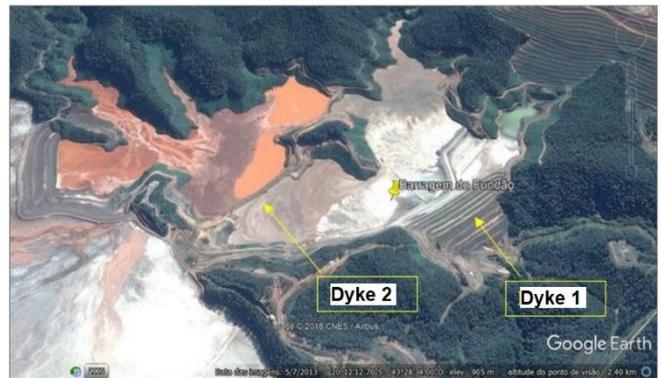
In the Fundão Dam, the sandy tailings were initially disposed in the reservoir of Dyke 1 and the slimes in the reservoir of Dyke 2, shown in Figure 1.

Figure 1. Fundão dam and its dykes in 2013 (Fabre, 2019)

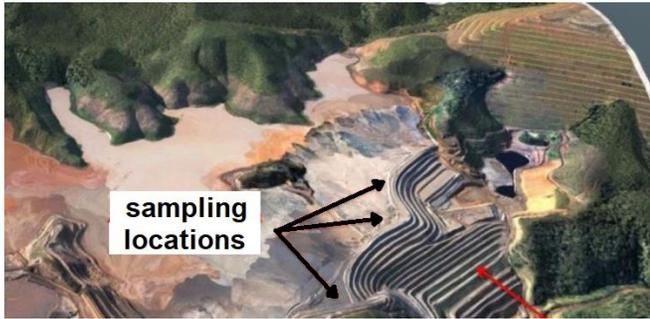
The disturbed samples were collected at the tailings discharge points located in the beach of Dyke 1. Figure 2 shows the sampling points.

Figure 2. Sampling locations (Flórez, 2015)

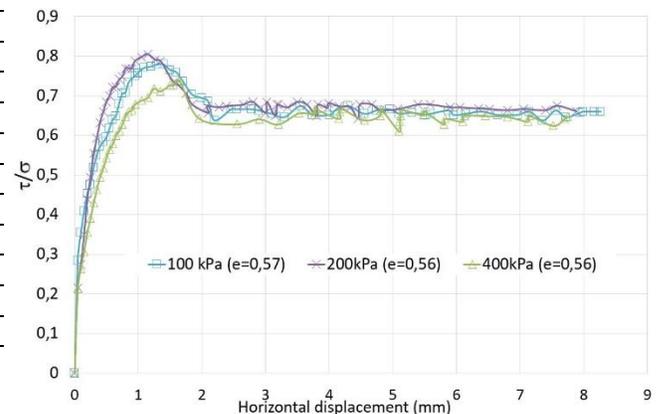
Figure 3 shows the normalized shear stress versus horizontal displacement.

Figure 3. Normalized Shear Stress x Horizontal Displacement –  $D_r = 98\%$

The behavior of the  $D_r = 98\%$  tailings shows a peak of resistance followed by quick loss of strength and stabilization.

The tests indicated a peak friction angle ( $\phi'_p$ ) of  $37^\circ$  and a “constant volume” friction angle ( $\phi'_{cv}$ ) of  $33^\circ$ . It is worth mentioning that, although the ultimate normalized shear stresses of all tests have stabilized at the same approximate value, the vertical displacement vs horizontal displacement curves have not.

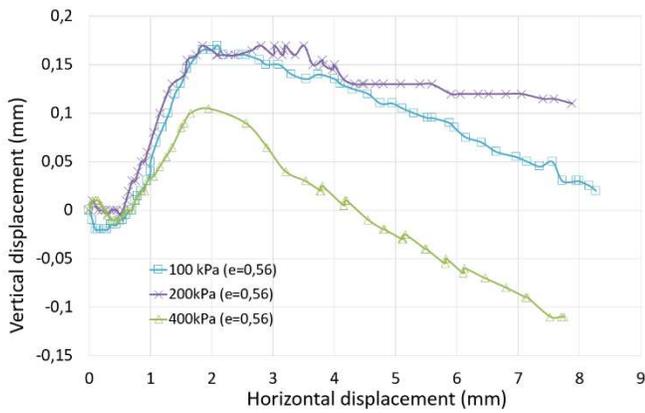
Figure 4 shows the graph of vertical displacement vs horizontal displacement. All tests showed a slight contraction followed by dilation. There was no volume stabilization in the tests of 100 and 400 kPa, in spite of the stabilization of the normalized strength in all tests.

Figure 4. Vertical Displacement x Horizontal Displacement –  $D_r = 98\%$

After a horizontal displacement of approximately 2.0mm, the vertical displacements of some tests exhibited a negative tendency. This lack of stabilization is probably due to uneven settlements of the top cap.

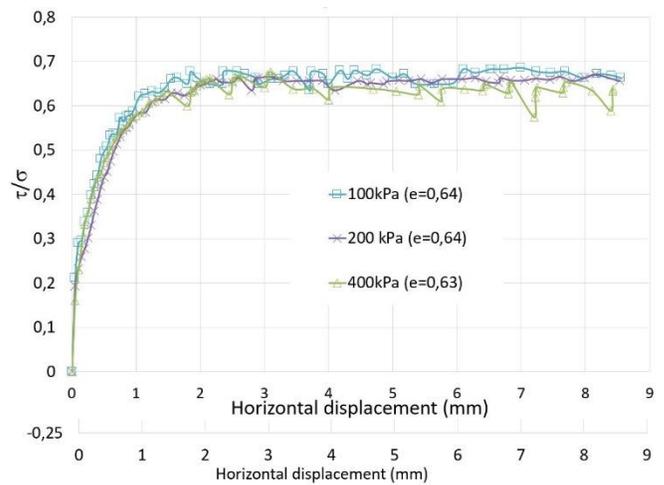
Figure 5 shows the graph of normalized shear stress versus horizontal displacement.

Despite the average relative density after consolidation of 81%, no peak is seen in the stress-displacement curves.

The vertical displacement vs. horizontal displacement curves show initial contraction, followed by a slight expansion, especially in the test with the lowest normal stress, as shown in Figure 6. The lack of volume stabilization is seen again in the, despite the constant strength.

Figure 5. Normalized Shear Stress x Horizontal Displacement –  $D_r = 81\%$

Figure 6. Vertical Displacement x Horizontal Displacement –  $D_r = 81\%$

The test results of samples with average relative density of 81% showed a “constant volume” friction angle ( $\phi'_{cv}$ ) of  $33^\circ$ , equal to that measured in samples with average relative density of 98%. The same consideration made regarding the “constant volume” for the compact sample applies to this situation.

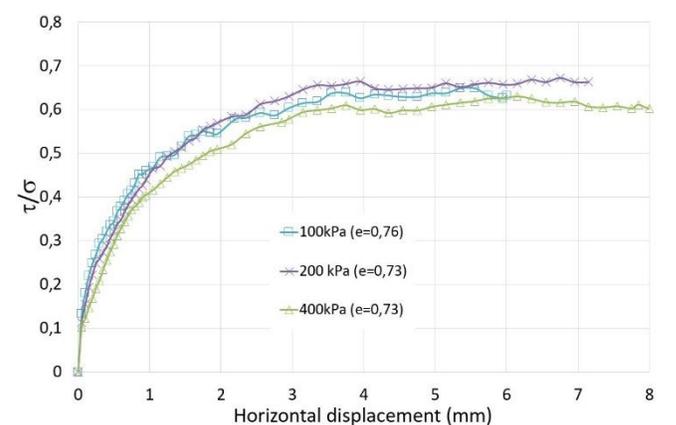
Figure 7 shows the graph of normalized shear stress versus horizontal displacement.

The horizontal displacement necessary to reach the stabilization of the strength in the  $D_r = 58\%$  was higher than that of the samples with  $D_r = 98\%$  and  $D_r = 81\%$ .

Figure 7. Normalized Shear Stress vs Horizontal Displacement –  $D_r = 58\%$

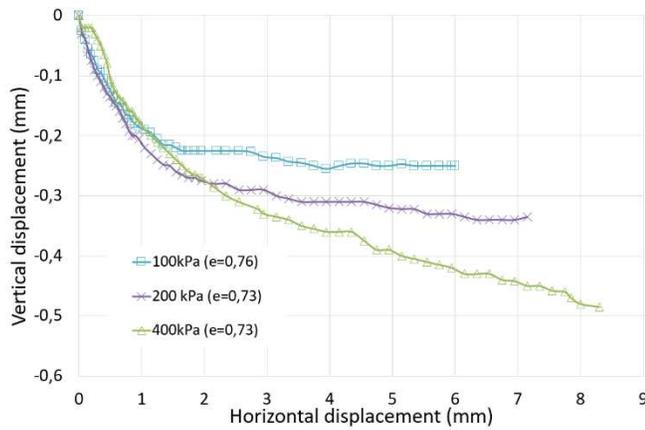
Figure 8 shows the graph of vertical displacement vs horizontal displacement.

Figure 8. Vertical Displacement x Horizontal Displacement –  $D_r = 58\%$

All samples with  $D_r = 58\%$  showed volume reduction during shear. It is noticed that the specimens subjected to lower normal stresses showed less volume reduction.

In addition, Figure 8 shows that there was a stabilization of the vertical displacement vs horizontal displacement curve for specimens with initial normal stresses of 100 and 200 kPa. The 400 kPa showed a tendency of stabilization, but the top cap tilt probably prevented the stabilization.

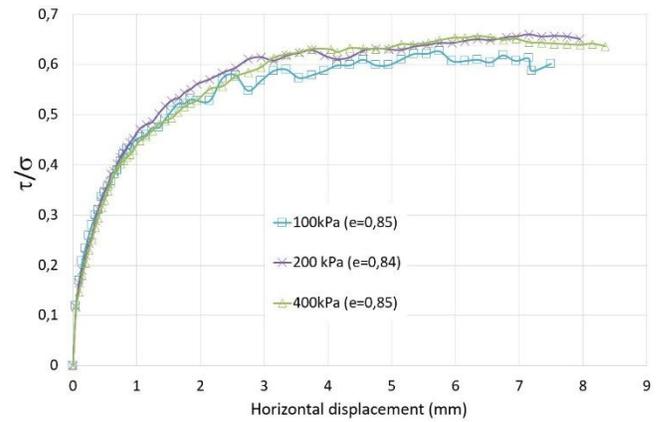
Figure 9 shows the graph of normalized shear stress vs horizontal displacement.

The results showed no peak and constant strength only after horizontal displacements in excess of approximately 4 mm.

Figure 9. Normalized Shear Stress vs Horizontal Displacement –  $D_r = 35\%$

The “constant volume” friction angle ( $\phi'_{cv}$ ) for this relative density was  $33^\circ$ .

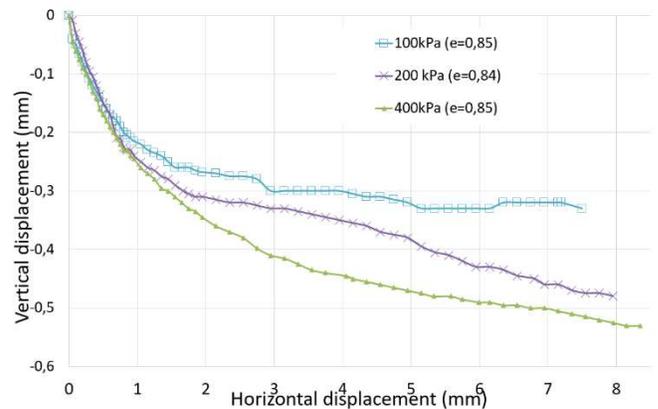
Figure 10 shows the graph of vertical displacement vs horizontal displacement.

All specimens showed volume reduction, the tests of higher normal stress showing more contraction. Only the curve of the 100 kPa test stabilized.

Figure 10. Vertical Displacement x Horizontal Displacement –  $D_r = 35\%$

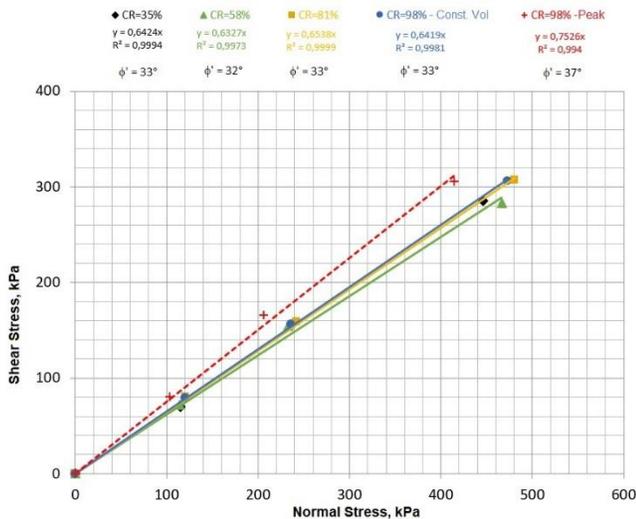
The strength envelopes of the four relative densities are presented in Figure 11.

The red dashed line with  $37^\circ$  represents the  $D_r = 98\%$  and is the only peak envelope because the other densities did not show peak.

The high  $R^2$  values showed that the shear strength presented excellent repeatability. As mentioned earlier, the “constant volume” friction angles obtained for the all densities were practically the same ( $33^\circ$ ).

Figure 11. Strength envelope of tests performed

To verify the effects of the lack of volume stabilization the tests were separated into two groups: those that showed stabilization at some point and those that did not present volume stabilization. The friction angles of both groups were almost identical indicating that the tilting of the top cap was not enough to distort the value of  $\phi'_{cv}$ .
