The paper was published in the proceedings of the 13th International Symposium on Landslides and was edited by Miguel Angel Cabrera, Luis Felipe Prada-Sarmiento and Juan Montero. The conference was originally scheduled to be held in Cartagena, Colombia in June 2020, but due to the SARS-CoV-2 pandemic, it was held online from February 22nd to February 26th 2021.

Debris flows in a tropical environment: relation between magnitude, deposits and watershed morphometry

Vivian Cristina Dias¹, Marcelo Fischer Gramani², Rebeca Durço Coelho¹, Helen Cristina Dias¹, and Bianca Carvalho Vieira¹

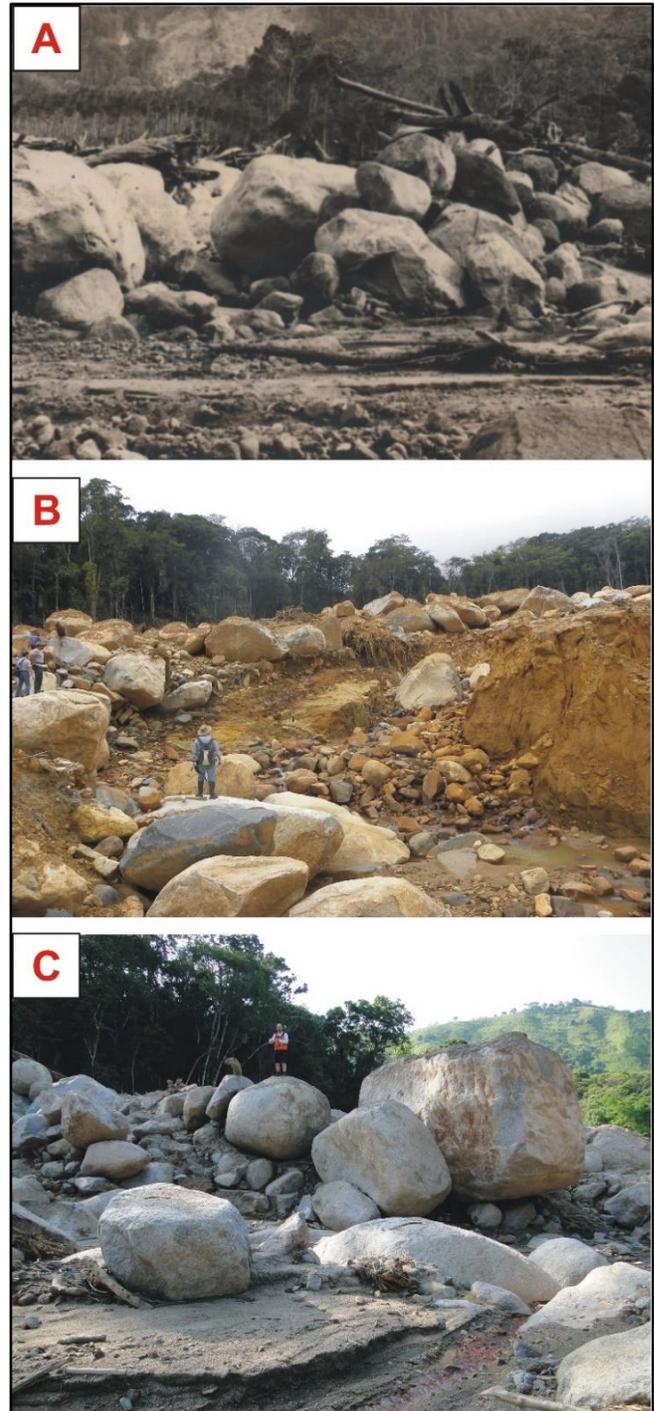
Figure 1. Debris-flows occurrences in Brazil. A: Caraguatatuba, in 1967; B: Serra da Prata, in 2011; and C: Itaoca, in 2014. Source: O. Cruz (A); GPMorfo (B); and M. Gramani (C).

In “Serra do Mar”, a mountain range that extend for about 1.500 km through the south and southeast coastline region of Brazil, debris-flows occurrence is quite common due to relief and climate characteristics (Jones, 1973; De Ploey & Cruz, 1979; Jica, 1991; Kanji et al., 1997; Gramani & Augusto Filho, 2004; Vieira & Gramani, 2015; Vieira et al., 2019). The mostly known disasters in Brazil occurred in Serra do Mar, highlighting Caraguatatuba and Serra das Araras, in 1967; Rio de Janeiro Mountain Range Region and Serra da Prata, in 2011; and Itaoca, in 2014 (Avelar et al. 2011; Brollo et al., 2015; Gramani & Martins, 2016; Picanço et al. 2016) (Figure 1).

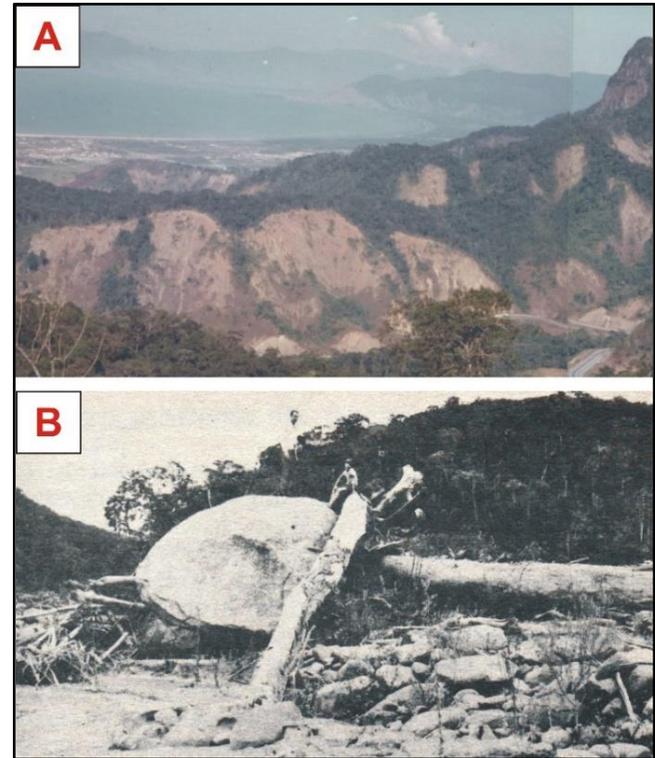
Figure 3. Caraguatatuba Disaster: landslides (A) and debris flows (B). Source: O. Cruz.

In March of 1967 rained an average of 946 mm, with a critical value in days 17 and 18, when rained 586 mm in just 48 hours, triggering landslides and debris flows (Figure 3). About 2 million of tons of sediments and boulders were mobilized, reaching the urban area of the city, in the lowland, causing 120 deaths, the destruction of 400 houses and damaging the main highway to the city.

Almost all watersheds in the city were affected, both by landslides and debris flows. Debris flows were triggered by landslides whose materials (e.g. soil, boulder, vegetation) hit the channels already saturated by the large amount of rain, turning into a viscous plastic flow. One of the most affected watersheds was Santo Antonio, in which is located the downtown (Figure 4). At the time, most of the city was occupied by farms, which contributed to minor damages compared to the size of the disaster. Nowadays, most part of the territory it is occupied by the population, which increased the size of the urban areas. Also, recent occurrences with less impact (2017, single landslides without victims; 2020, landslide at Rio-Santos Highway without

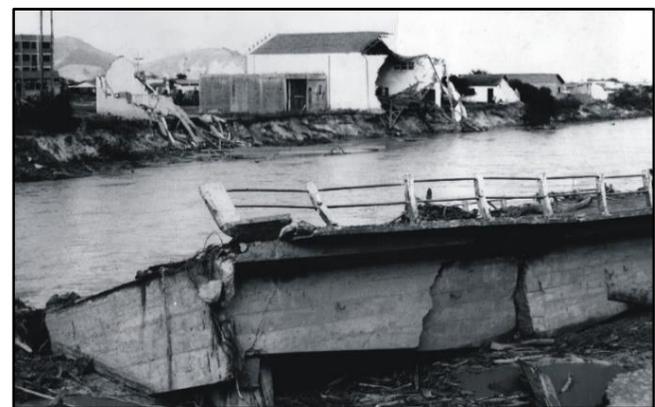
Figure 4. Destruction of a bridge in downtown. Source: Public Archive of Caraguatatuba.

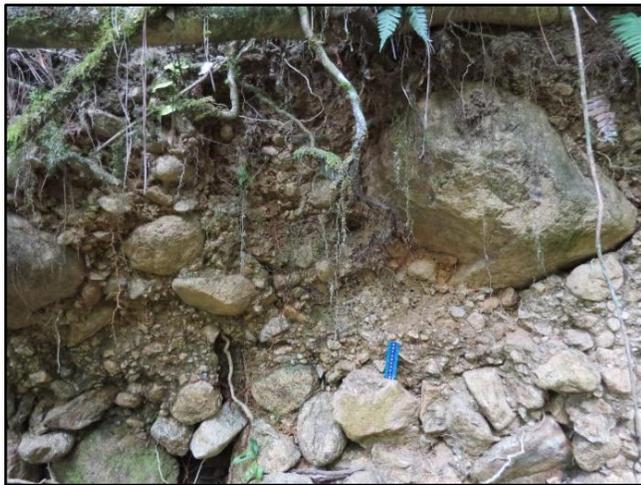
Figure 6. Deposit of debris flow Pau d’alho watershed.

The mapping of debris-flows morphology showed that all main features related to the occurrence of debris flows (levees, inverse grading and large boulders) were founded in the four watersheds, highlighting Pau d’alho watershed, which presented deposits more preserved on riverbanks (Figure 6). These features are like the description of debris flows in literature from other climate zones, especially in temperate environment (Eisbacher & Clague, 1984; Ujueta & Mojica, 1995; Jakob, 2005).
