The paper was published in the proceedings of the 13th International Symposium on Landslides and was edited by Miguel Angel Cabrera, Luis Felipe Prada-Sarmiento and Juan Montero. The conference was originally scheduled to be held in Cartagena, Colombia in June 2020, but due to the SARS-CoV-2 pandemic, it was held online from February 22nd to February 26th 2021.

Effect of thermal cycles on rock outcrops

V. Merrien-Soukatchoff, M. Gasc-Barbier

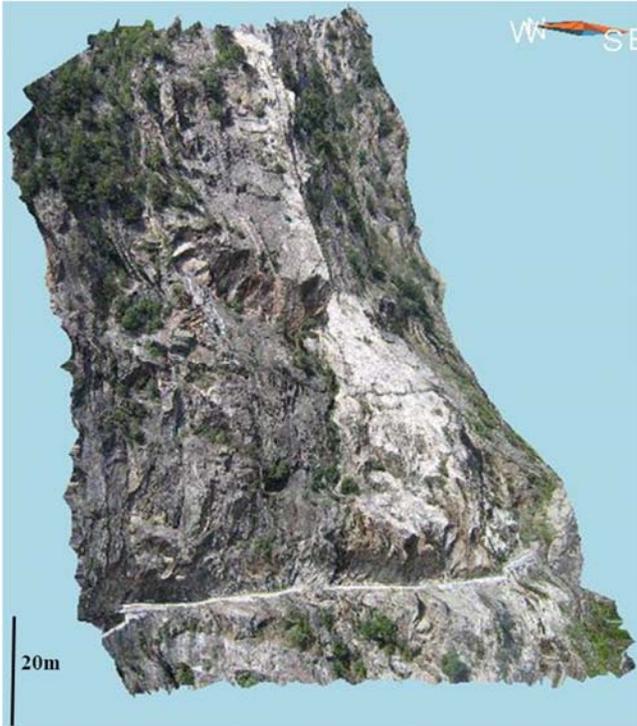
Figure 1 : 3D view of les Rochers de Valabres site AFTER Clement (2007)

For several years, geotechnical in situ measurements (including thermal quantities) have been collected at the “Rochers de Valabres” site (Figure 1), a gneissic rock mass, located in Southern French Alps. This site has been described in several papers (Gunzburger et al, 2005; Clement

The site, overhanging a busy road and a bridge, experienced two rock falls in May 2000 and October 2004 with volumes of 1000 m³ and 40 m³, respectively. Both periods did not coincide with any particular rain-fall event, seismic activity or freeze-thaw period occurrence and thermomechanical origin was suspected. The site was monitored with different thermometric and

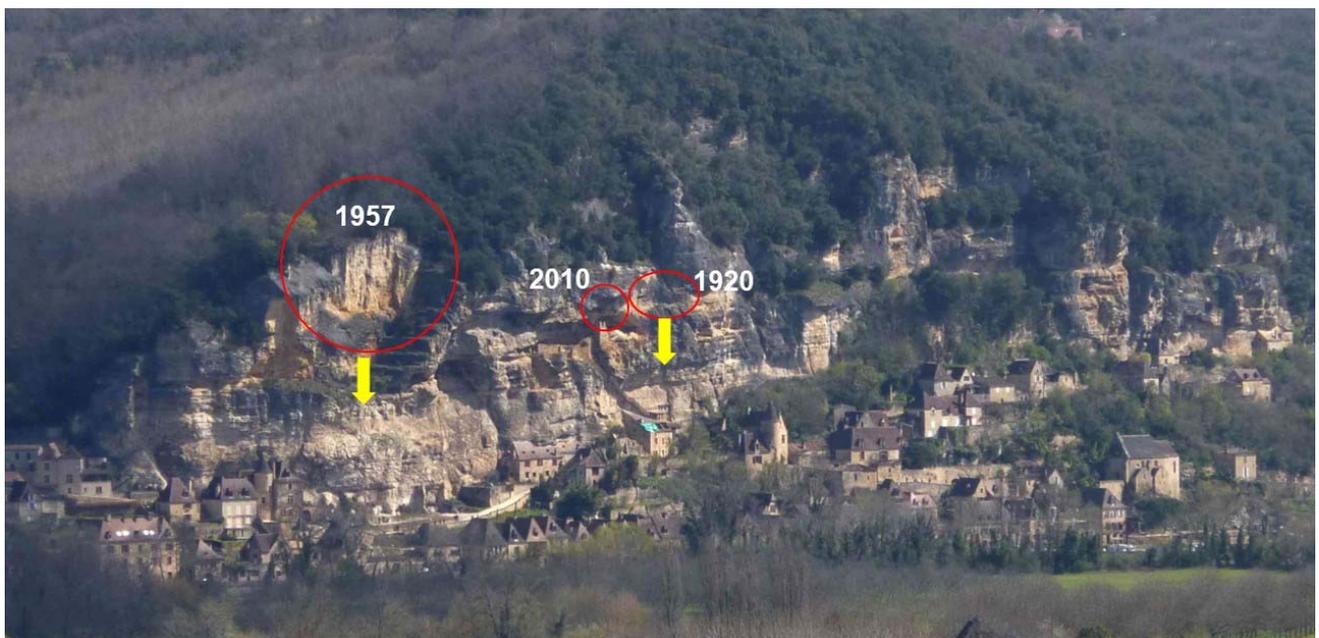
Figure 2 : Localization of the rockfall above La Roque-Gageac.

At least, four rockfalls have been referenced since 1920. Three of them, which were well documented were situated precisely. The 1920 rockfall is due to the collapse of a section of the rock cliff above the east of the village. In 1957, the collapse of a whole section of the cliff in the west caused the death of three persons. The collapse of 1994, at the center of the cliff could not be localized so precisely. Finally, the one in 2010, which led us to become interested in the site, correspond to the collapse of part of the roof of a perched cavity showed on Figure 2 which was turned into a troglodyte fort in the Middle Ages.
