## Lessons learned from some landslides in Rio Grande do Sul, Brazil

*This article presents three cases of landslides that were studied in Rio Grande do Sul state from which relevant lessons on landslide mechanisms in this region have been learned. São Vendelino's case consisted of a series of translational quick landslides that occurred in 2000 during a short rainfall episode. The study focused on one single movement with field and laboratory soil permeability tests, shear strength test and the determination of characteristic curves. The numerical simulations confirmed that only those heavy rains could have caused the landslides. The second case is a landslide in Malhada suburb of the town of Santa Cruz do Sul. The landslide mobilized  $\sim 15 \times 10^6$  m<sup>3</sup> of soil and rock comprising a basaltic plateau in successive movements. The movements were observed for some years and they have been studied using field instrumentation and laboratory tests. Its kinematics were well reproduced in the failure models with the mobilization of residual shear strength in a siltstone layer. Siltstone, residual soils of sandstone and basalt were studied to achieve an accurate geomecha

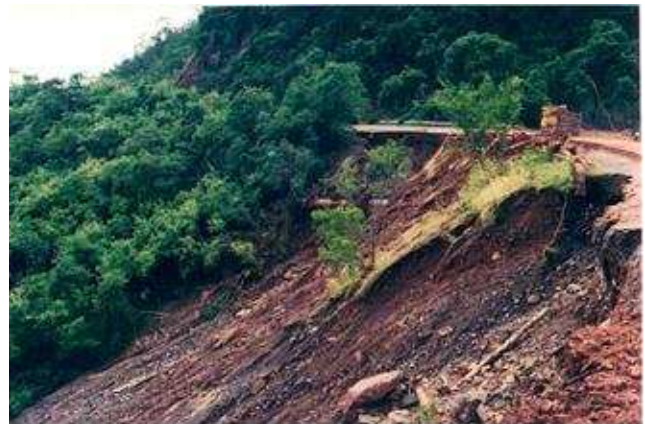
Figure 2. View of the embankment's body erosion caused by a debris flow.

damage to the RS 122 highway, municipal roads and some houses. Dozens of debris flows were formed in the main drainages, burying culvert and gullies, destroying small bridges and eroding road embankments. Some roads were closed for months until drainage could be restored. Figure 2 shows the erosion caused in a embankment fill by the overflow of the debris wave in one of the drainage lines.

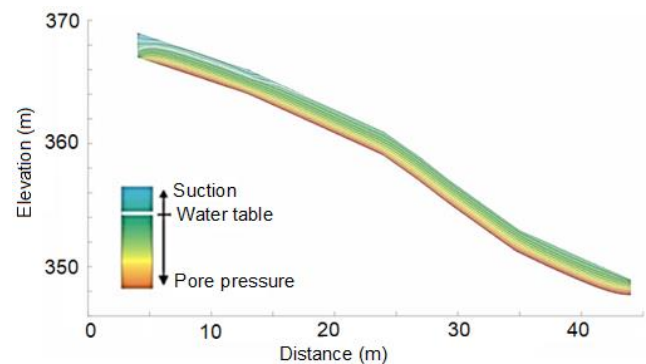
Figure 3. Pore pressure distribution along the slope.

The soil water retention capacity curve was also used, allowing an estimate of hydraulic conductivity as a function of suction (unsaturated condition). Figure 3 shows the pore pressure levels simulated along the slope after 2 hours.

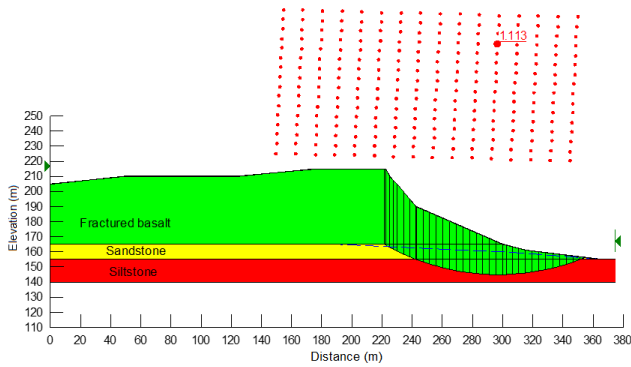
Figure 8. Stability analysis performed for the upper slope using the Spencer model.

Figure 8 shows the result of the stability analysis for the upper part of the slope, considering the circular movement, indicating the most critical rupture surface obtained with the Spencer model.

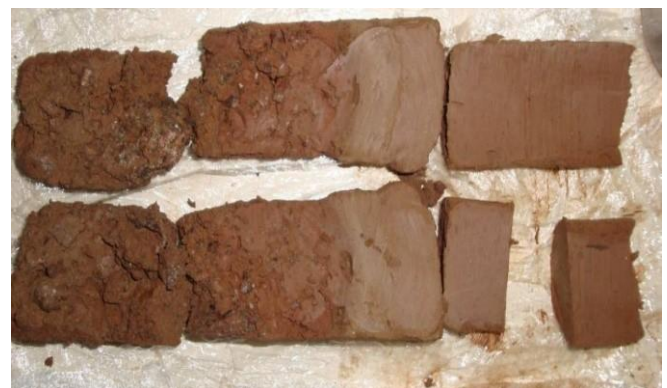
Figure 10. Soil samples from the bottom of the colluvium.

During geotechnical investigations in the area, the presence of a very clayey thin layer was detected at the base of the colluvium, in the transition to the sandstone. Disturbed sampling of this clay was carried out using the SPT apparatus. Figure 10 shows the appearance of the deformed samples taken from the bottom of the colluvium.

Ring shear tests carried out on this colluvium contact material indicated a low shear strength - a residual friction angle of  $10^\circ$  was measured. The low residual friction angle can be explained by the

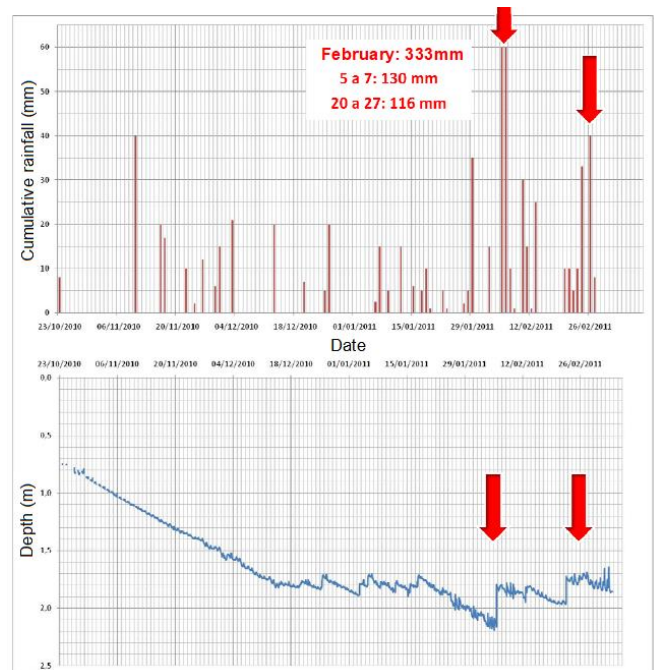
Figure 12. Records of precipitation close to the studied area and pore pressure levels measured on the slope.

The relation between rainfall and excess pore pressure was also commented by Nichel (2011). Records of a pluviometer installed close to the area were compared with pore pressure measurements made with an electric piezometer. Figure 12 shows the pluviometry records at a spot close to the

February 2011 was the rainiest month of the monitored period with 333 mm rainfall in 28 days (arrows in Figure 12). In three days, 130 mm of rainfall have been recorded close to the historical monthly average of 165 mm.

This 3-day concentrated precipitation represented an increase in the piezometric level inside the colluvial mass of approximately 40 cm (data obtained from the electric piezometer).
