*The paper was published in the proceedings of the 3<sup>rd</sup> International Symposium on Coupled Phenomena in Environmental Geotechnics and was edited by Takeshi Katsumi, Giancarlo Flores and Atsushi Takai. The conference was originally scheduled to be held in Kyoto University in October 2020, but due to the COVID-19 pandemic, it was held online from October 20<sup>th</sup> to October 21<sup>st</sup> 2021.*

## Characterizing-water seepage damage in the chest-abdomen area of the Leshan Giant Buddha

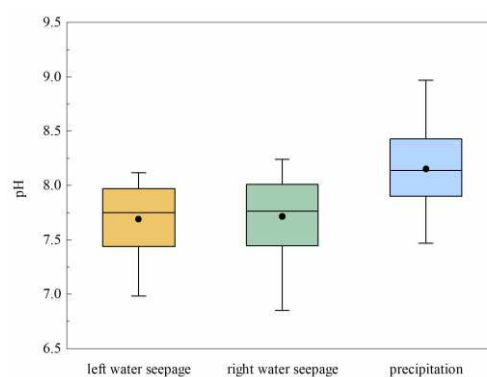
Fig. 8. Variation range of pH value.

During the monitoring period, the average pH for the left and right water seepages were 7.70 and 7.72 (Fig. 8), which are not significantly different. Compared to water seepage in the chest-abdomen areas, the pH of the atmospheric precipitation is more alkaline. The pH of the water seepage increases over time and then stabilizes (Fig. 9). During atmospheric precipitation, the pH of the initial water seepage for the left and the right are close to 7.0. However, with time, the water seepages pH increases towards that for the atmospheric precipitation, and finally stabilizes at about 8.0 after about 22 h.

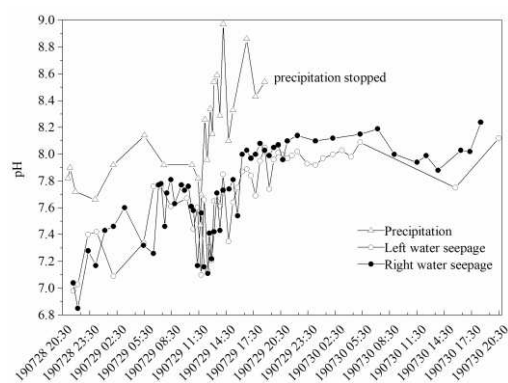
Fig. 9. pH value change over time.

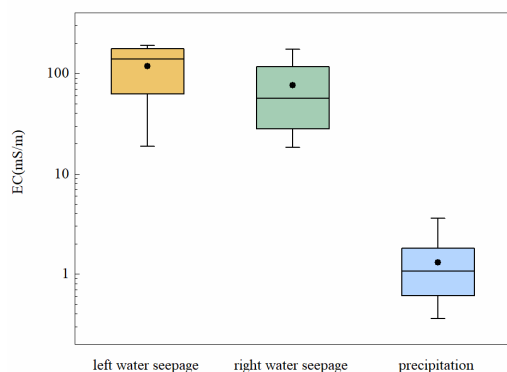
Fig. 10. Variation in EC.

The EC is an indicator of the contribution of ions in water, and to a certain degree reflects the length of the water cycle and the residence time (Xianfang et al. 2006). The average EC of the atmospheric precipitation, left-side water seepage and right-side water seepage were 2 mS/m, 117.8 mS/m, and 76.3 mS/m (Fig. 10). The EC in the chest-abdomen area of the Buddha was 40 to 60 times greater than that for the atmospheric precipitation, indicating that water seepage in the chest-abdomen of the Buddha stayed longer in the bedrock, and the water seepage contained a large amount of ions. The EC for the left side was greater than that for the right side, indicating more dissolved ions in the left side.

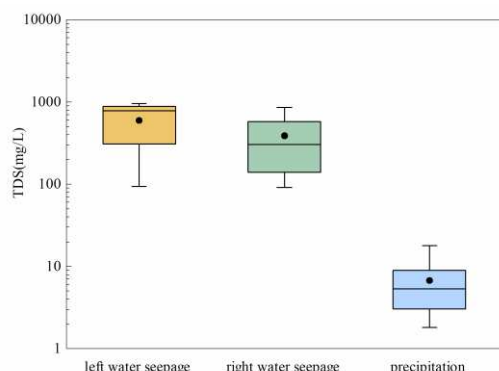
Fig. 11. Variation in TDS.

dissolved in water, which can reflect the lithology, soil, vegetation, weathering erosion rate, and human activities to a certain extent. The average TDS of the atmospheric precipitation, left-side, and right-side were 19.5 mg/L, 594.1 mg/L and 387.7 mg/L, respectively (Fig. 11). The TDS of atmospheric precipitation was low, and the TDS in the chest-abdomen area of the Buddha was 20-30 times greater than that of atmospheric precipitation, which indicates that the atmospheric precipitation has a strong dissolution capacity on the bedrock during the seepage-flow-drainage process. Consistent with the *EC* value, the TDS for the left side is higher than that for the right side.

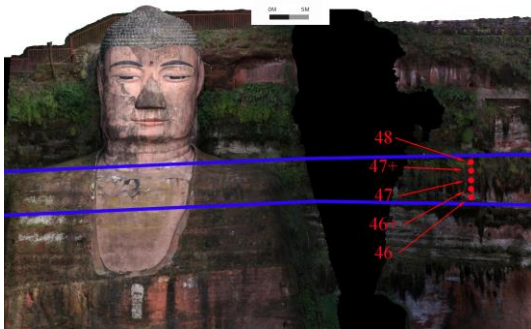
Fig. 15. Rock sampling locations.

The Buddha sandstone is the lower layer of the lower Cretaceous System jiaguan formation (K2j). Samples of the sandstone were recovered from the left cliff at the elevation of the chest-abdomen area of the Buddha and analyzed (see Fig. 15). Five sampling points were designed according to the height, and each sampling point was sampled at different depths (depth B: 0—2 cm, C: 2—4 cm, D: 4—6cm).
