InSAR for Climate Change Geo-Resilience: Quantifying the Risks of Urban Flooding

Jennifer SCOULAR¹, Pooja RAMAKRISHNAN¹, Tom HIJNEKAMP¹, Pieter Bas LEEZENBERG¹

¹SkyGeo, Delft, Netherlands

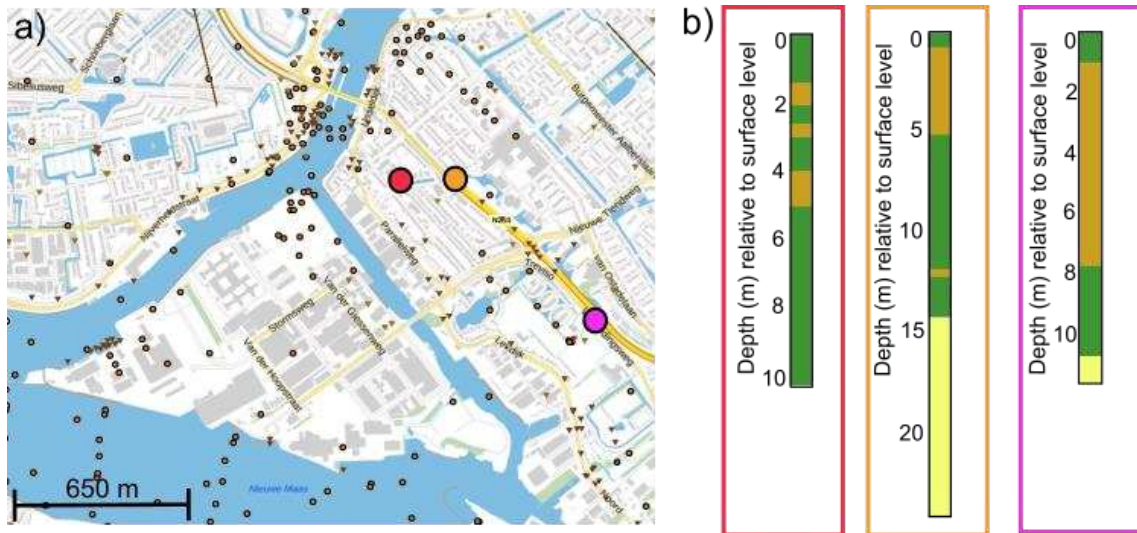
Figure 2: Three examples of boreholes in Krimpen aan den IJssel showing the variation in peat thickness in an area less than 1 km across.

Subsidence is a well-known problem in Krimpen aan den IJssel. It is located between two large rivers, the IJssel and the Maas to the east of Rotterdam. It is largely built on peat soil, interspersed with clay, underlain by sand. The variability of subsurface geology is shown in Figure 2.

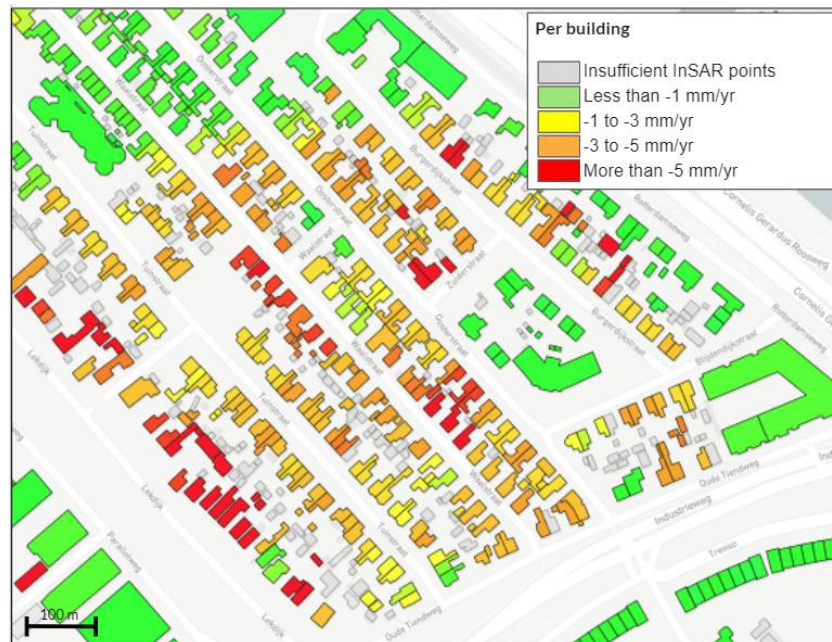
Figure 3: Average settlement rate per building, over the period 2009 to 2020, in a neighbourhood of Krimpen aan den IJssel. Settlement rates are variable across the area, to the north-west and south-east the houses are generally stable with displacements less than 1 mm/yr. However, in the centre, there are several houses subsiding at > 5 mm/yr.

The aim was to quantify the subsidence of houses in the area to understand which houses were most at risk from groundwater problems and flooding and to provide input to their groundwater care plan and long-term climate strategy. InSAR displacements were estimated from 2009 to 2020. InSAR points were then separated between those on buildings and those on the ground by applying a height threshold of 2.5 m above the AHN height. Using the building shapes from BAG, points above 2.5 m and within 1 m of a building shape were then aggregated to the building to provide an estimation of displacement per building. The output is shown in Figure 3.

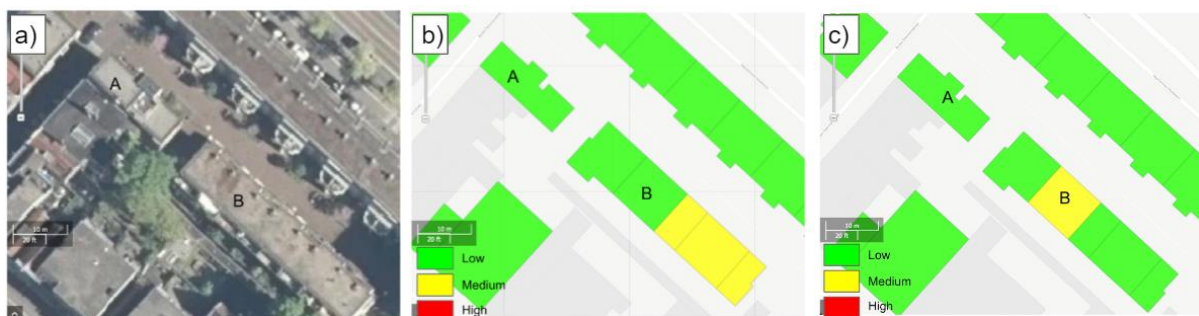
Figure 6: a) Orthophoto of the building of interest. b) Building risk map in 2018 c) Building risk map in 2020.

For example, in 2020, two buildings A and B (Figure 6a) to the north-west of the city of Amsterdam agreed to the CO₂ reduction pact (improved insulation) as well as to have solar panels installed on their roofs. However, Buildings A and B are state protected infrastructure and built in 1982 which makes them potentially high risk when it comes to renovations. They are both multistorey buildings with 4 four floors. Fortunately, the buildings have previously not shown any visual cracks or have ever needed any foundation repairs. But this means that there are also no measuring bolts installed and thus no historical traditional measurement information on the building. Using SkyGeo’s risk map, Ymere could look back in time at the building’s risk levels in the previous years.

In 2018, both Building A and Building B exhibited little to no characteristics for poor foundation health (Figure 6b). It is worth noticing however that the buildings adjacent to B seem to show concerning displacements. In 2020, however, B was graded as a building with moderate risk (Figure 6c). Thus, only building A was chosen for solar panel installation. In 2021, the risk assessment of buildings A and B indicated that building A’s risk continued to be low indicating that the building was successfully transformed as per the CO₂-pact.

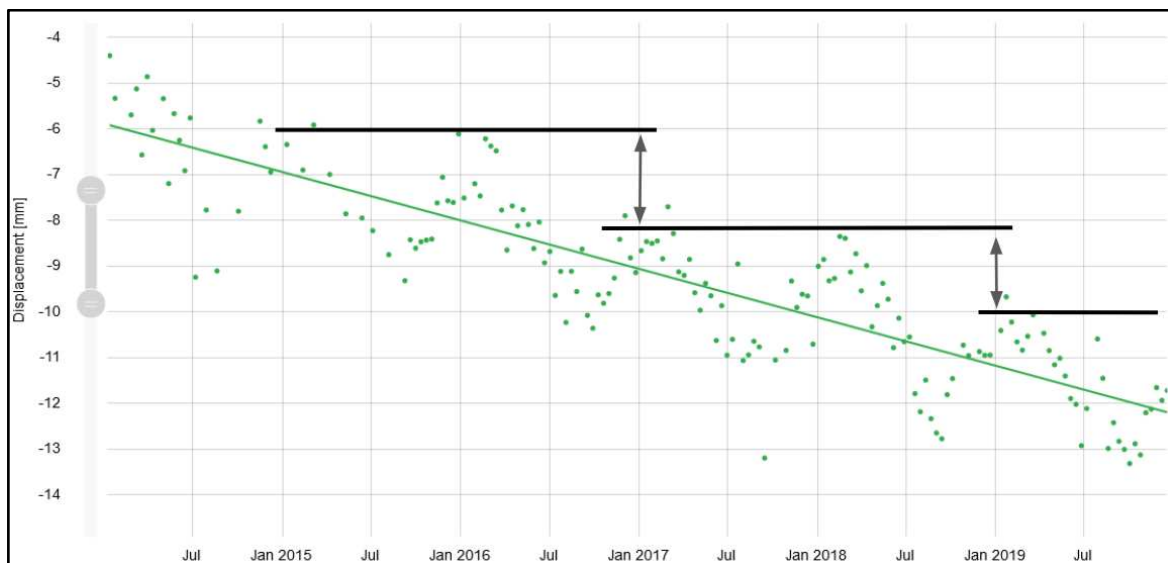
Figure 8: A subsection of Figure 7, from January 2016 to January 2020 with the black lines the displacement at the beginning and end of the year is marked, with the black arrows the permanent displacement is marked. For the year 2016 also the total movement is marked with the blue line and arrows.

Figure 8 shows that in some years the settlement that occurs in the spring/summer is then compensated by a swell in the autumn/winter, but in others, permanent settlement is observed. Looking at a subsection of the last 13 years, between January 2014 and January 2020, two years with permanent settlement are observed in 2016 and 2018 (Figure 8). The permanent settlement is approximately 2 mm in each of those years. The two years of permanent settlement correlate with notable dry summers as reported by the Dutch National Weather Service (KNMI, n.d.). The description of the summer weather 2016 and 2018 respectively are as follows “Very warm, very sunny and on the dry side” and “Extremely warm, extremely sunny and very dry”.
