Integrated Geohazard Monitoring of At-risk Slopes and Historical Retaining structures

Roberto PANTOJA^{1,2}, Jimmy Murphy², Zili Li², John O'DONOVAN¹, Cian DESMOND¹, Michael O'SHEA²

¹Gavin and Doherty Geosolutions Ltd.

The paper was published in the proceedings of the Geo-Resilience 2023 conference which was organized by the British Geotechnical Association and edited by David Toll and Mike Winter. The conference was held in Cardiff, Wales on 28-29 March 2023.

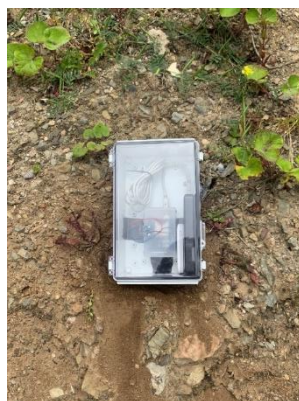
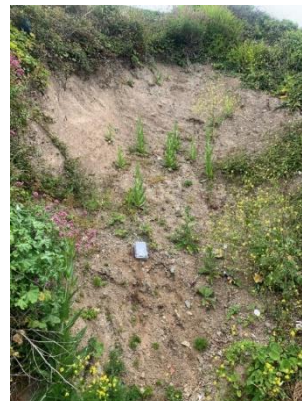
Figure 2: Sensor deployment on Connolly St slope, Cobh. **Figure 3:** Sensor deployment on Connolly St slope, Cobh.

A sensor network to monitor the slope movement was designed using accelerometers. The market offers a wide variety of accelerometers, all of which perform their functions perfectly, but for this project, it was initially decided to limit the study to one type of accelerometer and gyroscope model MPU 6050. Accelerometers were used for the monitoring of the slope in this research as they are more efficient and cost-effective in comparison to other sensors as well as the added benefit of ease of coding the sensor. The data extracted from accelerometers is easy to interpret and can be integrated into a 3-D orientated model easier when compared to other sensor types such as barometers.

The accelerometer is a sensor capable of measuring acceleration forces in single or multi-axis directions. An accelerometer itself has the ability to measure the orientation of a fixed platform relative to the earth's surface, while a gyroscope has the ability to measure gravity and linear motion. For this reason, the monitoring carried out on the Connolly Street slope was performed with accelerometers and gyroscopes, in order to measure the orientation through angular momentum (gyroscope) and the vibration that could be produced (accelerometer). This sensor network is non-intrusive and can be extended and applied to masonry walls and other structures requiring monitoring.
