Comparison of Menard pressuremeter test results around the DSI buildings before and after Kahramanmaraş earthquakes on 6th February 2023

Kubra Golbasi^{1#}, Cemal Yildiz¹, and Ayhan Kocbay¹

¹General Directorate of State Hydraulic Works, Department of Geotechnical Services, Ankara, Türkiye
#kubra.k@dsi.gov.tr

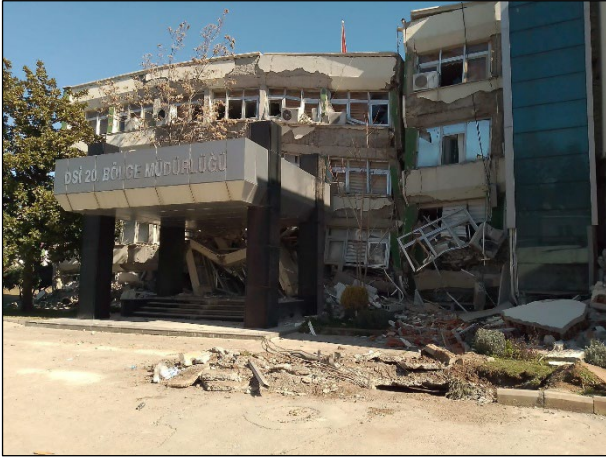
Figure 1. DSI 20th Regional Directorate building after earthquake

Due to its proximity to the earthquake epicenters, the central area of Kahramanmaraş was significantly affected, and the structures within the campus of the DSI (State Hydraulic Works) 20th Regional Directorate sustained extensive damage (Figure 1). As a result, the need for new building sites within the campus area, led to the conduction of geotechnical investigations in the region. Prior to the earthquake, the campus was planned for redevelopment, and geotechnical studies had already been conducted. However, following the earthquake, all geotechnical investigations were repeated, and data from both pre- and post-earthquake conditions were collected for the same area.

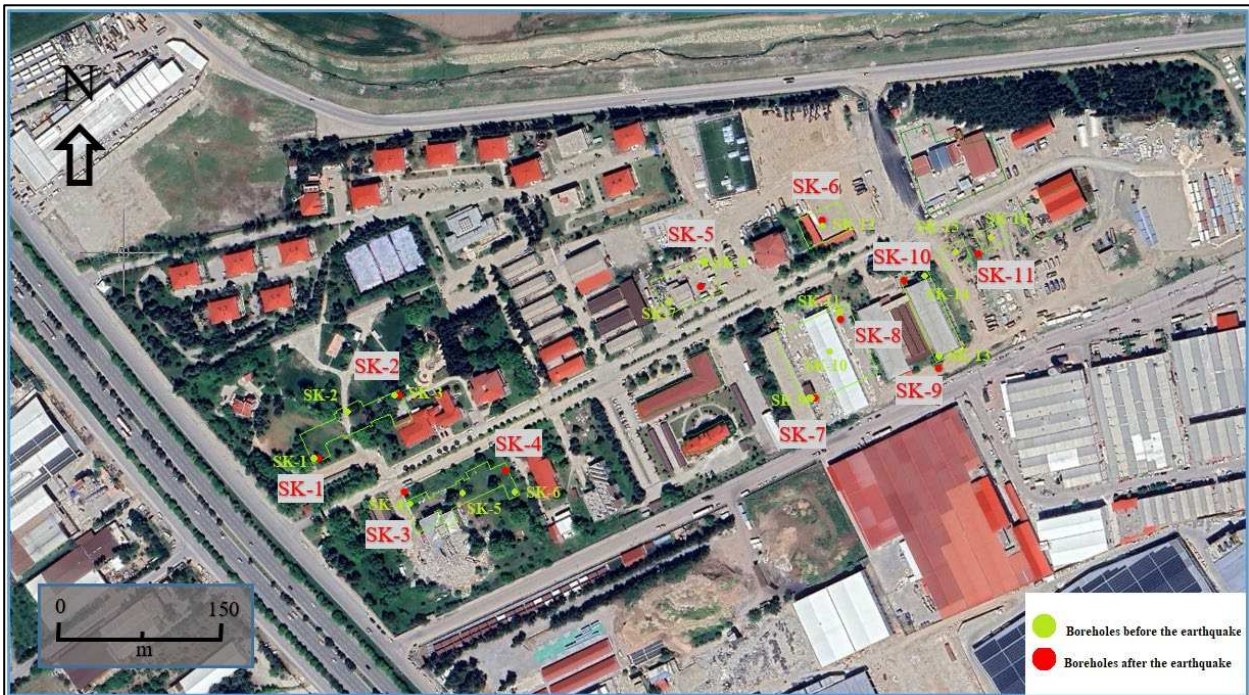
Figure 2. Borehole locations before and after earthquake.

The geotechnical studies in the field involved a total of 27 boreholes with the drilling of 16 boreholes before the earthquake and 11 boreholes after the earthquake. The data used in this study were obtained from a total of 17 boreholes, with 8 boreholes drilled before the earthquake and 9 boreholes drilled after the earthquake since the pressuremeter tests were conducted in these boreholes. Figure 2 presents the locations of boreholes. The depths of the borings ranged between 20-30 metres. The groundwater level is more than 24 m below the ground surface in two of the boreholes while others does not have any evidence of groundwater.

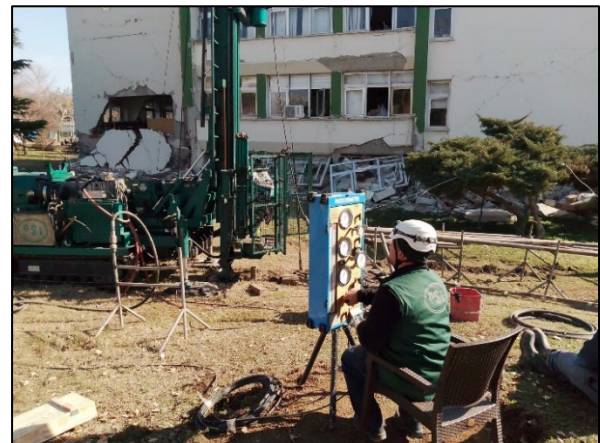
Figure 3. Pressuremeter test being conducted in study area

The pressuremeter tests conducted in the study area is presented in Figure 3.
