Case Studies and Field Applications of Cyclic Pressuremeter Test to Liquefaction Damaged Ground by Noto Peninsula Earthquake in 2024, Japan

This paper provides an overview of the cyclic pressuremeter testing system developed by our research group. Additionally, we will discuss some testing results as an application of this system at a site in Uchinada Town, Ishikawa Prefecture, Japan, where lateral flow occurred due to liquefaction following the Noto Peninsula Earthquake in 2024.

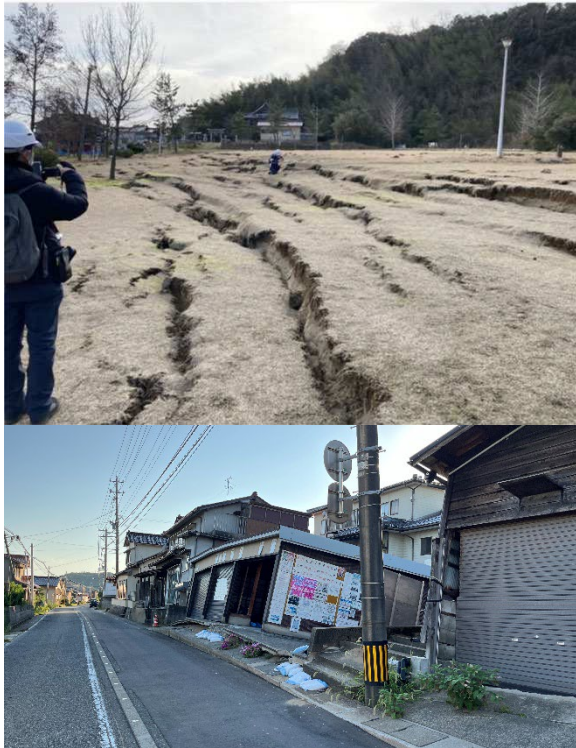
Figure 2. Damages from liquefaction in Uchinada Town

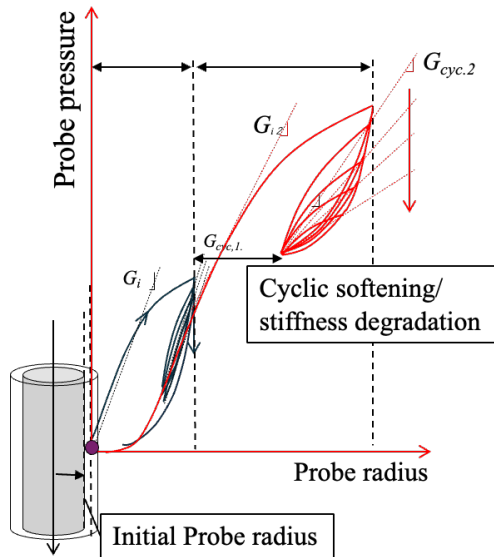
Figure 4. Cyclic loading scheme and stiffness degradation

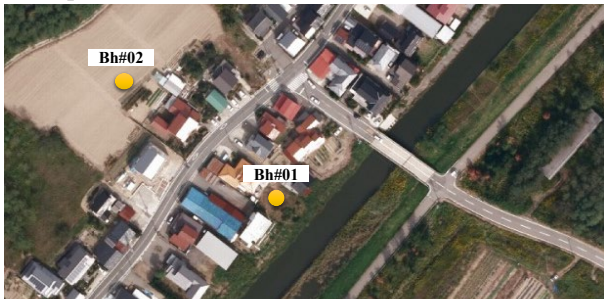
Figure 6. Location of the test sites in Uchinada Town

Uchinada Town is a typical area affected by the 2024 Noto Peninsula earthquake, where damage was primarily caused by liquefaction-induced lateral flow. Point Bh#01, shown in Fig. 6, is located near a north-south stream, suggesting that the groundwater level was likely high during the earthquake. As a result, the lateral flow damage at this location is classified as severe, in contrast to Bh#02, which is situated on the dune side and experienced less impact. The earthquake damage depicted in Fig. 2 was photographed at Point Bh#01. The CPMT for this study was also planned and conducted based on the findings from these two surveying points.

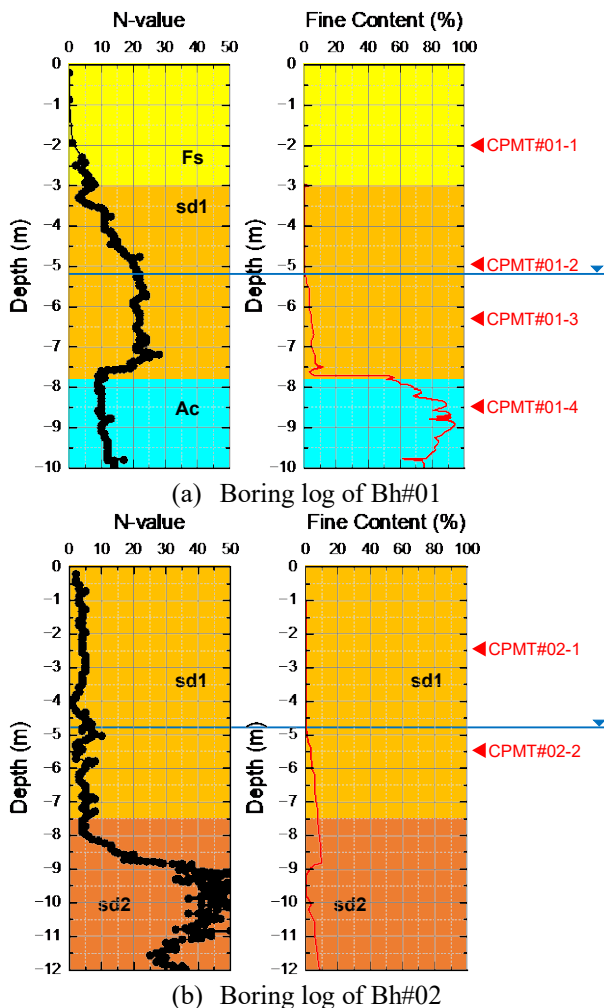
Figure 7. Ground condition at two test sites

The soil conditions identified from the borehole investigation at two test points are summarized in Fig. 7. During the boring survey at location Bh#01, fine sand (Fs) was primarily found as embankment material used in land reclamation, extending up to 3.0 meters below the ground surface as depicted in Fig. 7(a). Beneath this layer, a thick original sandy dune bed was present, reaching down to a depth of 8.0 meters below ground level. Below the dune bed, there is a layer of silt (Ac). The groundwater level observed during the survey was approximately 5.0 meters below ground level. However, since this location is near a stream, it is expected that the groundwater level may fluctuate depending on the water levels of the stream at different times. The results from a separate portable dynamic cone penetration test (PDCPT) indicated that the groundwater level is at the same level as the ground surface. The N-value of the Fs layer is relatively low, i.e., less than 10, and the sd1 layer has a relatively high value of up to 30. The Ac layer was observed to have

Bh#02 is situated approximately 100 meters northwest of Bh#01. Fig. 7(b) shows the boring logs obtained from the geotechnical survey conducted at this location. The stratigraphic analysis confirmed the presence of a loose sandy layer (sd1) extending down to G.L.-7.5m, followed by a dense sandy dune layer (sd2) that reaches G.L.-12.0m. The N-value for the sd1 layer is less than 10, indicating it was deposited in a loose state. In contrast, the sd2 layer has a significantly higher N-value of up to 50, indicating it is dense and compacted. At this site, CPMTs was performed at two points within the sd1 layer, where there is a potential for liquefaction.

The results of the experiments conducted on CPMT#01-4, which represents a silt layer (Ac), and CPMT#02-2, which represents a loose sand layer (sd1), are discussed here. As shown in Fig. 7, both sites have N-values of 1 and 3, indicating that they are very soft, with no significant differences between them. The silt layer is characterized by very low permeability and small particle sizes, suggesting that it is unlikely to be susceptible to earthquake-induced liquefaction. The soils were subjected to loading in up to 22 steps, with the waveforms illustrated in Fig. 8.

The test results will now be compared across different N-values within the same borehole to observe how soil behavior varies with these values. The following is a comparison of the test results for CPMT #01-1 to #01-3 in Fig. 7(a), where the N-values are 4, 13, and 20 respectively.

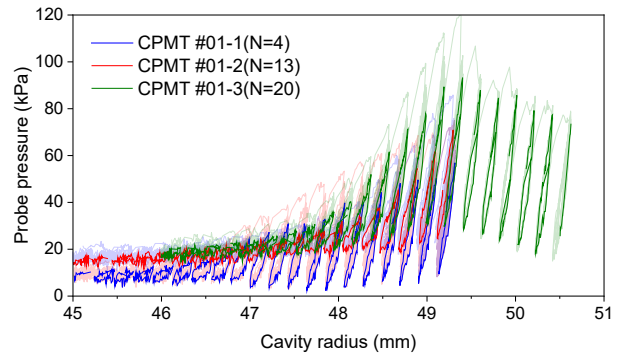
Figure 13. Relationship between probe pressure and cavity radius by N-value

Fig. 12 illustrates the pressure history of the probe after adjusting for the tension in the rubber membrane caused by the cyclic loading. The peak values recorded for each testing point were 74 kPa, 85 kPa, and 120 kPa, respectively. This data demonstrates that a higher N-value corresponds to an increased pressure needed to expand the probe. In essence, the findings effectively reflect the magnitude of the ground reaction force as a function of the N-value. Fig. 13 illustrates the relationship between cavity radius and probe pressure. The data presented in this figure is collected from the moment the probe contacts the cavity wall until the completion of the loading phase or the destruction of the soil structure, allowing for comparison. The comparison of these figures is challenging due to the varying timings of when the cavity wall is hit and when it is terminated. However, the results indicate that the probe pressure needed to increase the probe radius rises as the N-value increases.

Fig. 12 and Fig. 13 present the maximum probe pressure limit, beyond which the value does not increase, particularly in relatively dense sand with relatively high N-values, such as CPMT#01-3. As

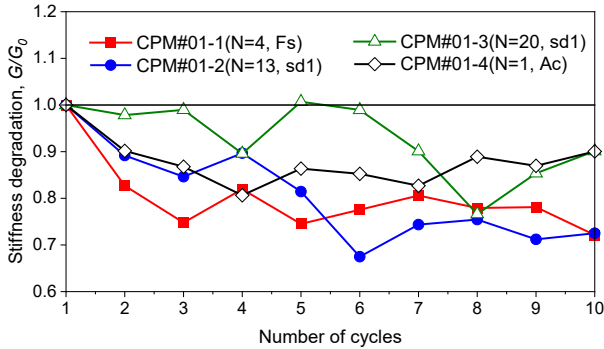
Figure 15. Stiffness degradation under various soil conditions occurs when K_0 is equivalent to 1.0

Fig. 15 compares the stiffness degradation depicted in Fig. 14 across each test case for a specific cyclic loading step. As the point of contact with the cavity wall varies slightly in each test case, this figure is based on data from the load step when the earth pressure coefficient reaches zero. The differences among the various soil conditions were not distinctly noticeable; however, certain trends emerged concerning clay and sandy soils, as well as N-values. Notably, in CPMT#01-4, which featured a clayey soil, and CPMT#01-3, characterized by a comparatively high N-value, the stiffness degradation from the initial to the final cycle was approximately 0.9. On the other hand, it was about 0.75 for CPMT#01-1, which had the smallest N-value in the same cavity. This result is consistent with previous studies that the smaller the

particle size, the more stiffness degradation occurs when N-value is larger. It is challenging to observe significant stiffness degradation in these tests because the number of cyclic loadings per cycle was limited to 10, and the cavity wall was enlarged. However, the authors have confirmed stiffness degradation due to cyclic loadings in other experiments where they increased the number of loads per step without enlarging the cavity wall (Azuno et al. 2024, Kazama et al. 2024, Kwon et al. 2024).

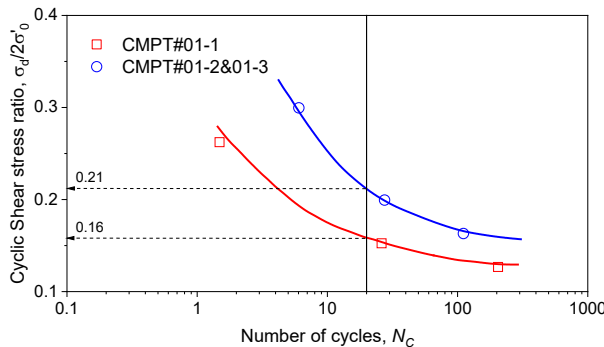
Figure 16. Comparison of liquefaction strength curves

The outcomes of an undrained triaxial compression test using undisturbed specimens taken from two different depths where CPMT was conducted are illustrated in Fig. 16. The figure shows the liquefaction strength curves, depicting the relationship between the number of cycles and the cyclic shear stress ratio, CSR. For CPMT#01-2 and CPMT#01-3, the liquefaction strength, RL_{20} , was measured at 0.21, with relatively high N values, which closely resembles the results observed in medium-density sandy soil. The CPMT#01-1 sample, which has a relatively small N value, exhibited an RL_{20} of 0.16. It was observed that the CPMT test results, based on the N-values presented in Fig. 12 through Fig. 14, are in good agreement with the triaxial test results obtained using undisturbed soil samples. Confirming the similarity between the trend of the CPMT results and the triaxial test results is a notable achievement; however, the compatibility of two values remains questionable. To enhance the utilization of the CPMT results, it is essential to evaluate its experimental results in relation to quantitative design constants like the CSR. This evaluation is still an area of ongoing research, and the authors believe it should be a focus for future studies.
