# **Abutment Scouring and Erosion Mitigation Measures for a Bridge on an Active Lahar-Draining River Channel: A Case Study of the Pasig-Potrero Bridge**

A case study of a bridge located in the Central Luzon Region in the Philippines is presented. The bridge is situated on the channel bend of a lahar draining river. During the onslaught of a tropical storm in 2013, which was intensified by the Southwest Monsoon, strong currents in the river caused diversion of deposited lahar from the channel, eroding one embankment of the bridge. Due to the erosion of the embankment, and the continuous scouring at the toe of the abutment, a portion of the bridge collapsed. River basin and channel modelling were performed using to evaluate the scouring and erosion risk at the piers and abutments. Geotechnical investigation of the riverbanks was also conducted. Based on the analyses, several mitigation measures were recommended within and outside the Road Right of Way (RROW). Moreover, non-structural measures were also proposed in order to minimize the erosion and scouring risk.

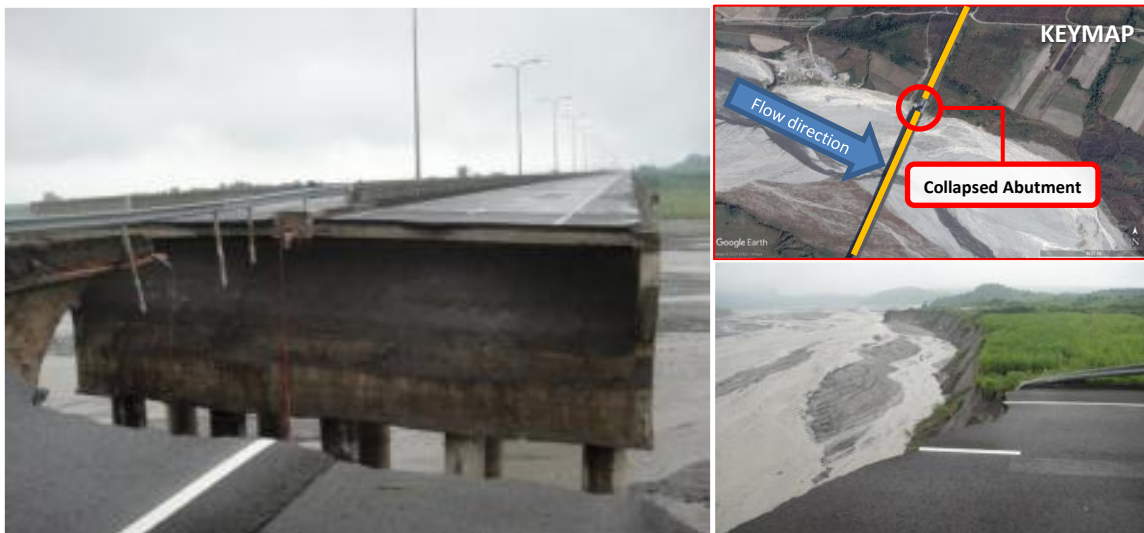
During the onslaught of Tropical Storm Maring (Trami) in 2013, which was intensified by Habagat (Southwest Monsoon), strong currents in the river caused diversion of the deposited lahar from the channel, eroding the embankment of the Pasig-Potrero bridge. Due to the erosion of the embankment, and the continuous scouring at the toe of the abutment, a portion of the bridge (first span) collapsed, cutting off the access along SCTEx.

**Figure 1. The collapsed approach embankment at Sta. 45+540 in 2013**

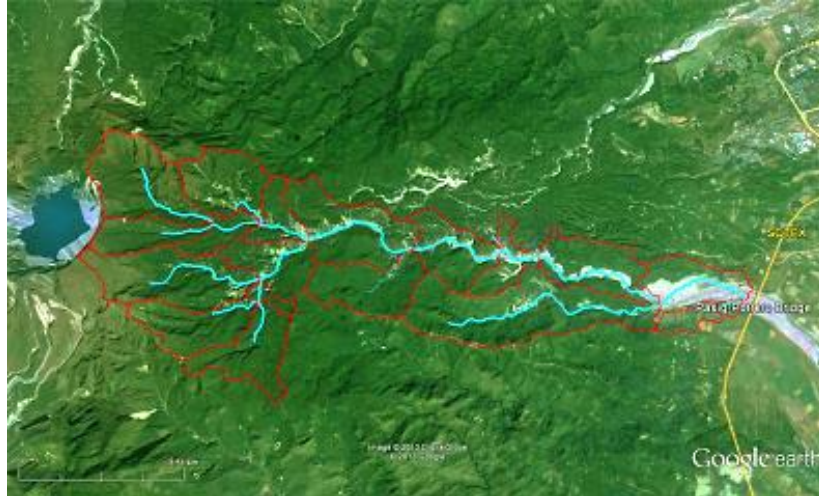
**Figure 4. Pasig-Potrero Catchment Boundaries (Source: Google Earth)**

The Pasig-Potrero catchment is in the east of Mt. Pinatubo's crater, and measures about 50 square kilometers. The upper sub-catchments have steep slopes, forming large gullies and defined ridges. Lower sub-catchments, on the other hand, are flatter, with a wider coverage of lahar. Google Earth images overlain with the catchment boundaries are shown in Figure 4.

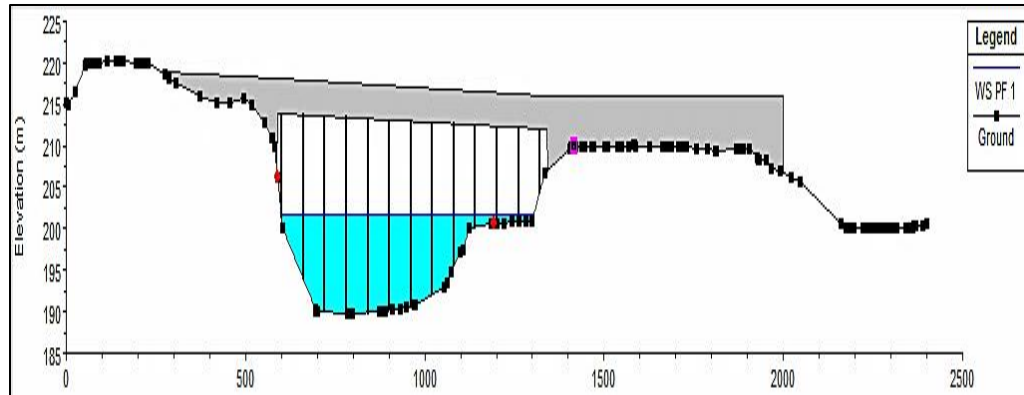
After the completion of the hydrologic model results, the hydrograph above was utilized as input to the hydraulic model in HEC-RAS as unsteady flow data. HEC-RAS included the cross sections of the river, sampled from the ASTER DEM, as well as the locations and geometry of the piers and abutments to account for flow restriction at the bridge. The hydraulic analysis result at the river's cross section at the bridge is shown below.

**Figure 7. HEC-RAS water levels during peak flow at Pasig-Potrero Bridge**

The maximum depth of flood at a 100-year return period can reach up to 10.5 meters. A 3D plot of the Pasig-Potrero River in HEC-RAS that includes the assumed bridge geometry is shown below.

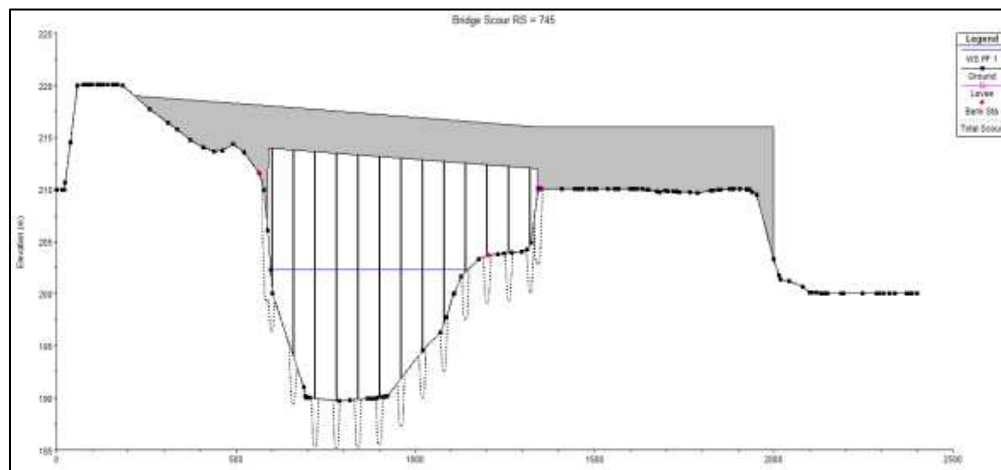
From the results of initial HEC-RAS simulations, it can be seen that the abutments are susceptible to a local scouring depth of around 7 meters. The piers, which are more exposed to scouring, may experience 4.6 meters of local scouring. Because the river is very wide (at least 600m wide), as compared to the width of the piers at 2.5 meters each, the contraction scour is considered negligible. A plot of the possible local scouring at the piers and abutments is shown below.

**Figure 8. HEC-RAS local scouring analysis results**

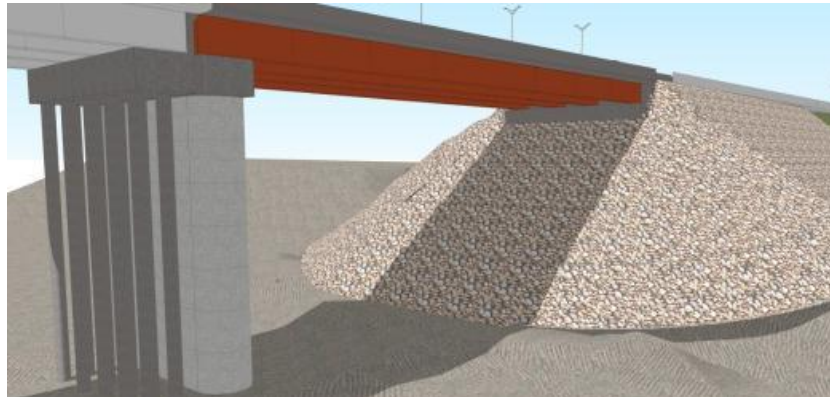
The old approach embankment was scoured and left a 25-meter (approximate) gap between the road and the bridge abutment. This 25-meter gap plus the horizontal distance that a 1V:2H slope makes (considering a height of 20 meters), rounding up the results to a bridge length of 60 meters. A conceptual design of the proposed scheme 1 is presented in the rendered 3D image below:

**Figure 9. Conceptual design of 60m bridge extension with revetment**

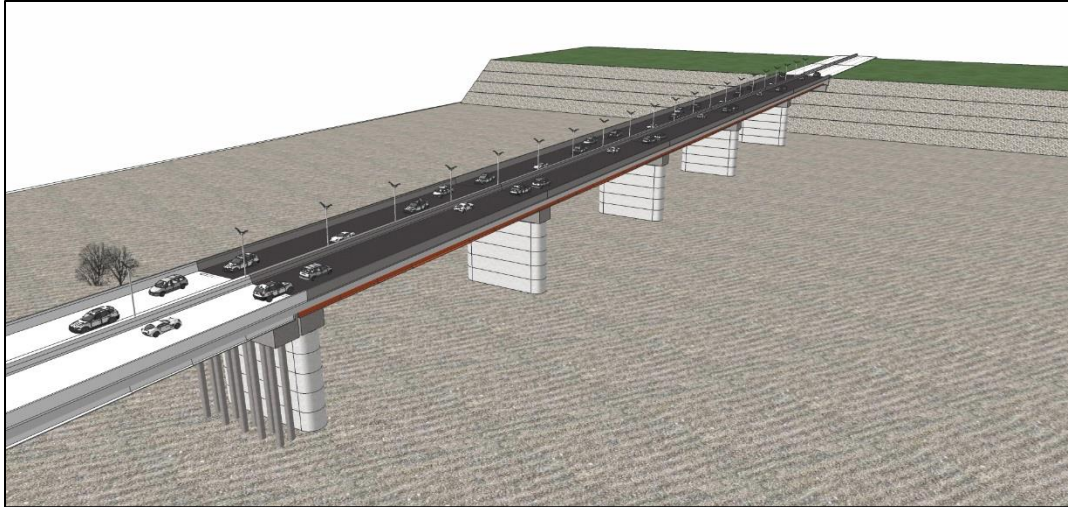
The second scheme is similar to the first. However, a 240m bridge shall be installed rather than just a 60m bridge span. The 240m bridge shall have bored piles which shall act as columns when eroded. The scheme accounts for future scouring and erosion. It can be constructed in phases depending on the rate of erosion in the succeeding years, and it requires comprehensive monitoring program. A satellite image with the 3D visualization of the bridge are shown below.

**Figure 12. Conceptual design of 240m bridge**
