The paper was published in the proceedings of the 10th International Conference on Scour and Erosion and was edited by John Rice, Xiaofeng Liu, Inthuorn Sasanakul, Martin McIlroy and Ming Xiao. The conference was originally scheduled to be held in Arlington, Virginia, USA, in November 2020, but due to the COVID-19 pandemic, it was held online from October 18th to October 21st 2021.

Detection of Internal Erosion Using Seismic Techniques

Y. Maalouf¹, C. Jalekian², E. Geara² and N. Khoury³

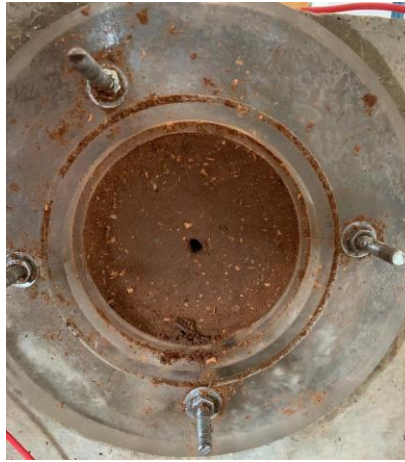
Figure 2 – Weak zone for the concentrated leak testing showing the 8 mm hole in the middle of the sand-clay mixture

In this test, a mixture of 50% sand ($\gamma_d = 14.2 \text{ kN/m}^3$) and 50% clay (properties summarized in Table 1) was prepared. The sample was mixed at hygroscopic moisture content and then water was added to reach a moisture content of approximately 10.9% leading to dry unit weight $\gamma_d = 15.4 \text{ kN/m}^3$. For the simulation of concentrated leak erosion, a hole of 8 mm was drilled in the center of the soil as shown in Figure 2. This setup is similar to the Hole Erosion Test that was developed by Wan and Fell (2002, 2004a, 2004b and 2008) and Benahmed and Bonelli (2012). Details of the test process and examples of results are given in ICOLD (2016).

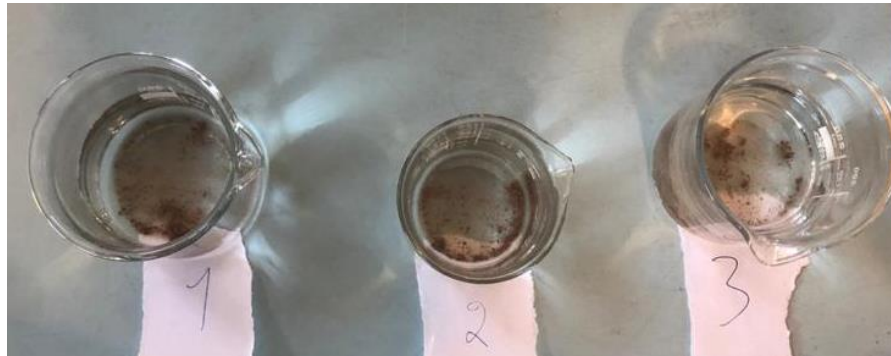
Figure 4 - Water samples collected during water seepage in the hole. Beaker 1 corresponds to the time when samples were first witnessed downstream (6 mins), beaker 2 is during the first collapse (13 mins) downstream and beaker 3 corresponds to the time before the failure of the weak zone (15 mins)

The time series corresponding to geophone 6 is presented in Figure 3. At time $t_1 = 3$ mins the valve is opened to permit water seepage into the sample. Small events are detected between t_1 and $t_2 = 13$ mins where small particles are being washed away from the hole as seen in Figure 4 – showing beakers containing soil particles detached from the weak soil sample zone and transported downstream at different time intervals during water flow. For t_3 between 17 and 19 mins, collapse (lump of soil falling) of soil is observed at the downstream end of the weak zone. At $t_4 = 19$ mins, the entire weak zone failed resulting in a big event of high amplitude highlighted in Figure 3.

observed exiting the hole (shown in Figure 4 beaker 1). This effect could be due to the enlargement by erosion of the walls of the hole (from 8 mm to 9 mm).
