The paper was published in the proceedings of the 10th International Conference on Scour and Erosion and was edited by John Rice, Xiaofeng Liu, Inthuorn Sasanakul, Martin McIlroy and Ming Xiao. The conference was originally scheduled to be held in Arlington, Virginia, USA, in November 2020, but due to the COVID-19 pandemic, it was held online from October 18th to October 21st 2021.

Experimental investigation on the erosion of vegetated soils by flume tests

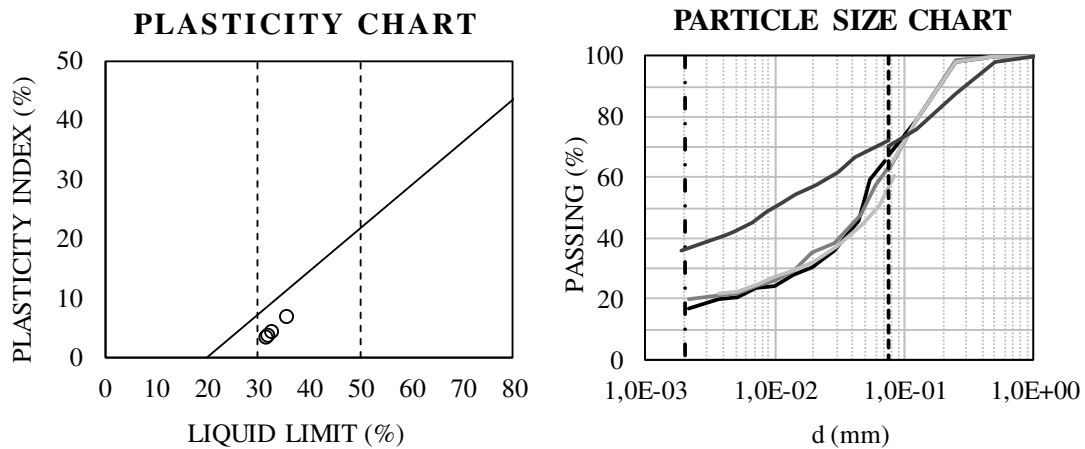
Figure 1. Casagrande plasticity chart (left) and particle size distribution curves (right) obtained from soil samples taken within 0.6 m depth from river berm.

Soil samples were collected from the riverbank where the vegetation cover will be successively tested in the real-world case study. Soil classification tests, like particle size distribution, Atterberg's limits, specific gravity, organic content and free calcium carbonate concentration were firstly executed on different samples taken at shallow depths (within 0.6 m depth from the river berm). The soil resulted a mixture of inorganic silt (≈ 35 to 45%) and very fine sand (≈ 30 to 35%) with clay (≈ 20 to 36%), characterized by low plasticity, a CaCO₃ content of about 10%, an organic matter of $\approx 2\%$ in weight and a specific gravity of 2.71. Main laboratory results are still presented in Figure 1. Unsaturated soil behavior was preliminary investigated through the execution of evaporation tests, following the procedure suggested by Schelle et al. (2013) for extending the measuring range up to about 300 kPa of suction. The test was

executed on an undisturbed soil sampled at 0.5 m depth from the berm and characterized by a void ratio of about 0.589, unit weight equal to 20.1 kN/m³ and a gravimetric water content of 22.6% (measured subsequently to a high-water event occurred in May, 2019). The widely-adopted van Genuchten model (van Genuchten, 1980) was considered to fit the laboratory data, obtaining values of soil retention properties α and n respectively equal to 31.0 kPa and 1.183, while a value of 1.0E-08 m/sec was obtained for the saturated hydraulic conductivity.

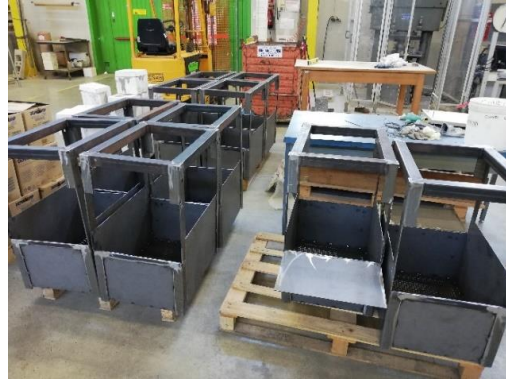
Figure 2. 3D sketch of the metallic caissons and picture of the finished elements.

The volumes of the soil samples to be vegetated and then inserted in the flume were chosen to allow the growth of a relevant rooting system, keeping into account the characteristics of the flume channel. To this aim, metal caissons for soil storage and plant growing were specifically designed and then custom-made, as sketched in Figure 2. For each caisson, the base is 60x45 cm ($L_1 \times L_2$); the four sides are closed through 40 cm and 30 cm height metallic slabs on the L_1 (flow direction) and L_2 sides, respectively; thus, an open height of 10 cm was realized to allow sediment flux in the longitudinal direction, allowing for a maximum of 10 cm-deep soil erosion. The soil volume overall involved in each test was approximately equal to 0.324 m³ with a potential eroded volume of about 0.081 m³ for the three caissons. Another feature of the caissons is the open bottom drainage, obtained through a perforated metallic base. In the experimental setup and tests, three caissons are placed inside the flume channel

(total length 1.8 m) and in contact each to the other along sides L_2 , with first caissons having a horizontal plate to direct the water flux upon soil surface.

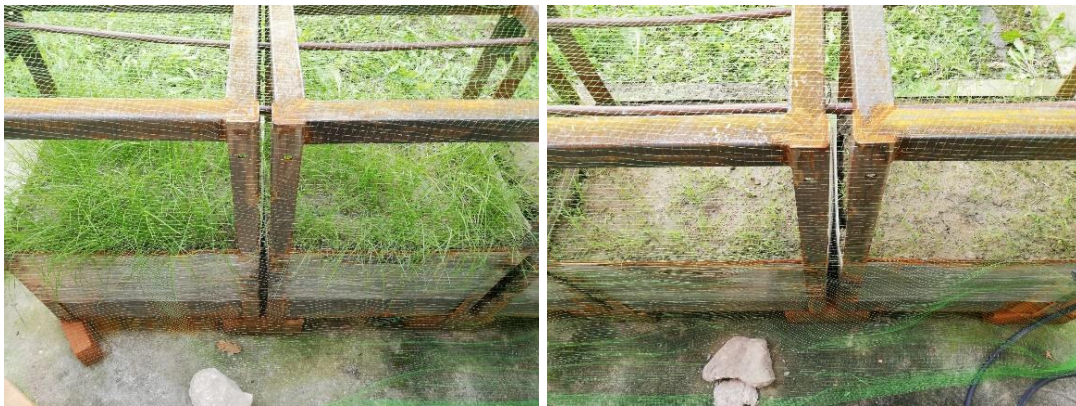
Figure 3. Plant growth 1 month from the seeding for Cases 1 (left) and 2 (right).

(Case 0) were prepared immediately before the test execution (November 2019) following the same specifications stated before. Following the seeding, a more diffused plant growth was observed in Case 1 respect to Case 2; this evidence persists for the whole duration of the experiment and is depicted in Figure 3, where plant growth in Cases 1 and 2 was compared one month from the seeding. At the time of experiments (i.e. around three months from the plants seeding), the vegetation of Case 1 was characterized by significant plants density on the soil surface, thus with limited exposure of nude soil to flow erosion and shallow roots; on the opposite, vegetation of Case 2 was characterized by limited density but higher rooted depths. Thus, Cases 1 and 2 depicted very different situations in terms of water-vegetation-soil interaction, as deep-rooted vegetation offered a limited hydraulic resistance to flow when compared to traditional grass, whatever the flume slope and corresponding discharge.

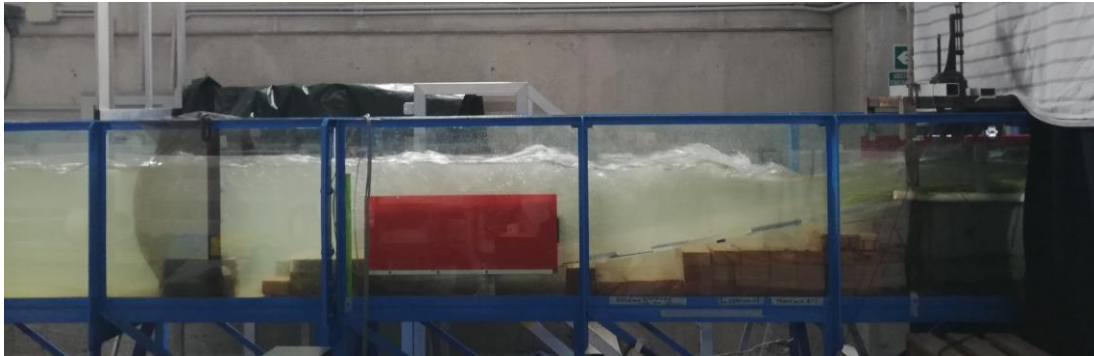
Figure 6. Ending section of the flume channel for Case 1 and 8.5% bed slope.
