The paper was published in the proceedings of the 1st International Conference on Scour of Foundations and was edited by Hamn-Ching Chen and Jean-Louis Briaud. The conference was held in Texas, USA, on November 17-20 2002.

Collapse and Erosion of Khon Kaen Loess with Treatment Option

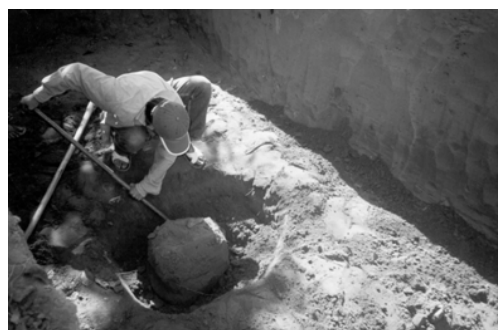
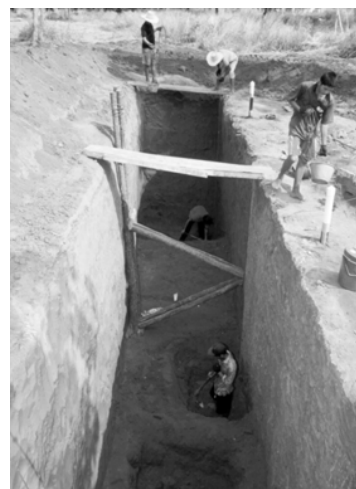
Fig. 2 – General view of a test pit at Khon Kaen University

A series of laboratory tests were carried out on red loess unit. The samples were from outcrop found in Khon Kaen University, where several foundation problems associated with this soil had occurred. Undisturbed samples of the soil were taken by means of block sampling. The samples were carefully trimmed and waxed from the bottom of excavated pits (Fig.2). The tests were initially conducted on the soil under in situ water content, after which the soil was wetted by water infiltration from the ground surface. In the laboratory tests, engineering properties of the loess were investigated through index tests, the direct shear test, the oedometer test and the saturated and unsaturated triaxial compression test.

(a) Block sample

(b) Excavated pit

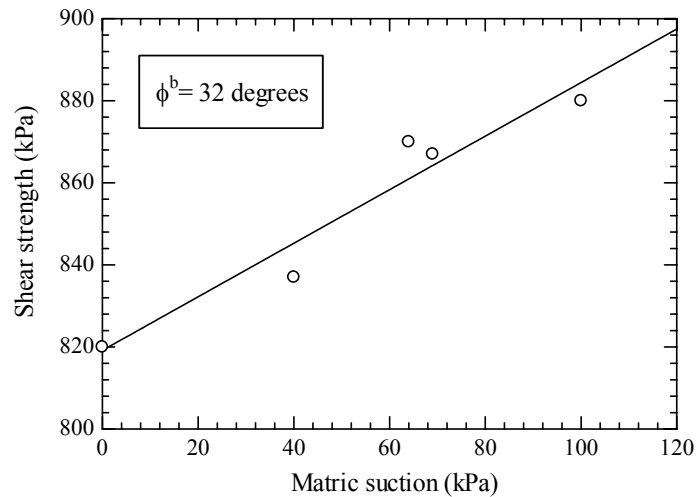
(a) Relationship between shear strength and matric suction at a constant net normal stress of 200 kPa

Fig. 10 – Shear strength versus metric suction

Figure 9 shows the schematic diagram of modified triaxial apparatus for unsaturated soil. A series of unconsolidated-undrained triaxial tests were carried out in order to find the ϕ^b value. The shear strength under constant net normal stress and varying matric suction are summarized in Table 2. Figure 10 (a) shows the relationship between shear strength and matric suction up to 100 kPa. An extended Mohr-Colomb equation (Eq.1) is used to interpret the test results. When matric suction is zero (saturated condition), the

shear strength is calculated as 820 kPa with c' equal to zero, ϕ^b equals to 32 degrees under a constant net normal stress of 200 kPa. The shear strength data of Khon Kaen loess subjected to high suctions are presented in Fig.10 (b). A constant net normal stress of 200 kPa was applied with various total suctions. The suctions applied were always larger than the residual suction of 500 kPa. Figure 10 (b) shows that shear strength of Khon Kaen loess remains constant beyond residual soil suction.

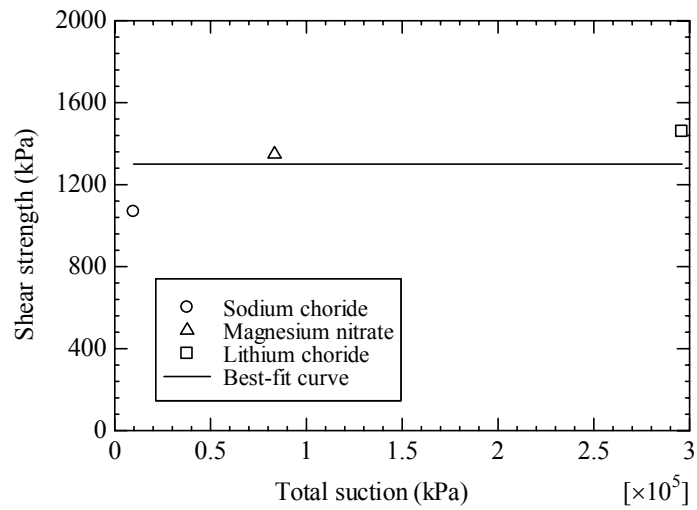
(b) Relationship between shear strength and high suction a net normal stress of 200 kPa

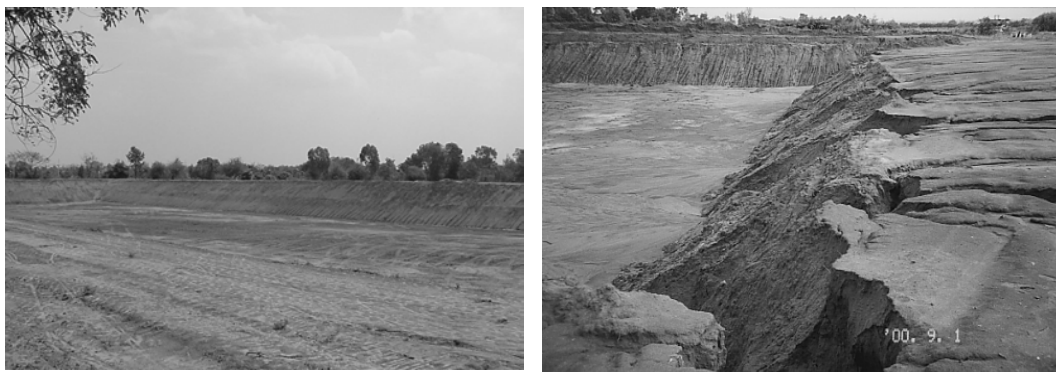
Fig. 13 – Collapse and erosion of agricultural pond

(a) Before

(b) After

Evaluation of slope instability is an inter-disciplinary effort requiring contributions from engineering geology and soil mechanics. The main objectives of the slope analysis of Khon Kaen loess embankment are to assess the stability of slope under given conditions and to assess the potential of the soil as a material for road construction. Natural slopes in soil are of interest to geotechnical engineers. The soil composing any slope has a natural tendency to collapse under the influence of gravitational and other forces. Figure 13 shows agricultural pond in Khon Kean University before and after raining. The collapse and erosion phenomenon of the loess are evident in Fig 13 (b).

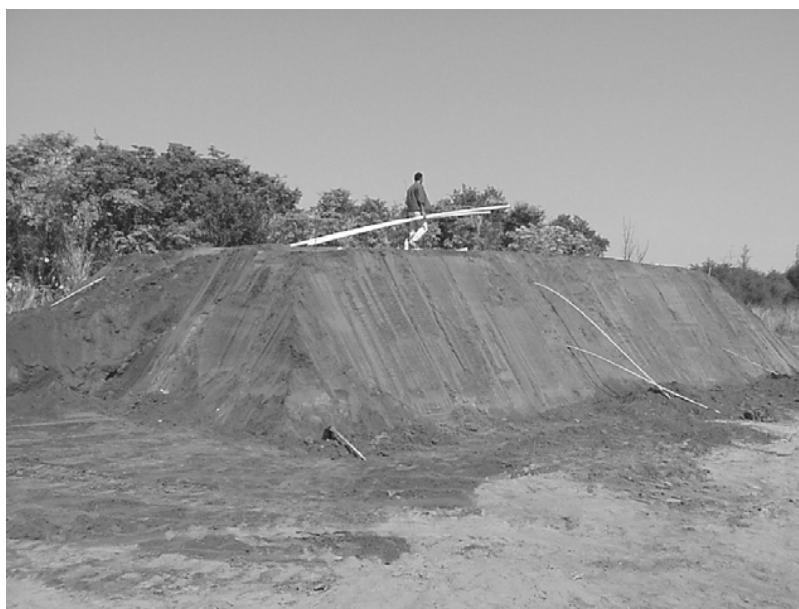
Fig. 14 – General view of trial embankment

The test site is located in Khon Kaen University. The construction area chosen was flat for the most part and near the borrow pits of fill material. The design of the test embankment configuration was based on the typical section from Department of Highway, Thailand. The final layout of the fill and the cross section of the embankment are shown in Figs.14 and 15, respectively. The test area is divided into two parts to simulate the general traffic load of 2 t/m² and to simulate the rainy season in the Northeastern region of Thailand as shown in Fig. 16 and Fig. 17. To facilitate monitoring of the construction and to observe the performance of the embankment, field instruments were installed. The instrument layout was selected based on the results of the limit equilibrium analysis and the total number of instruments. The instrumentation of unreinforced slope consists of piezometers, total pressure cells and inclinometer casings. Pneumatic piezometers were installed to monitor the positive and negative pore pressures. The pneumatic-type total pressure cells were installed to measure the total pressure imposed by the fill on the bottom of the embankment. The applied total stresses measured from the monitoring agreed well with those deduced based on the thickness of fill and the measured unit weight of the fill. Horizontal movement of the ground was monitored by measuring the displacement from inclinometer.
