Countermeasure Construction Using Jet Grouting Methods to Combat Foundation Scour

Dennis W. Boehm, MSCE¹

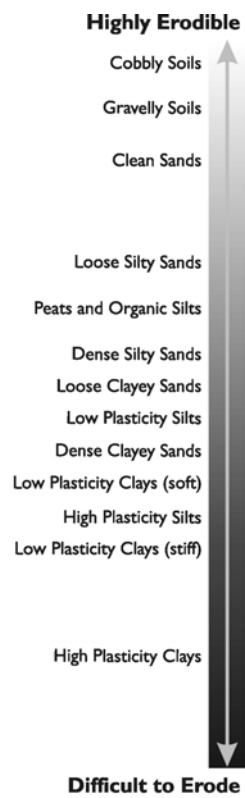
Figure 3. Erodibility scale for jet grouting systems, from Hayward Baker

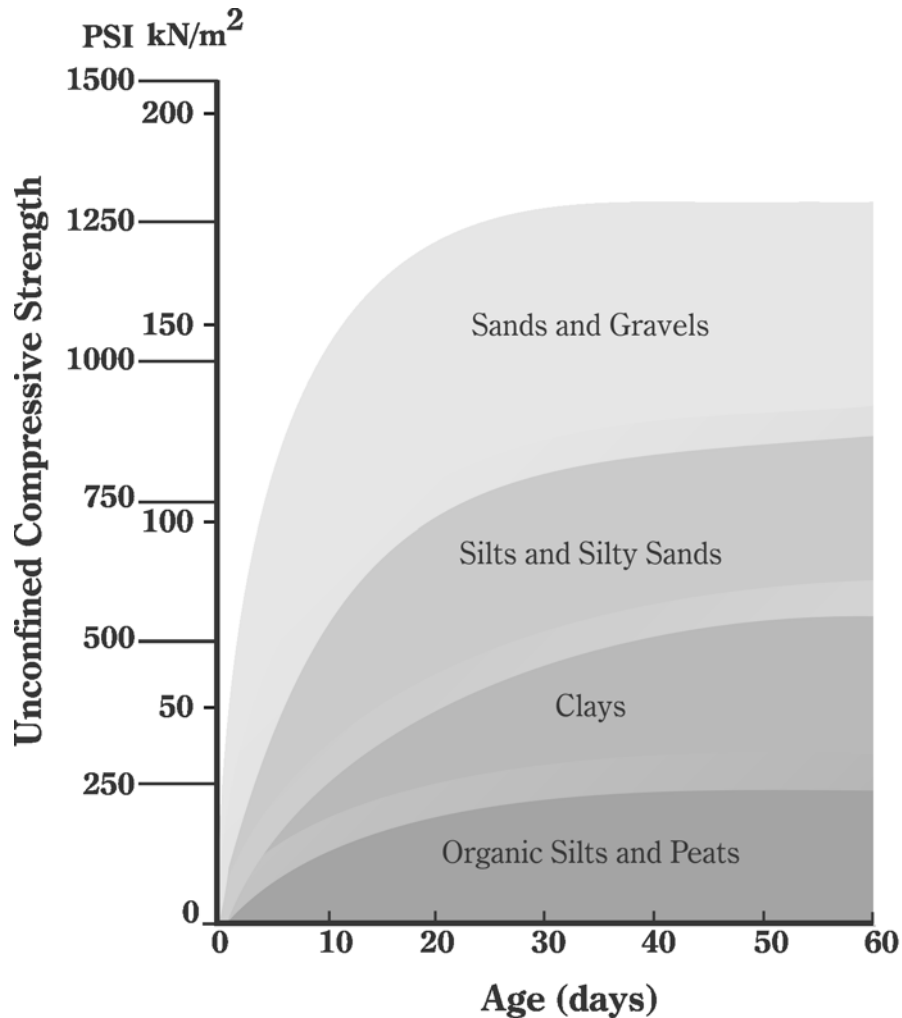
Figure 4. Typical strengths obtainable with jet grouting in various soil types, from Hayward Baker

Compared to any other grouting system, jet grouting is effective across the widest range of soil types, including silts and clays. Because it is a soil erosion-based system, geometry and quality can be predicted. The quality of the final jet grout product, often referred to as soilcrete (Burke and others 1992), is dependent on the soil types being jetted. Cohesionless soils typically erode more easily than cohesive soils as shown in Figure 3. Sands and gravels generally provide the highest strength, and clays provide the lowest (Figure 4). The result of higher strengths in granular

materials is due to sands and gravels providing a better aggregate within the soilcrete matrix as opposed to cohesive materials, which provide soft inclusions within the soilcrete matrix.

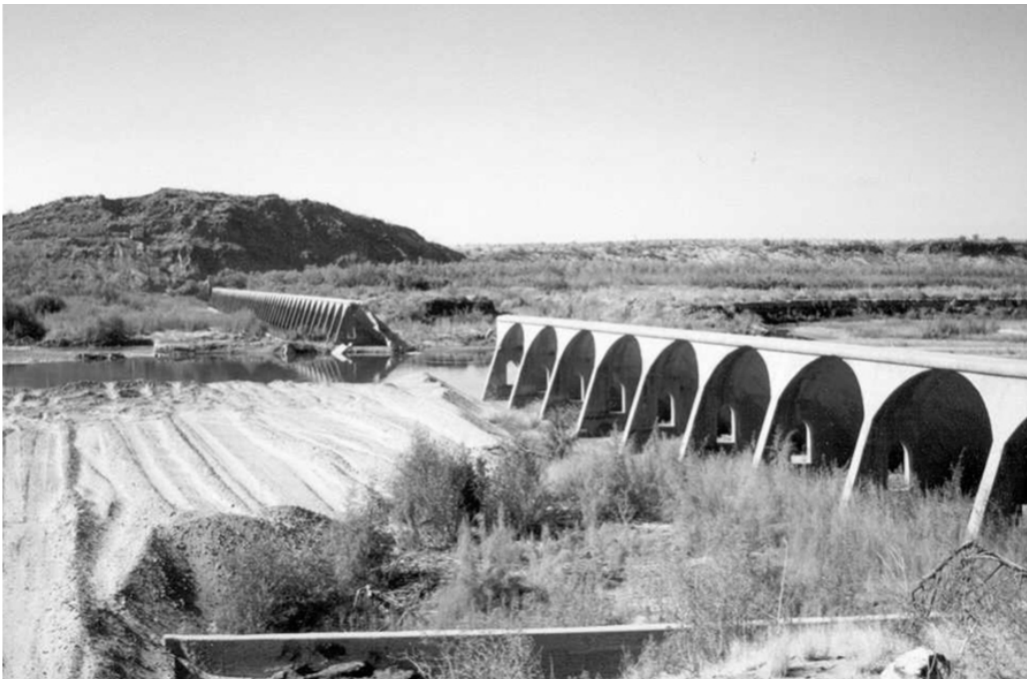
Figure 7. Failed portion of the Gillespie Dam just upstream from the US-80 Bridge

The Old US-80 Highway Bridge in Maricopa County, Arizona, over the Gila River is a nine span trestle type bridge constructed in the early 1900's. The bridge is situated approximately 91.44 meters (100 yds) downstream from Gillespie Dam, which controls downstream flows during heavy periods of upstream rains (Figure 5). The bridge's founding structure is composed of large concrete pedestal type piers founded upon caliche hardpan (Figure 6). During heavy desert monsoon rains in 1993, the dam failed, sending water in volumes of up to 4,248 cubic meters per second (150,000 cfs) downstream (Figure 7). The early 1900's bridge design did not allow for the structural endurance for such an event. As a result, the high velocity of water against the existing bridge created scour on the three eastern most piers. Pier numbers two, three and four suffered some minor cracking, which extended vertically down the center of the pedestal.

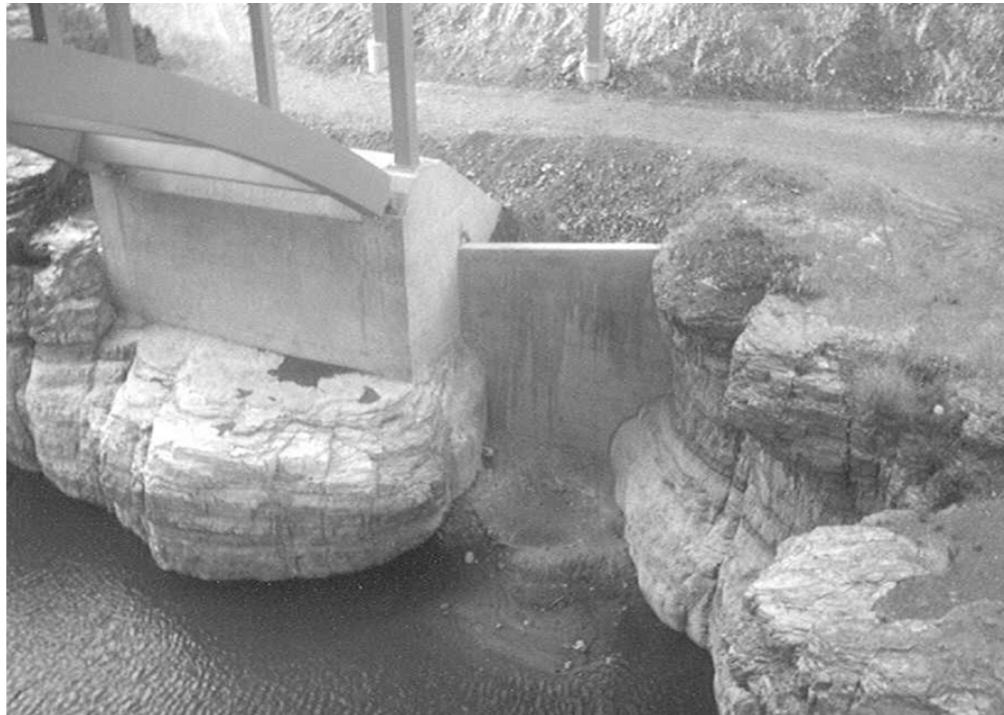
Figure 11. Completed repair of scour hole

Triple fluid system jet grouting was performed to construct 30, 0.9 meter (3 ft) diameter columns. Because of the tight working area and the loss of access roads,

heavy cranes were used to place the jet grouting equipment near the problem area. Special precautions were taken to ensure that none of the jet grout backflow entered into the river. Following construction of the jet grout wall, a new retaining wall was constructed to complete the repair (Figure 11).
