*The paper was published in the proceedings of the 1<sup>st</sup> International Conference on Scour of Foundations and was edited by Hamn-Ching Chen and Jean-Louis Briaud. The conference was held in Texas, USA, on November 17-20 2002.*

## **Countermeasures for Scour at Spill-Through Bridge Abutments**□

### **ABSTRACT**

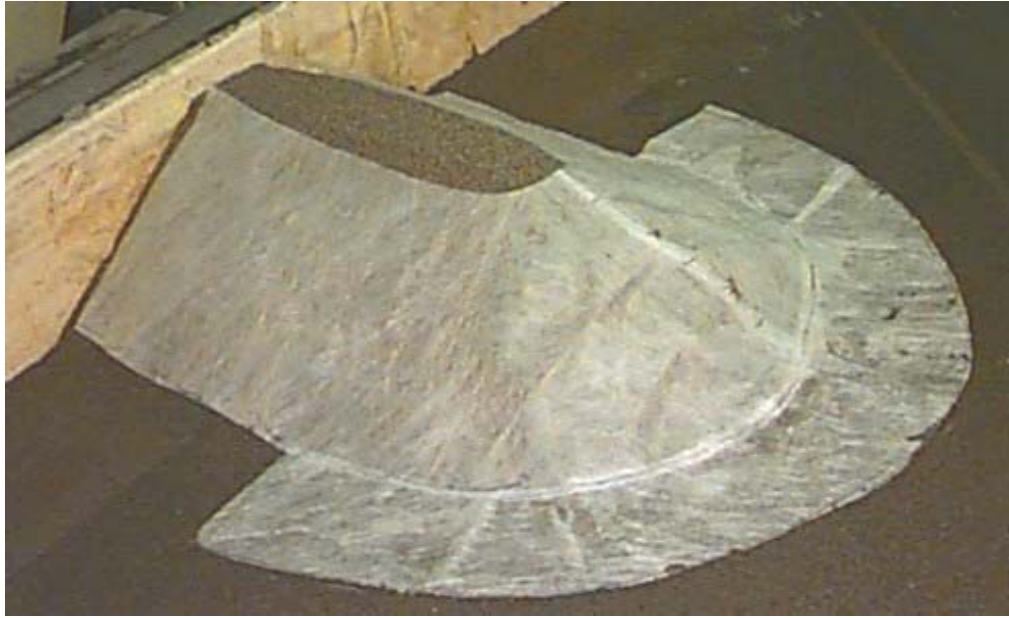
Figure 4 – The filter fabric placed over the sand embankment ready for placement of cable-tied blocks

The median sizes,  $D_{50}$ , of the three uniform riprap sizes used in the riprap experiments were 16.3, 21.5, and 27.8 mm. The riprap was placed on the embankment slopes to a thickness of  $2D_{50}$ . An apron of the dimensions required was placed on the bed around the embankment. Commercially-manufactured ceramic bathroom tiles, of dimensions 25 mm x 25 mm and 5 mm high, were used to represent the cable-tied blocks. A synthetic filter fabric was used in most of the cable-tied-block tests, Figure 4. All tests were conducted at the same flow depth ( $y = 150$  mm), under clear-water conditions on the

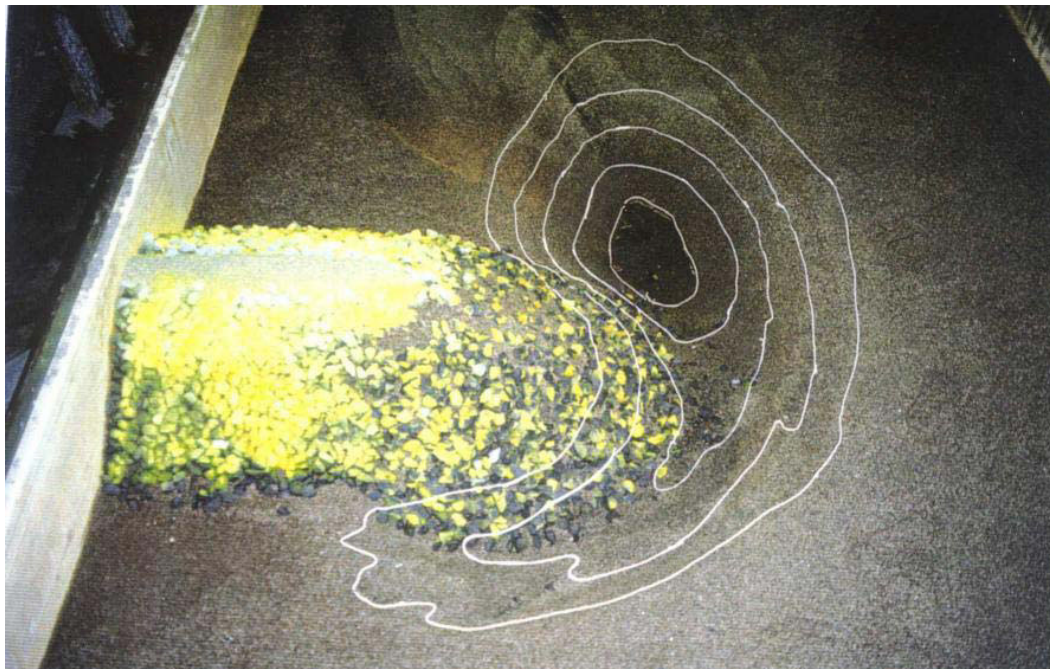
Figure 5 – Typical scour hole developed at an abutment (of no failure) with riprap protection, viewed from downstream

For a riprap apron of  $W = 0.3$  m, no abutments failed. A typical test result is shown in Figure 5. This would indicate that an apron width of twice the flow depth ( $2y$ ) is adequate for abutment protection under clear-water conditions, and within the limits of these tests. However, the results show that this is a conservative solution. The apron width can be reduced, and the extent of the apron in terms of  $\theta$  and  $\phi$  can be reduced also. The results suggest that there is a relationship between the total area of apron and degree of protection. The suggested form of this relationship is shown in Figure 6, which shows a clear zone of partial failure. Note that the values for the tests using a 0.3-m apron have been omitted, to allow the remainder of the data points to be seen more clearly.

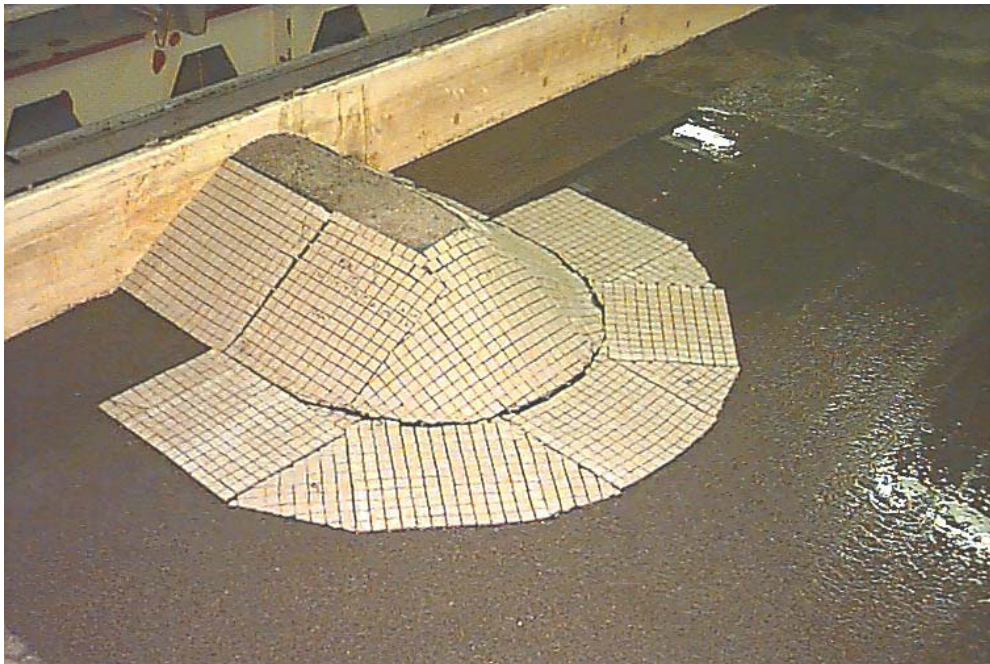
Figure 7 – The standard apron used in all cable-tied block tests

For the cable-tied block experiments, the standard layout used in all experiments is shown in Figure 7. This layout did not provide adequate protection for flow conditions approaching  $V/V_c = 1.0$ . In an attempt to improve the protection, additional cable-tied blocks were added for the final three experiments of  $V/V_c \rightarrow 1.0$ , as shown in Figure 8.

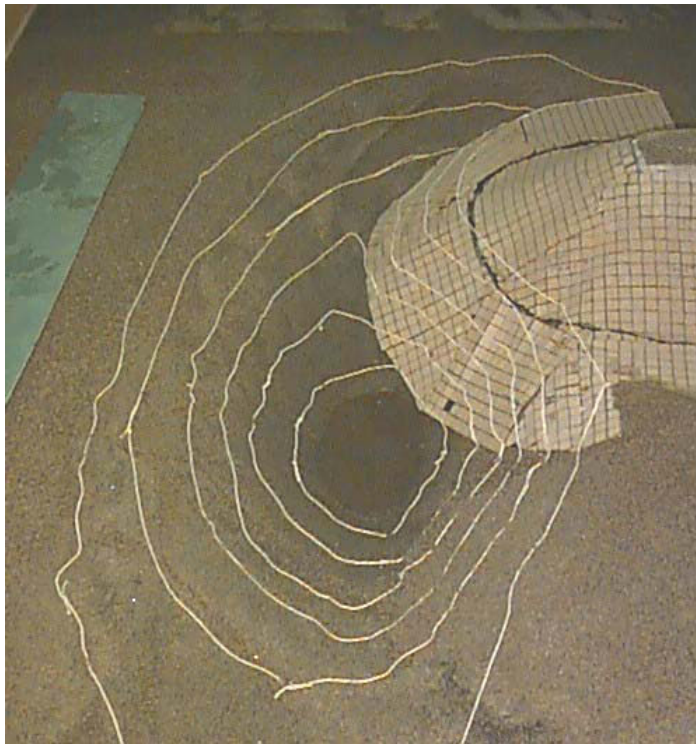
Figure 10 – Scour hole development for Test 4 using cable-tied blocks, with  $V/V_c = 0.66$ , viewed from downstream

The relative performance of riprap and cable-tied blocks is highlighted by comparing the results for riprap-Test 17 and cable-tied block-Test 4. For these tests, the experimental conditions were similar, the velocity ratios being 0.73 and 0.66, respectively. The scour depth reductions for these two tests were 42% and –11%, respectively. The scour developed in each of these tests is shown in Figures 9 and 10.

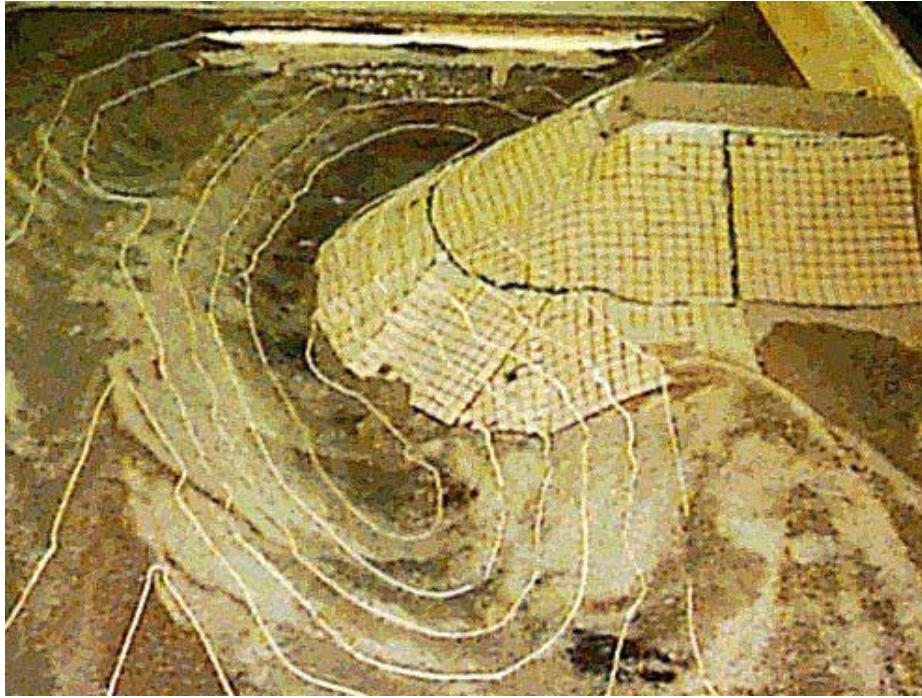
Figure 12 - Typical scour hole development for failed cable-tied block protection (Test 6), viewed from downstream. The failure was due to slumping of the fill material near the top of the embankment

abutment structure would not have failed. Conversely, Test 6 (Figure 12) was a failure because the fill material slumped near the crest.
