# **Comparison of Abutment Scour Equations Developed for Alluvial and Cohesive Sediment: Three Bridge Replacements on Brea Canyon Boulevard over Brea Canyon Channel in Brea, California**

**Holly L. Callahan, P.E.<sup>1</sup> and Catherine M.C. Avila, P.E.<sup>2</sup>**

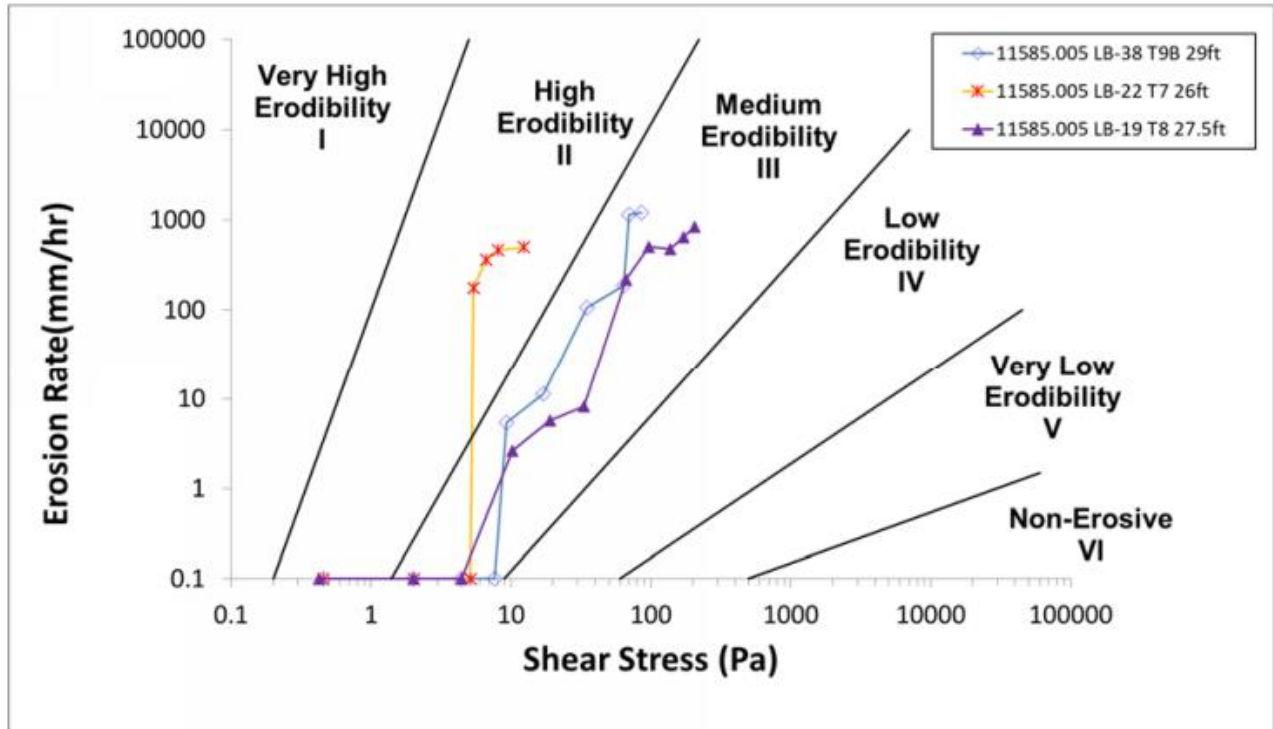
Figure 4 shows the graphical results of the erosion rate (mm/hr.) vs. the shear stress for each bridge and indicates the material at Bridges 1 and 3 have medium erodibility and at Bridge 2 has medium to high erodibility.

**Figure 4. Erosion rate vs. Shear Stress for the material at each bridge (Leighton 2020).**

Due to the medium to high erosivity of the material at each bridge, the Siltstone is not likely to be resistant to scour and limit theoretical scour depths. However, the material may have some cohesive properties which could not be accounted for because the NCHRP 24-20 abutment scour equations assume alluvial material.
