Geotechnical and environmental aspects of a land reclamation made by blasted rock from tunnel construction

M. Rømoen¹, T. R. Smaavik², G. A. Slinde³, and A. Pettersen⁴

Keywords: Land reclamation, marine sediments, geotechnics, environmental, case history, learning points

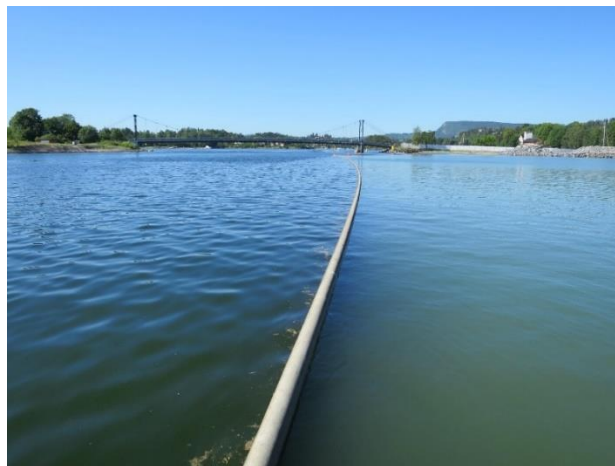
In addition, a silt curtain was established from sea level down to the seabed. This was established to prevent spreading of upwelling sediments, or fines from the filling outside of the boundaries of the remediation. Figure 4 shows the clear distinction between the outside (left) and the inside (right) of the project area, with the silt curtain in the middle.

Figure 4. Effect of silt curtain
