Learning from offshore field performance

ABSTRACT: This paper, the written version of the 7th ISSMGE McClelland Honor Lecture, documents and shares the learnings from the field performance of full-size offshore foundations under installation and operation loads. It details the events that led to the buckling of driven piles at the Valhall field during installation and compares the measured performance of MODUs anchors and mooring systems, jackets, and free-standing caissons to North Sea and Gulf of Mexico extreme environmental loads. It shows that the predicted performance of these structures is consistent with the field observations, if modern approaches to foundation modelling are used.

Keywords: anthropogenic geohazards; pile buckling; field performance; p-y curves

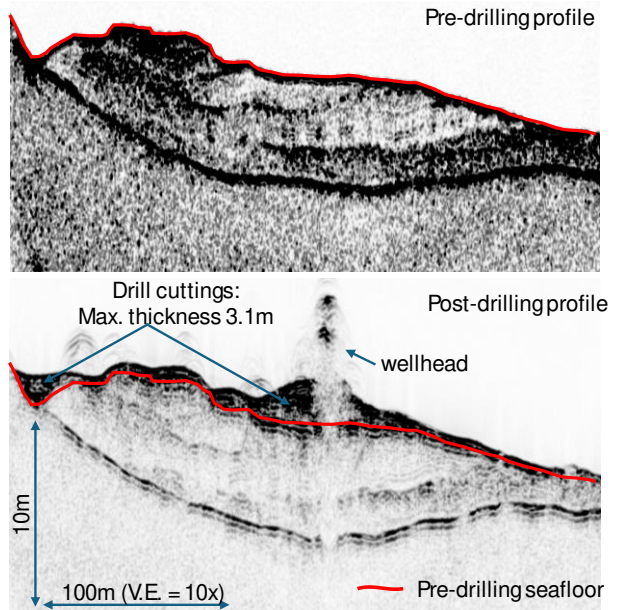
Figure 5 top) Example of drill cutting contours obtained from repeat pre- and post-drilling bathymetry surveys and bottom) Example of repeat AUV SBP records showing drill cutting thickness at multi-well drill center.

In the example in Figure 5, the drill cuttings were deposited as far as 200m from the nearest wellhead, and their maximum thickness exceeded 3m close to some of the wellheads.

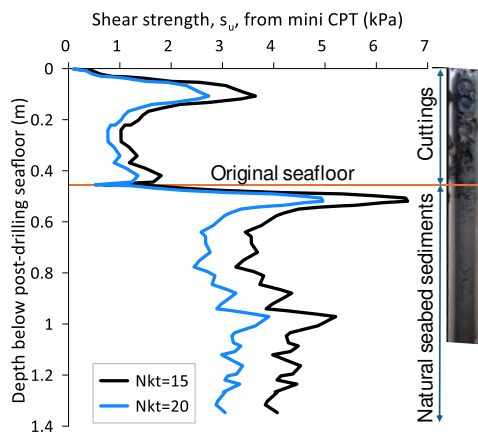
Figure 6 Example of shear strength measurement in uncemented drilling mud-rich drill cuttings.

Uncemented cuttings are usually made of natural clay materials mixed with drilling mud (e.g. bentonite, barite) and do not contain cement. Their texture can easily be identified in cores and their strength can be lower than that of the natural seabed (Figure 6).

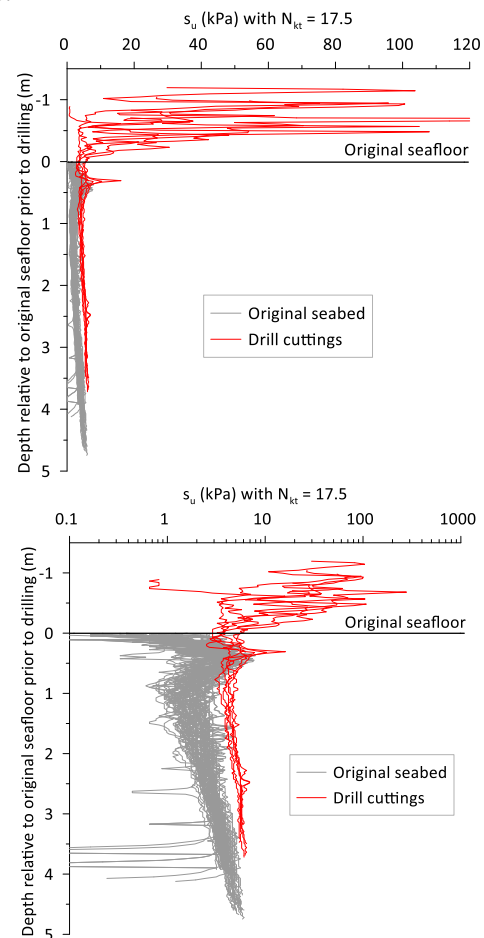
Figure 7 Example of shear strength measurements in very weakly cemented drill cuttings top) linear scale and bottom) logarithmic scale.

typical cone resistances less than 4MPa. This type of material can be broken apart by hand with little effort and tends to occur as plates of typical thicknesses of 0.1m on top of, or embedded into, uncemented cuttings. Figure 7 presents shear strength profiles derived from mini-CPT testing in locations where the cuttings were present and absent. It shows that these very weakly cemented materials can be up to 1.5m thick with shear strength in excess of 100kPa. They can pose a hazard to the installation of skirted foundations by preventing the skirts from penetrating to their design depths and by causing non-uniform embedment across the footprint of the foundation, resulting in foundation inclinations above allowable limits.

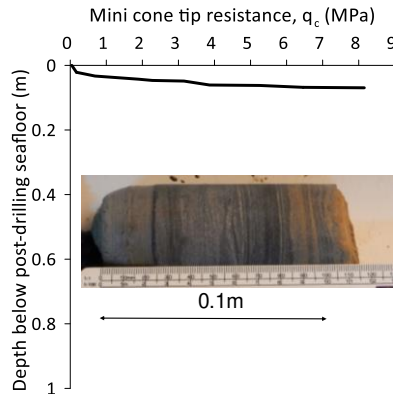
Figure 8 Example of mini-CPT record refusing in cemented cuttings about 0.11m thick.

A third type of sediment encountered consists of cemented cuttings with typical cone resistances greater than 4MPa. This type of material requires significant energy to be broken apart. The amount of cement in these materials can vary highly and reach up to 100%. Figure 8 shows an example of mini-CPT

refusal in such a material which was also rotary-cored to determine that its total thickness was about 0.11m.

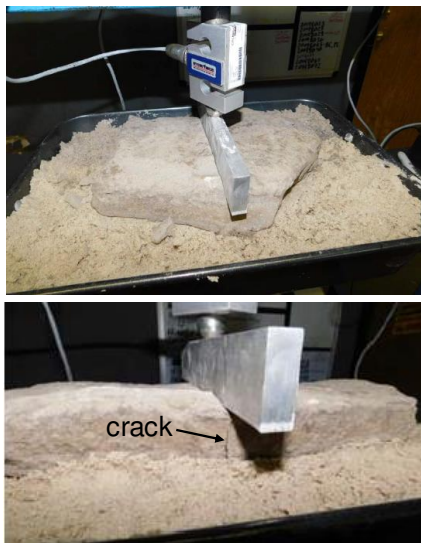
Figure 9 Testing of 50mm-thick cemented cutting block with loading bar: top) test set-up; bottom) crack in block at 2mm vertical displacement.

These cemented blocks can also be recovered from the seafloor using an ROV and tested in the laboratory to measure the maximum pressure that is required to break them. Figure 9 shows a test where a loading bar intended to model the tip of a shallow foundation skirt is progressively loaded up to the point where the cemented block breaks.

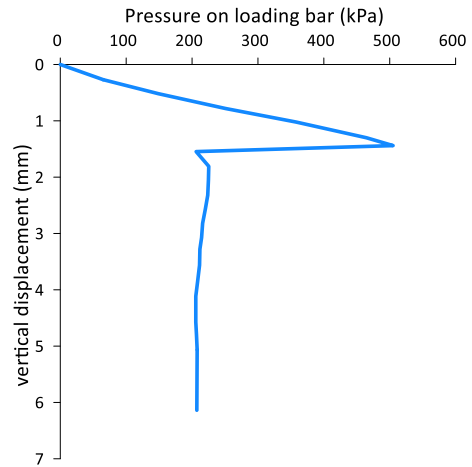
Figure 10 pressure-displacement curve on block of cemented cutting.

foundation skirt during installation, the likelihood of skirt refusal in the cement can be estimated.

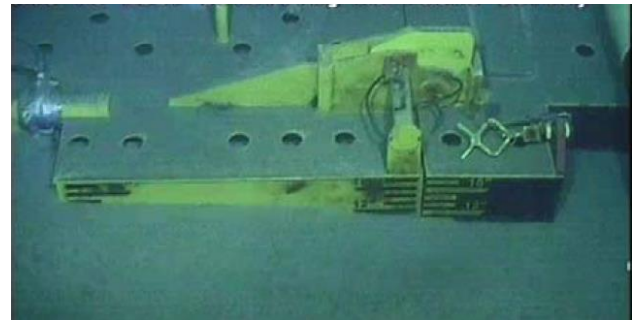
Figure 17 Example of uneven shallow foundation skirt partial penetration due to the presence of drill cuttings.

At the sites described, the thickness of cuttings was up to 3m with shear strengths ranging from 1kPa to over 500kPa. These test results give quantitative data which can be used to assess the likelihood of complete or partial shallow foundation skirts refusal in drilling cuttings and cement (Figure 17).

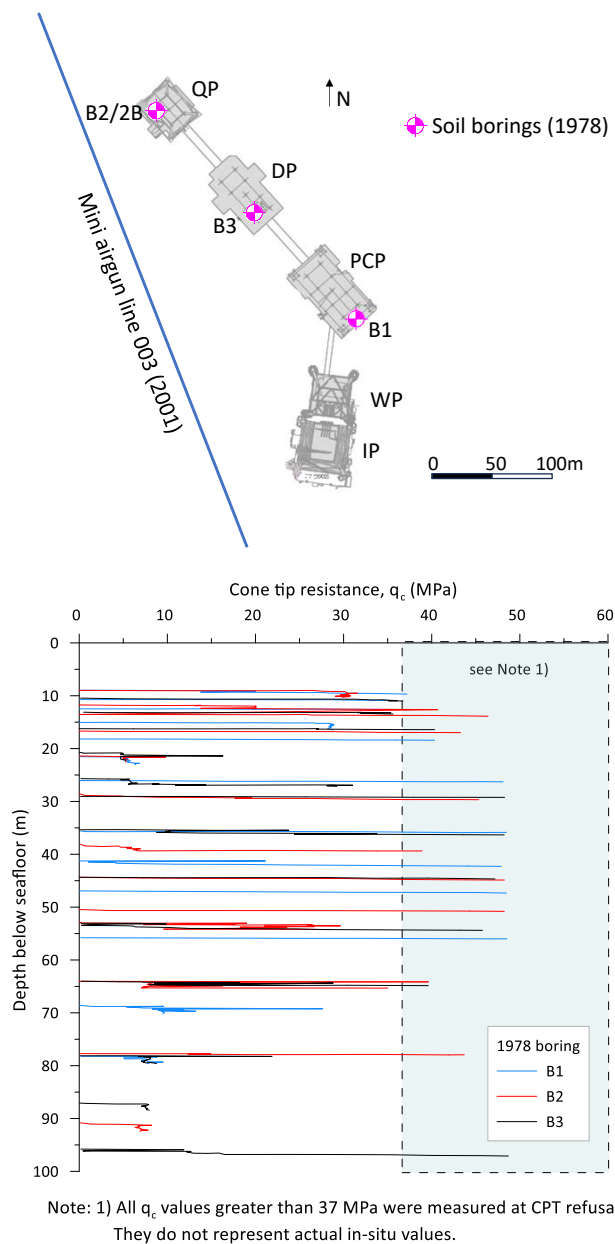
Figure 21 Base map and CPT records of the 1978 site investigation. Data also used for the original design of the WP and IP piles

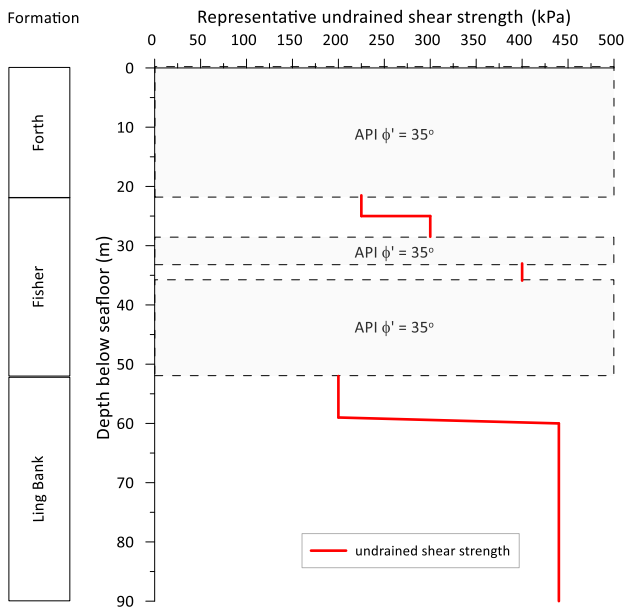
Figure 23 1978 soil properties used in the initial design of the IP platform piles

The soil parameters used on the original IP pile design were mainly influenced by the results of Borehole B3 and are shown on Figure 23. The piles were designed using the API RP2A (1993) methods for both clay and sand units, i.e. the CPT data were used to estimate the sand relative density but were not used explicitly when calculating pile axial capacity.

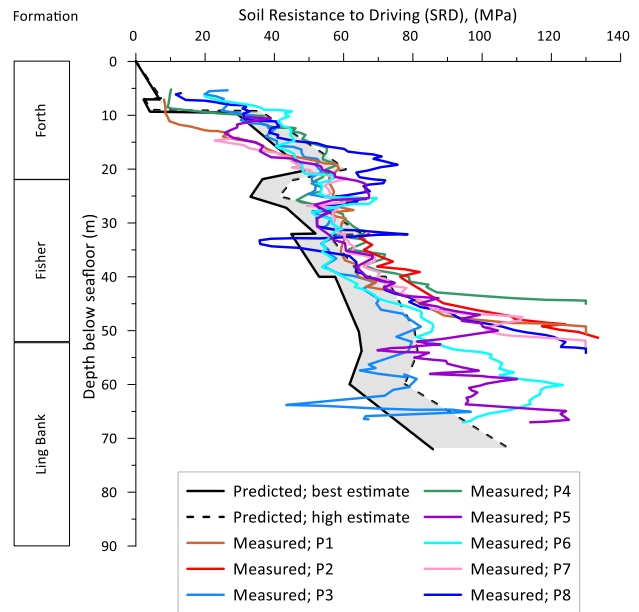
Figure 28 Measured IP pile SRD compared with pre-driving predictions

Noticeably, IP Piles P1 and P2 experienced a much higher SRD and refused at depths of 48.75m and 51.25m respectively in the lower Fisher formation whereas the WP Pile P3 of same diameter, located less than 10m away, was successfully installed to its target depth of 63m (Figure 29).

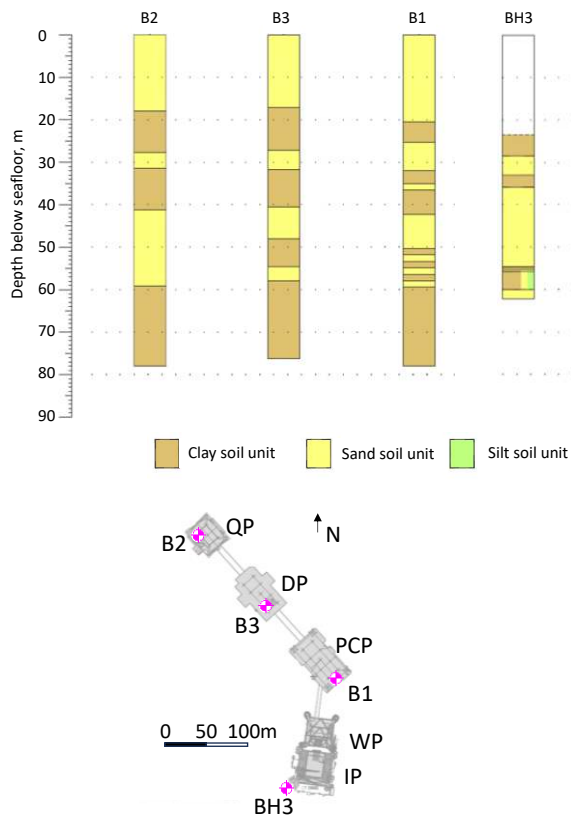
Figure 33 Inferred stratigraphy from Jack-up based post-refusal site investigation

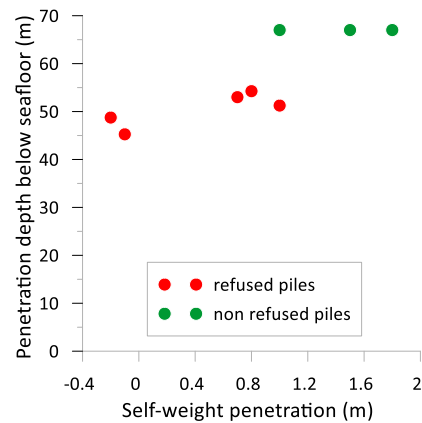
Figure 40 Pile self-weight penetrations and refused depths

The pile self-weight penetration seems to be correlated to its final penetration depth (Figure 40). Piles P1 and P4 appear to have hung up within the sleeve above the seabed (i.e. penetrations less than zero). The refused piles are those with the lowest self-weight penetrations into the seabed which could have been the result of tip damage that happened before the piles penetrated the seabed, making the pile end area greater and therefore giving higher resistance to penetration.

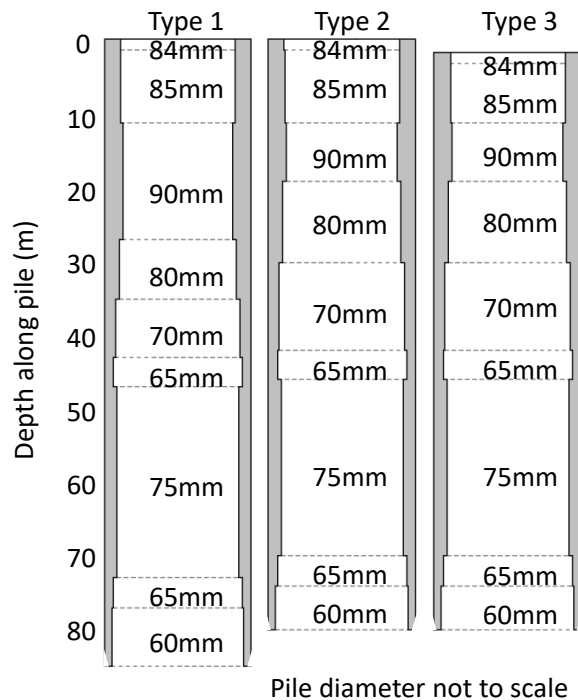
Figure 41 Wall thickness schedule for IP jacket piles original design

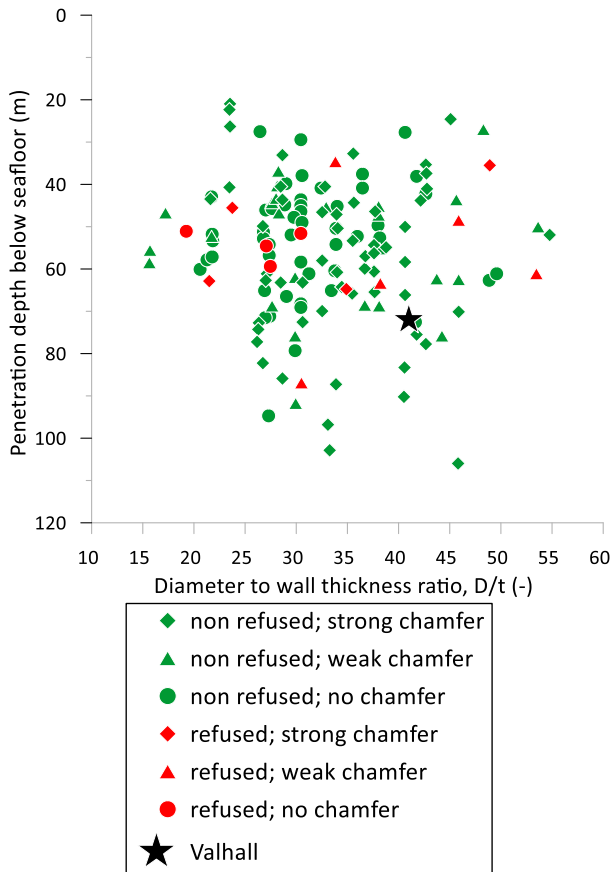
Figure 43 Case records of refused piles as a function of slenderness ratio and penetration depth

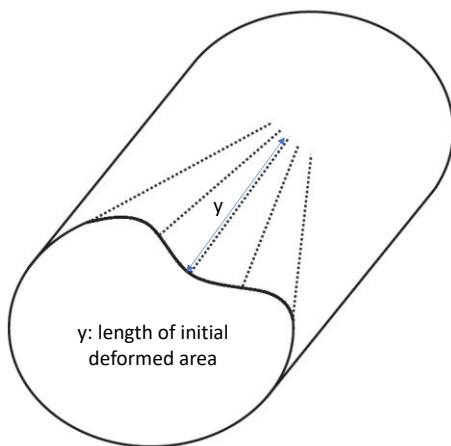
Figure 44 Shape of initial defect in the Aldridge et al. (2005) framework

The soil properties required to propagate a potential initial damage were first assessed using the framework eventually published by Aldridge et al. (2005) using the damage geometry of Figure 44.

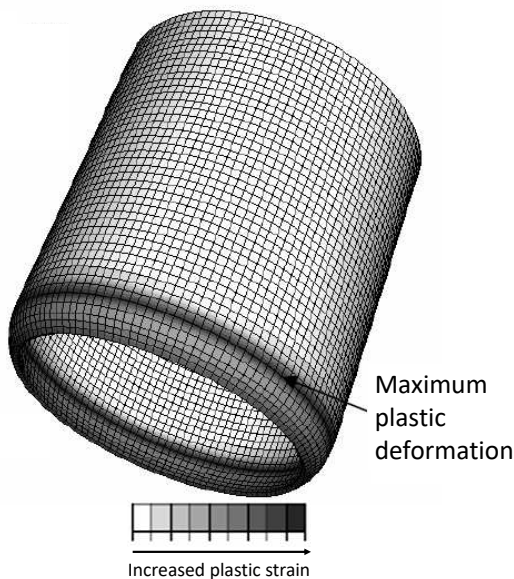
Figure 46 Stress distribution at failure for axisymmetric loading (displacements magnified by a factor of 4)

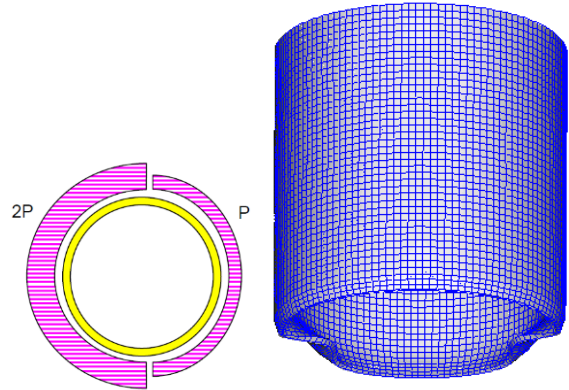
Figure 47 Illustration of non-axisymmetric load case simulating a sloping stratum and resulting failure mode (displacements magnified by a factor of 4)

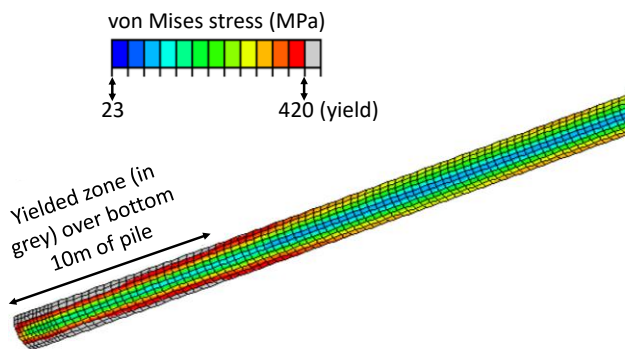
Figure 50 ABAQUS/BASIL analysis showing predicted von Mises stresses and yielding in the pile at 50m penetration

Figure 50 shows the predicted yield zone for a total pile penetration of 50m. The von Mises stress in the bottom 10m of the pile exceeds the nominal yield stress of 420MPa.

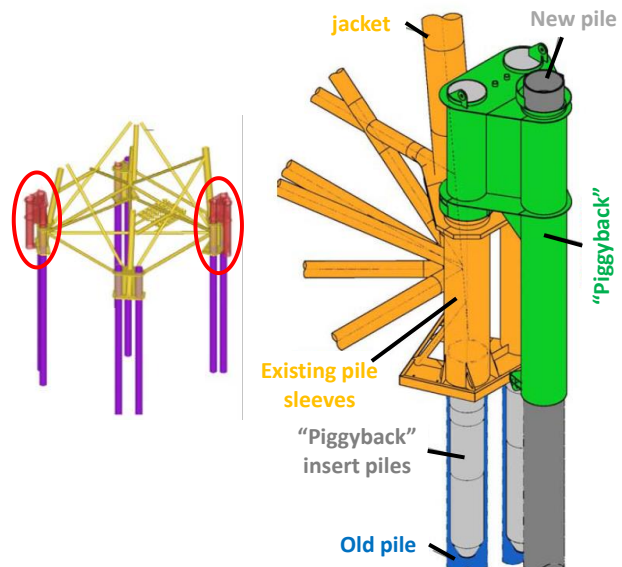
Figure 51 The piggyback repair system (modified from Alm et al., 2004)

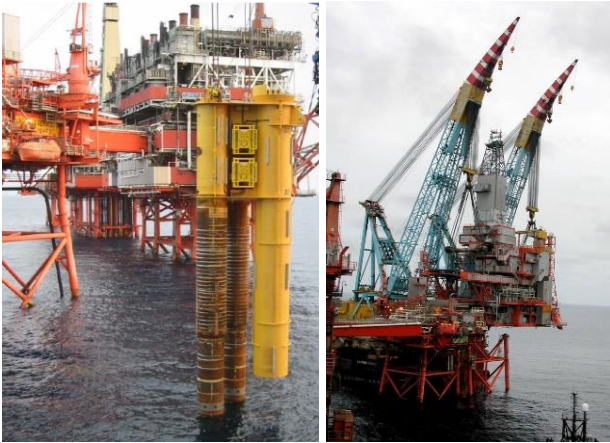
Figure 52 The piggyback repair system (from Alm et al., 2004) and IP jacket topside installation

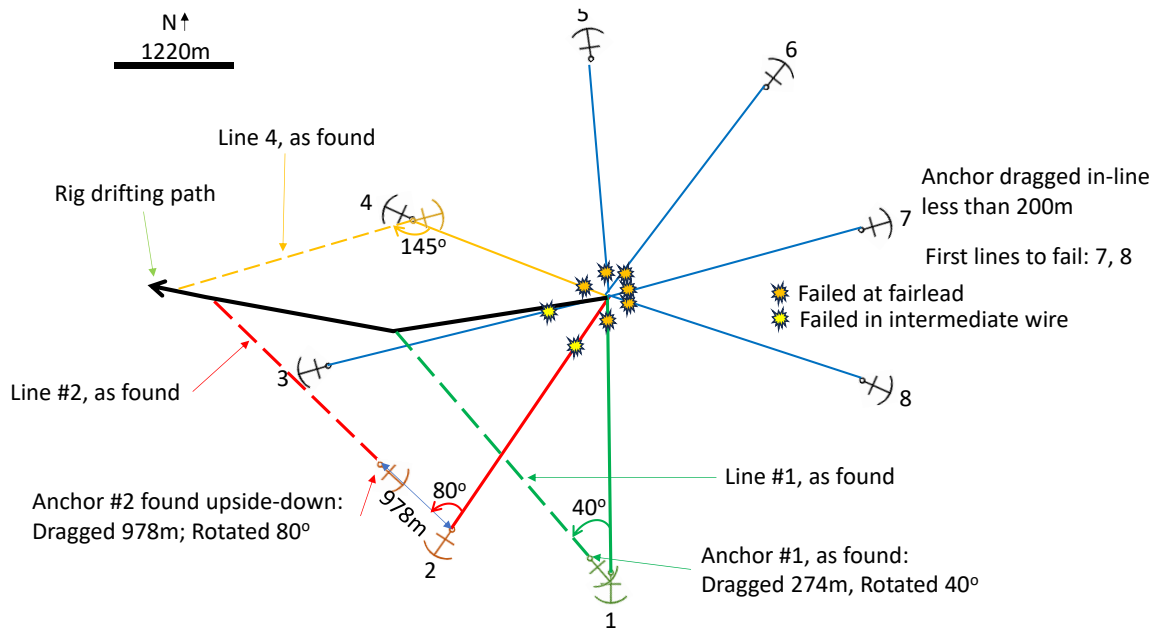
Figure 61 Details of mooring failure of the Marianas rig during Hurricane Rita (modified from Delmar, 2005b)

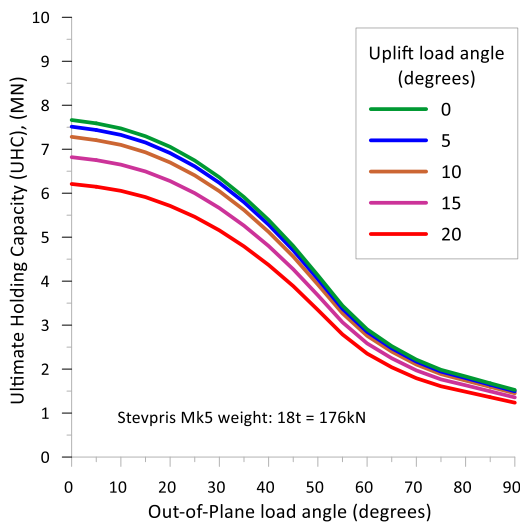
Figure 62 UHC of 18mT Stevpris[®] Mk5 anchor as a function of uplift and out-of-plane load angles (Delmar, 2005b)

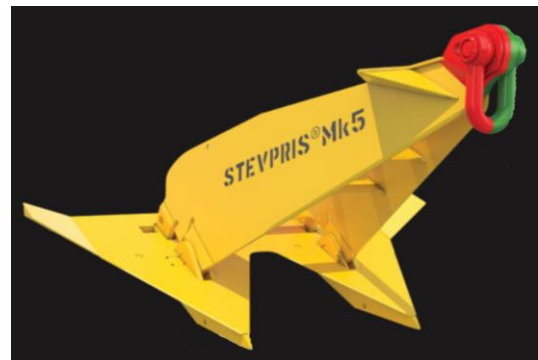
Figure 63 Typical 18mT Stevpris[®] Mk5 anchor (from Delmar)

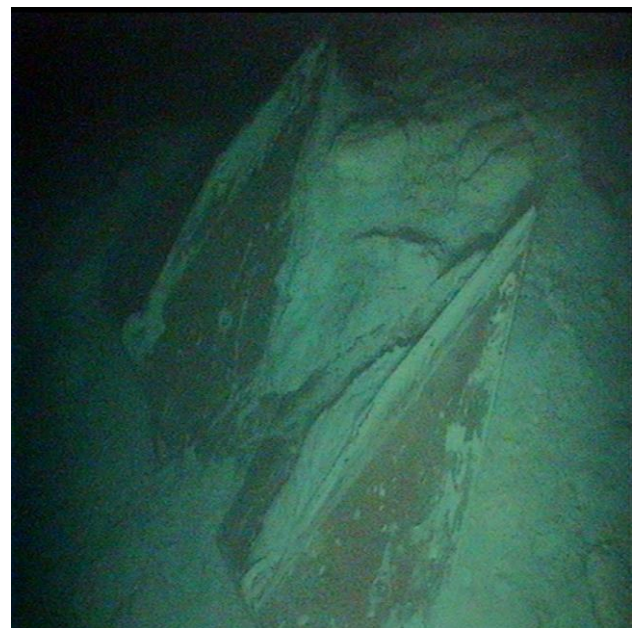
Figure 64 Anchor #2 as-found upside down after Hurricane Rita

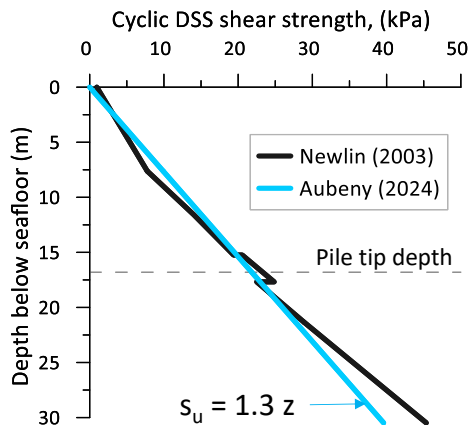
Figure 67 Soil profiles used for Jim Thompson suction pile performance

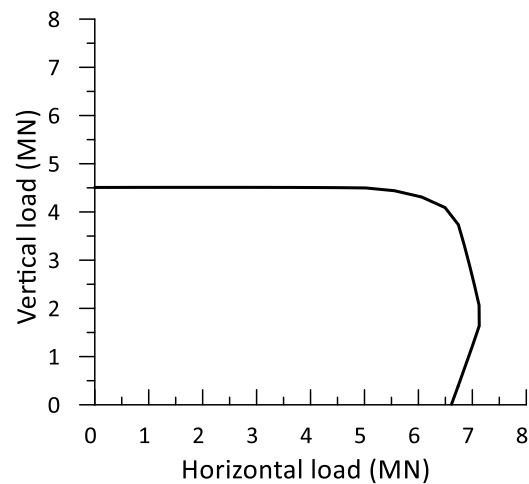
Figure 68 H-V failure interaction diagram for the 3.65m diameter suction piles (Aubeny, 2024)

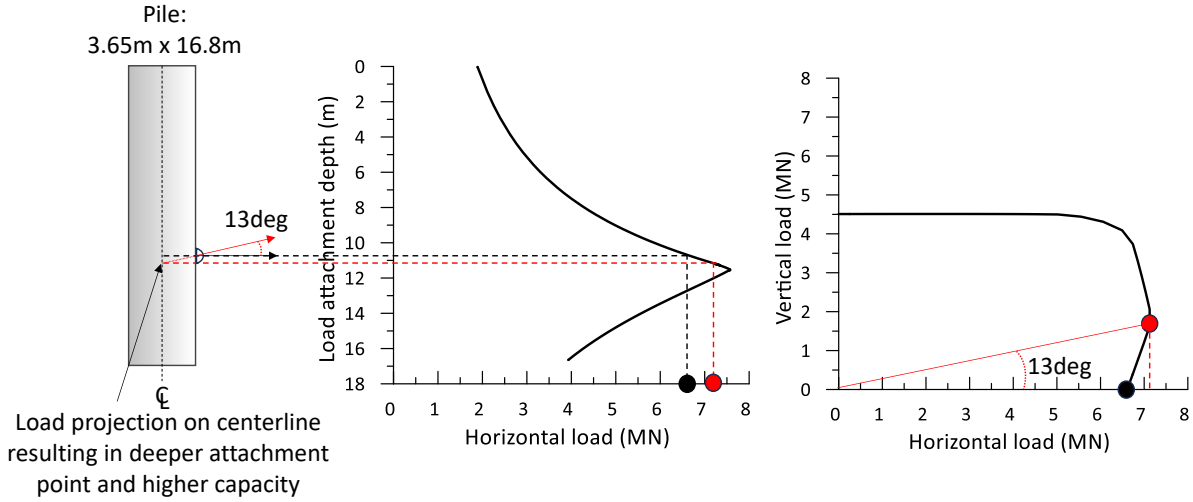
Figure 69 H-V failure interaction diagram and horizontal capacity vs padeye depth for the 3.65m suction piles (Aubeny, 2024)

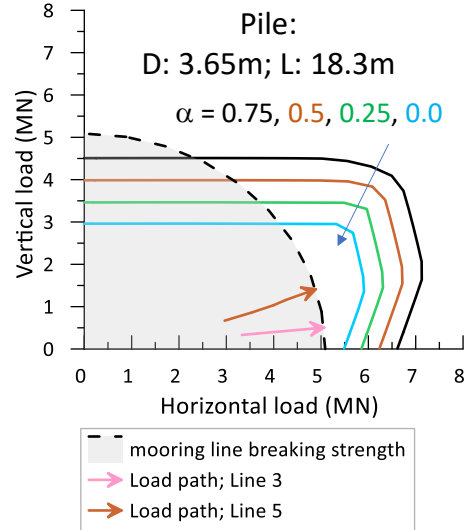
Figure 70 Failure interaction diagrams and load path for Lines 3 and 5.

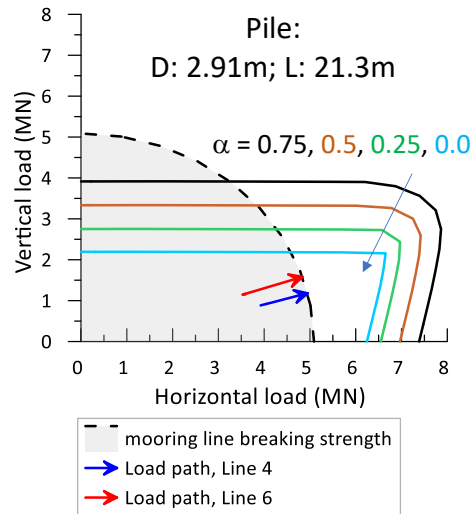
Figure 71 Failure interaction diagrams and load path for Lines 4 and 6.

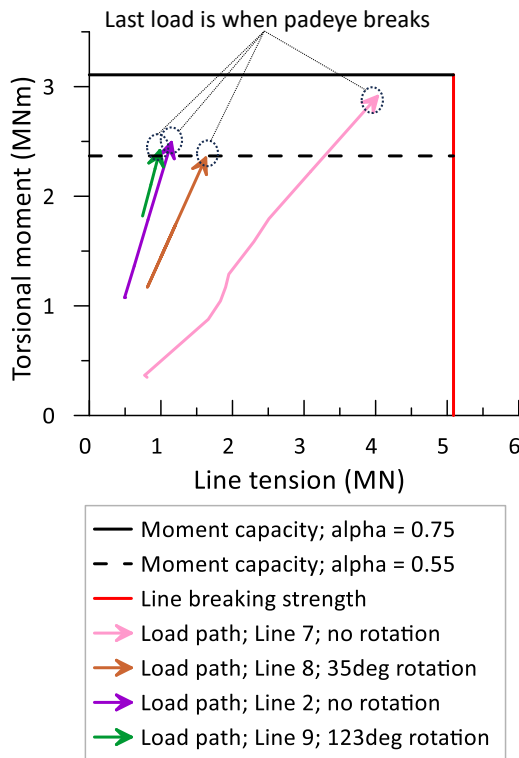
Figure 72 Moment and line tension load path at anchor during Hurricane Ivan for Lines 2, 7, 8, and 9.

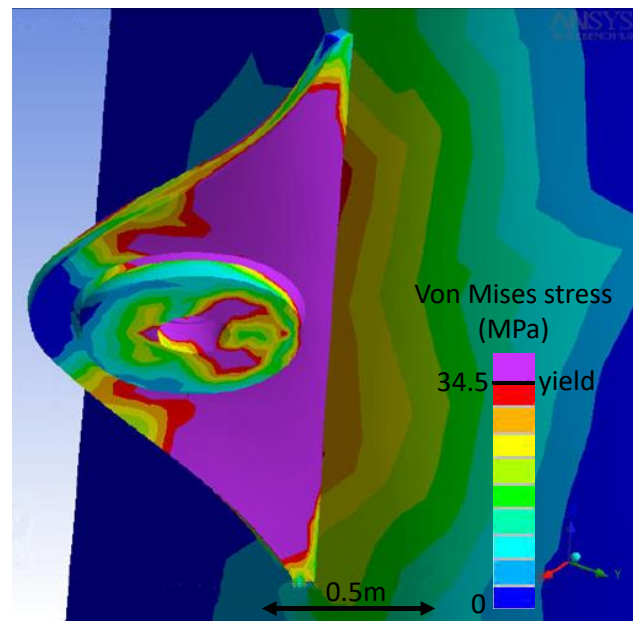
Figure 73 Stresses in padeye for Line 7 at failure (modified from Delmar, 2005).

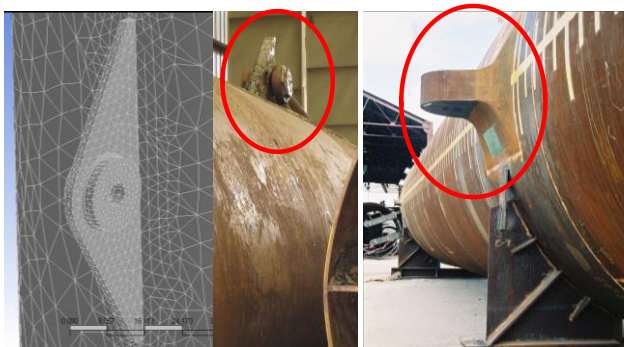
Figure 74 left) fabricated pad-eye for temporary moorings and right) typical cast pad-eye for permanent moorings.

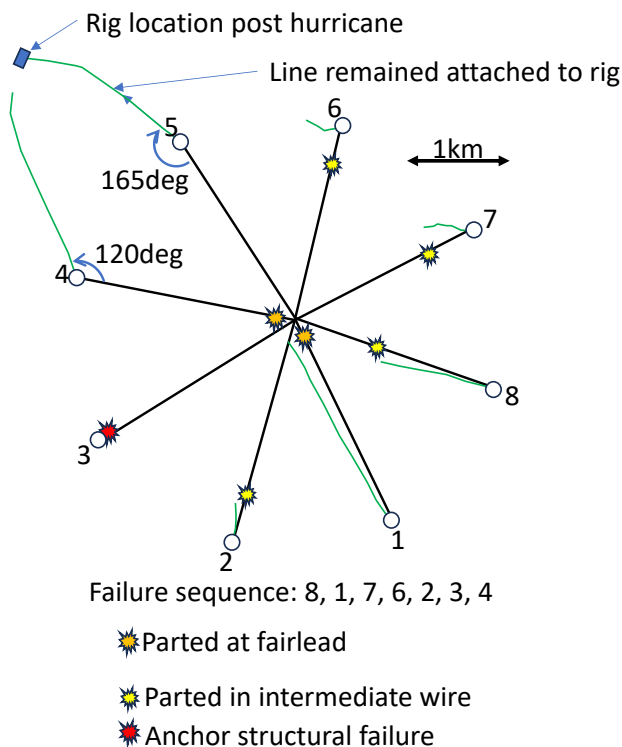
Figure 78 Installed (black) vs post Hurricane Gustav (green) mooring pattern (modified from Zimmerman et al. (2009)).

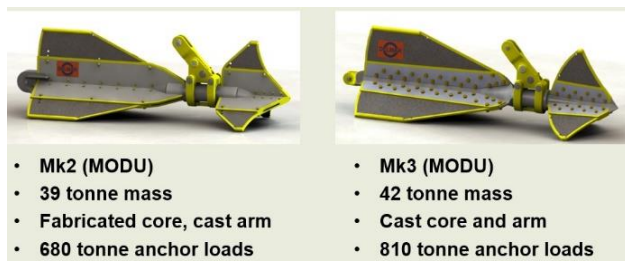
Figure 79 Comparison of OMNI-Max[®] Mk2 and Mk3 anchors (from Delmar, 2024).

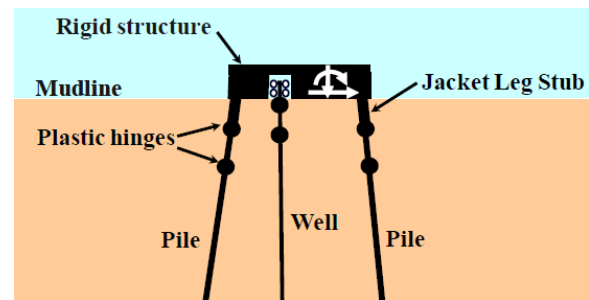
Figure 80 Simplified foundation collapse model (OTRC, 2009).

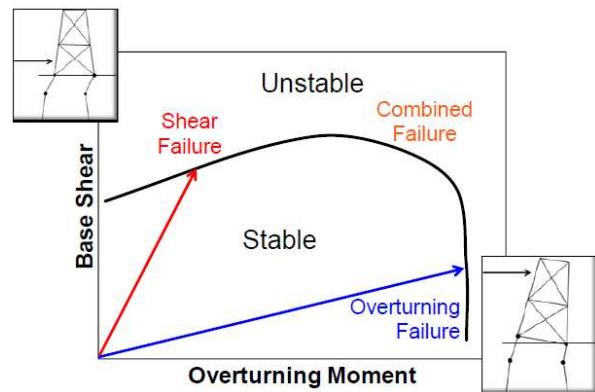
Figure 81 Simplified foundation collapse model (Chen, 2011).

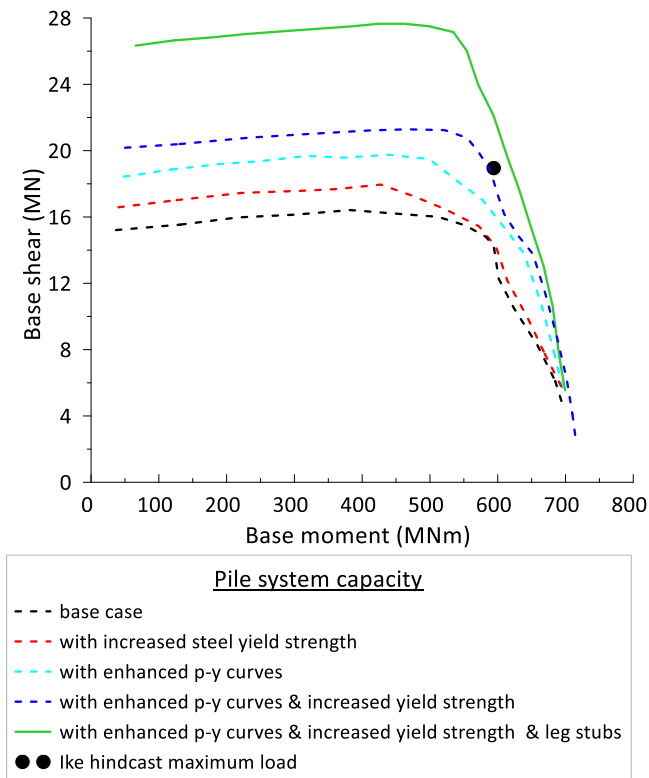
Figure 82 Pile system capacity and hindcast maximum load for Platform 31 during Hurricane Ike (modified from Gilbert et al., 2010, and Chen, 2011)

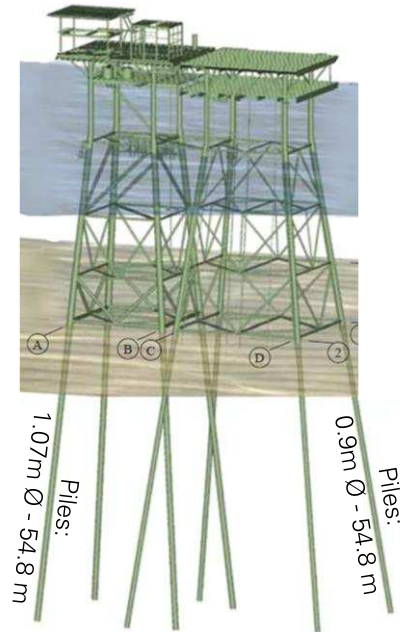
Figure 83 Schematic of SS-Platform. Left jacket installed in 1972, right jacket installed in 1969. (modified from EnergO, 2019)

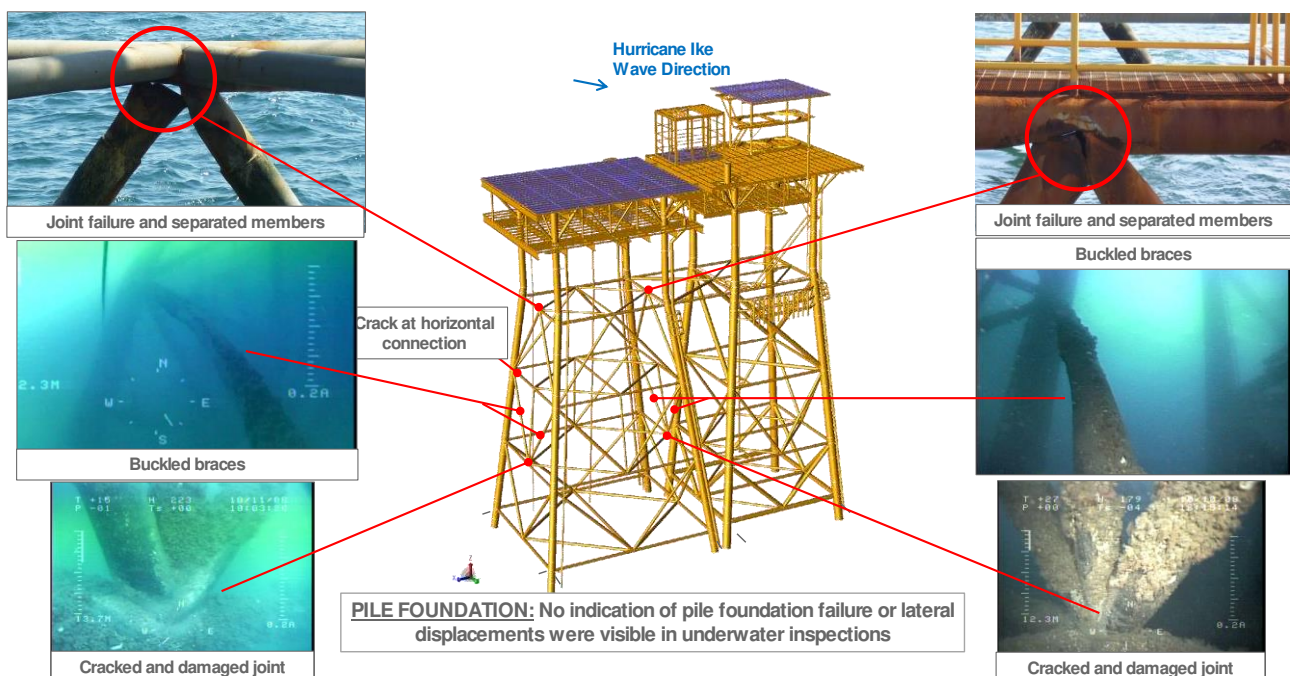
Figure 84 Summary of SS-Platform damages after Hurricane Ike (modified from EnergO, 2010, 2019)

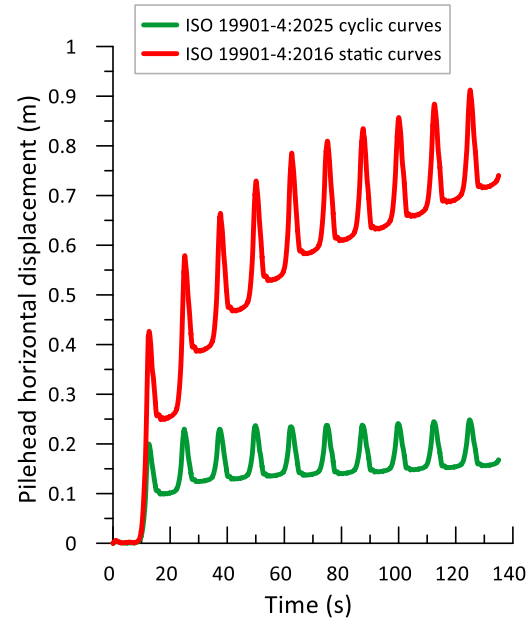
Figure 88 Pile head displacement vs time for two hindcasts

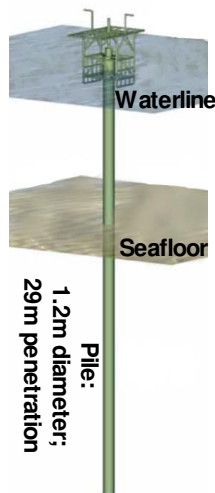
Figure 91 Schematic of free-standing SS-caisson (modified from Energo, 2019)

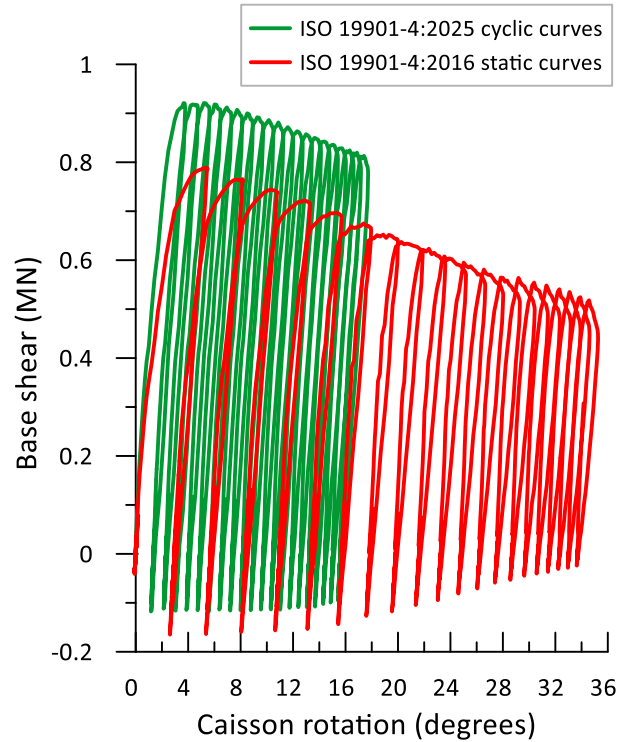
Figure 93 Hindcast of SS-caisson base shear and rotation during Hurricane Andrew (modified from Energo, 2019).

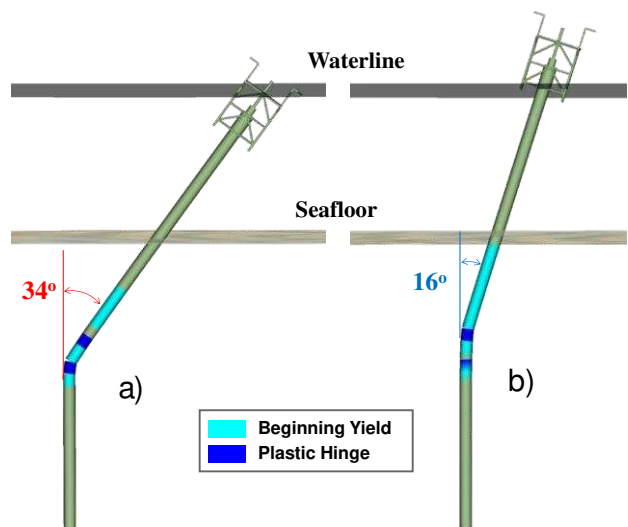
Figure 94 Hindcast of SS-caisson final inclination and plastic hinges with a) ISO 19901-4:2016 static p-y curves and b) ISO 19901-4:2025 cyclic p-y curves (modified from Energo, 2019).

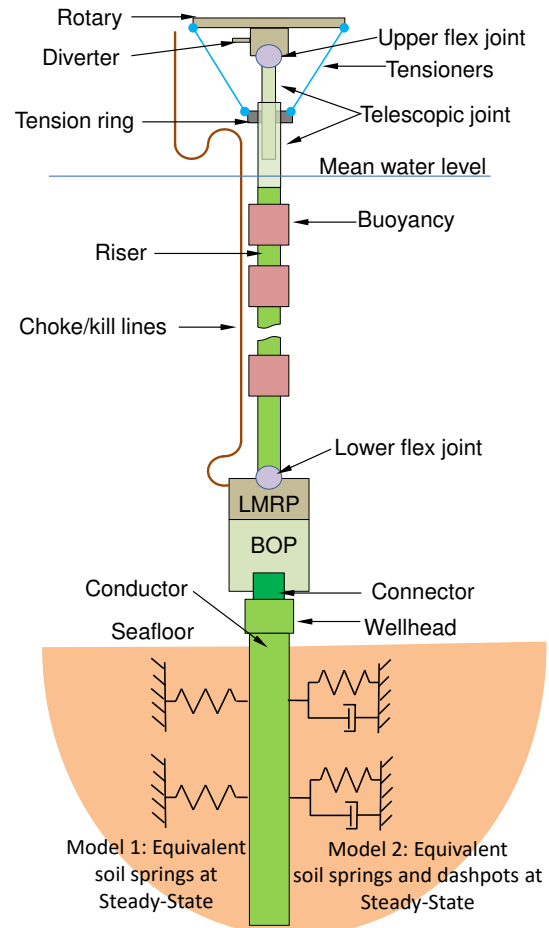
Figure 97 Schematic of deepwater drilling riser system and soil-structure modelling - not to scale (modified from Zakeri et al, 2015).

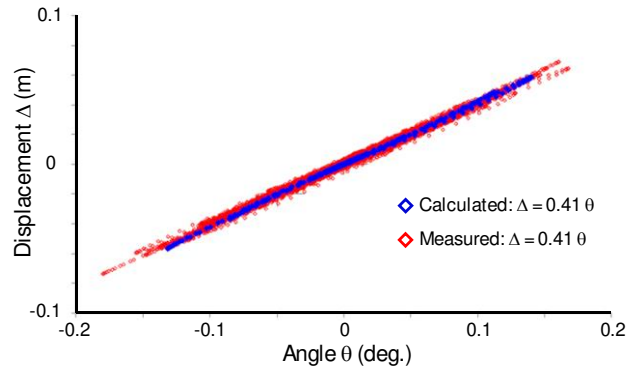
Figure 100 Comparison between measured and calculated riser VIV motions with best-estimate soil properties (modified from Kannala et al., 2016).

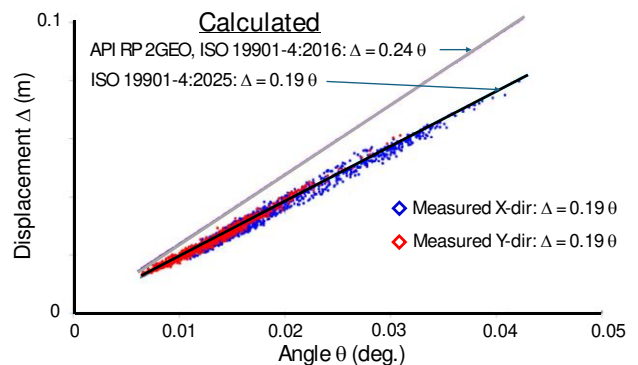
Figure 101 Comparison between measured and calculated riser motions with two soil spring models (modified from Mercan et al., 2017).

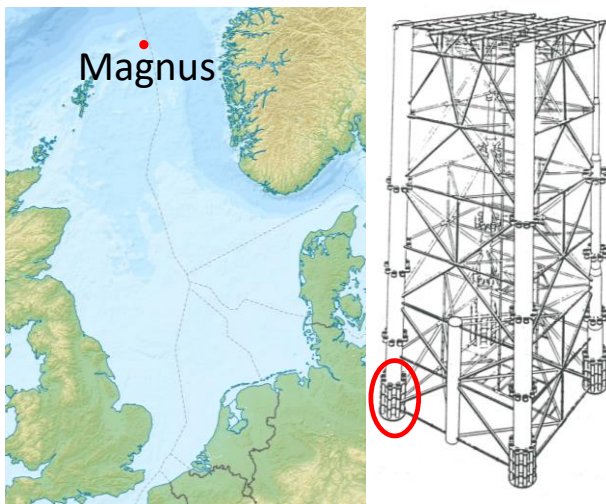
Figure 102 Magnus jacket and Leg A4 instrumentation

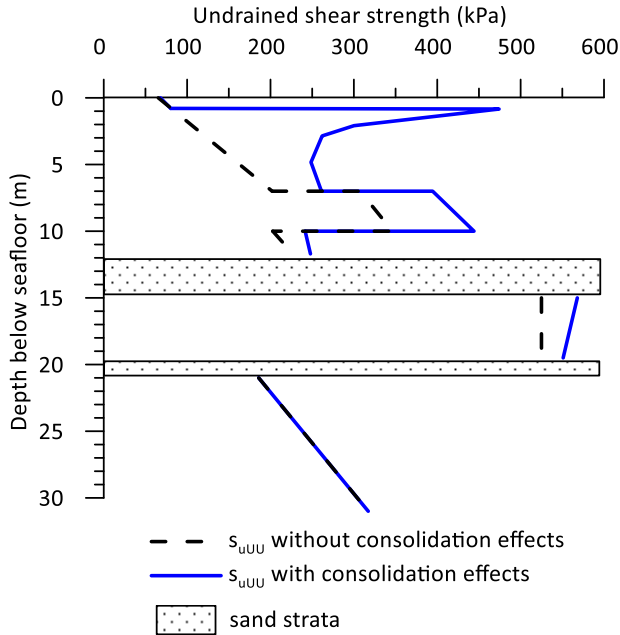
Figure 103 Shear strength profiles for Magnus jacket (Horsnell et al. 1993)

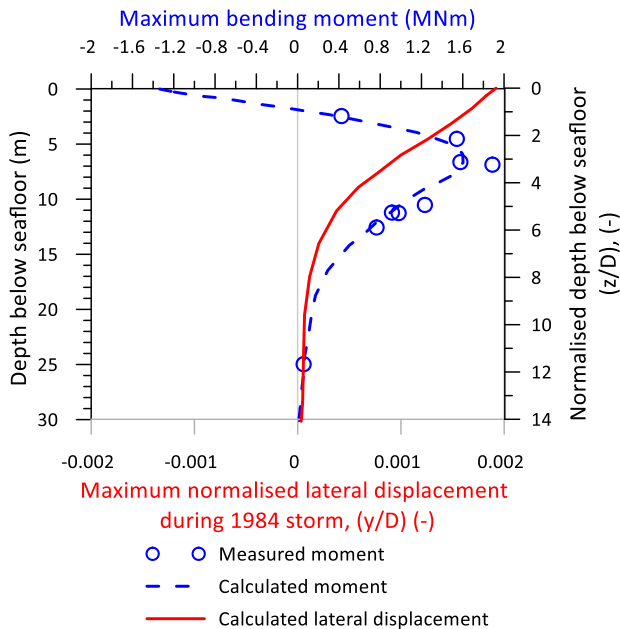
Figure 104 Pile monitoring results and hindcast (modified from Horsnell et al., 1993).

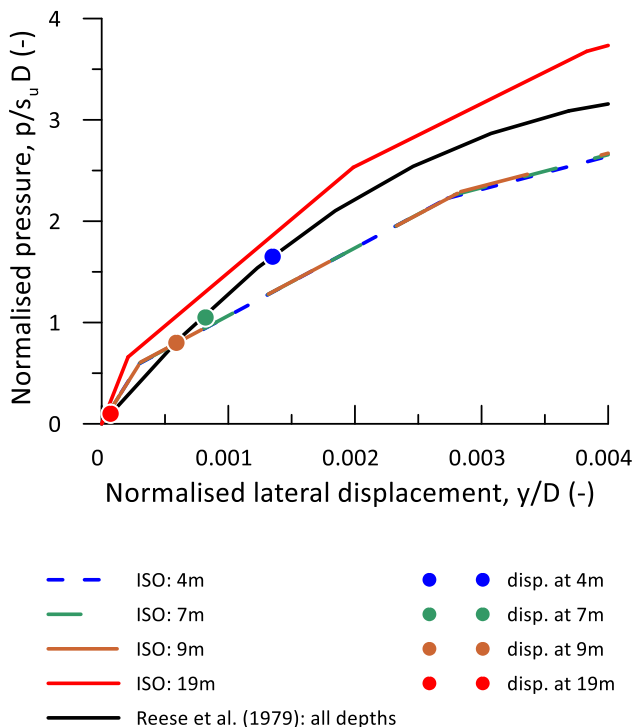
Figure 105 ISO and Reese et al. (1975) p-y curves with mobilized displacement at depths of 4m, 7m, 9m, and 19m
