# Anastylosis of the northeastern tower of the ancient fortress of Aegosthena in Attica: construction analysis, collapse mechanism and interventions for the improvement of the foundation conditions

El-E. E. Toumbakari<sup>1</sup>, and D. N. Egglezos<sup>2</sup>

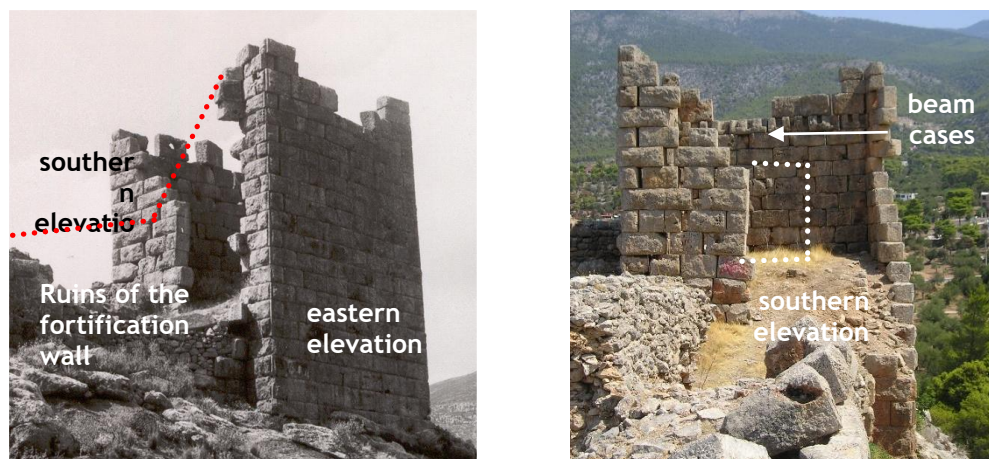
**Figure 1.** The southern & eastern elevations of the tower in 1933 (courtesy of the German Archaeol. Inst., Athens). In dotted line: the missing fortification wall (left). The tower after collapse of the S.E. corner and eastern elevation (1981)-in white dotted line the entrance to the first level is shown (right)

The tower was standing as shown in Figure 1 (left) until February 24<sup>th</sup>, 1981. This day, the eastern Corinthian Gulf earthquake (Papazachos & Papazachou (1997), Ambraseys (2009)) has struck the building, resulting mainly in the collapse of the free-standing southeastern corner and a big part of the eastern elevation (Figure 1 right). The pathology of the remaining structure was extremely severe and further collapse in case of a future, even low intensity, earthquake was certain. In addition, the foundations of the western and southern elevations had gradually settled due to the deformability of the filling material, resulting in block subsidence up to 40 cm in the middle of the western elevation. Sliding of the blocks of the still standing southern elevation was evident by the opening of the joints (Figure 1 right). Moreover, the N.E. corner top blocks (on the upper right of Figure 1 right) were in an extremely unstable situation due to the severe opening of joints, the rotation of the remaining blocks outwards and the subsequent loosening of the corner connection.

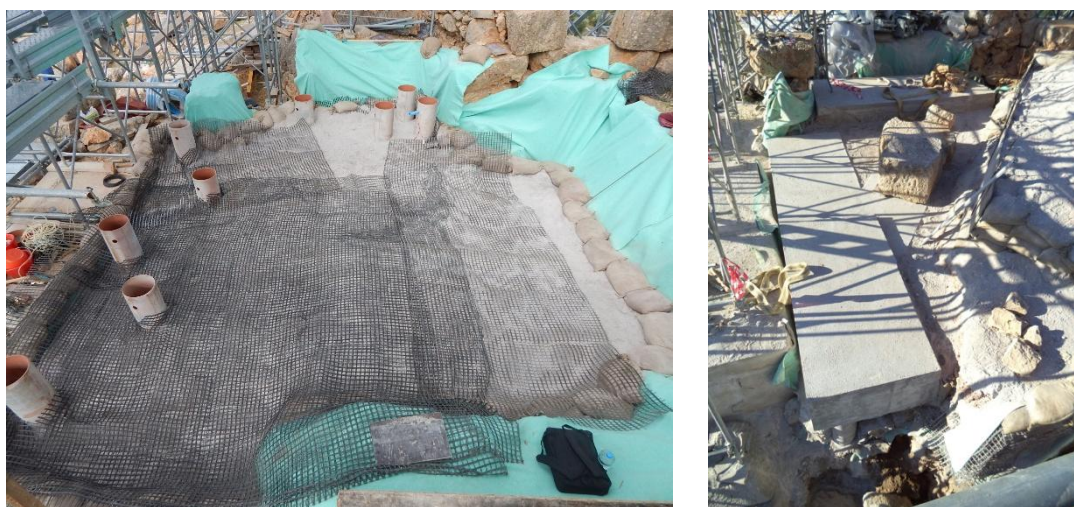
**Figure 11.** The deep foundation under construction (view from the east) (left). The pile cap of the eastern elevation before the anastylosis and, in the background the western one (right).

The study was approved by the Central Archaeological Council and subsequently implemented (Figure 11). The anastylosis of the tower (Figure 12) was completed in 2016. From the outset of the project, particular emphasis was placed on the significance of the internal fill, which constitutes valuable evidence of ancient construction technology. Its preservation, to the greatest extent possible, was adopted as a key criterion guiding the design of the proposed interventions, with the geotechnical study proving to be a critical tool in achieving this objective. The internal fill yielded important archaeological and technical insights, shedding light on construction methods, material selection, and building practices employed during the original erection of the tower. Its conservation therefore contributes not only to the structural integrity of the monument, but also to the documentation and broader understanding of ancient engineering knowledge.
