# Geotechnical Rehabilitation of the Cathedral of Mexico in 2020-2021

Between 1989 and 2001, the Cathedral of Mexico underwent a rehabilitation program to address significant damage caused by large-scale differential settlements resulting from subsoil consolidation, exacerbated by the overexploitation of deep aquifers. The work carried out within the scope of geotechnical engineering resulted in a significant reduction in both differential settlement and the rate of its growth. While this geotechnical program was in progress, structural interventions were implemented to address deficiencies in the structure, such as lateral cover connections, cracking in vaults, walls, and columns, and, finally, foundation reinforcement. The works continued into the first decade of the 21st century. Eventually, a lack of financing led to the suspension of maintenance work and of automated structural performance monitoring. The strong earthquakes of 2017 caused damage to the cathedral complex that was classified as low severity. Consequently, a rehabilitation project was undertaken to repair earthquake damage and perform foundation maintenance. As part of this project, updated topographic surveys w

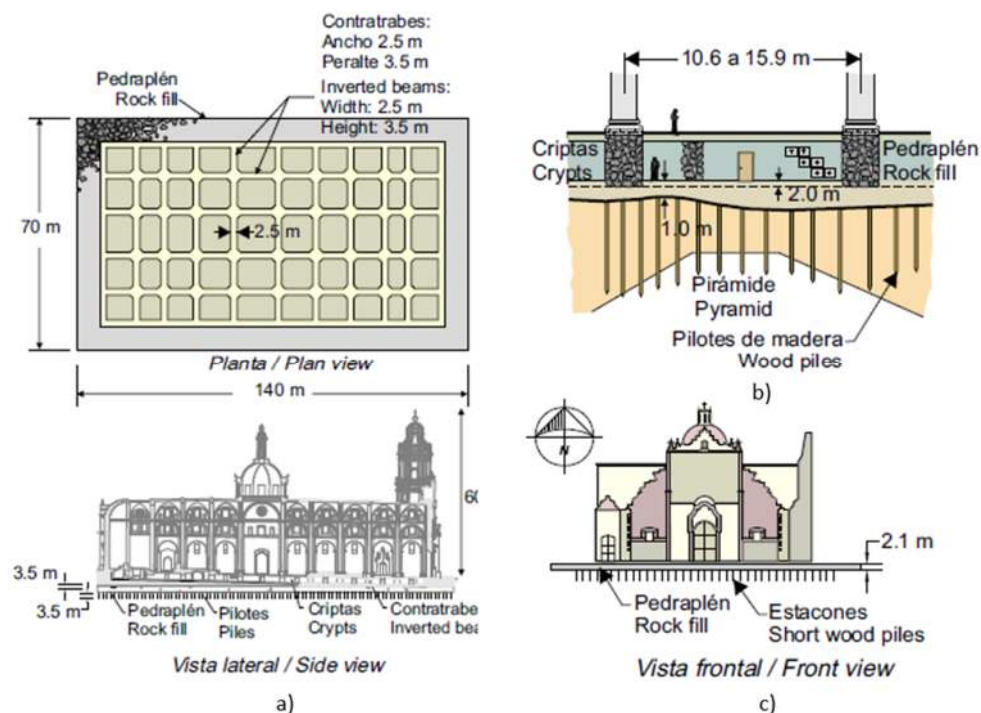
**Figure 1.** Schematics of the foundation of the Metropolitan Cathedral and the Sagrario. (Ovando-Shelley & Santoyo Villa, 2019).

The Metropolitan Cathedral was built on part of the natural island inhabited by the Mexica, which stood slightly above the lake level. The Mexica ceremonial center was located on this island; consequently, the Cathedral's foundations contain remnants of pre-Hispanic structures. The Sagrario was constructed over pre-Hispanic remains associated with the pyramid of the sun god, Tonatiuh. The ground surface beneath the Cathedral was reinforced by driving approximately 22,500 short timber piles, on top of which a masonry platform (stone fill platform) measuring 140 m in length by 70 m in width was placed. These dimensions exceed the footprint ultimately occupied by the Cathedral. The thickness of this platform—averaging 0.90 m—increases toward the south, indicating an intentional thickening to compensate for the differential settlements observed since the earliest stages of construction. On top of the platform, a grid of masonry tie-beams was built, approximately 3.5 m high, 2.5 m wide, and up to 127 m long, to support the walls, pilasters, and columns (Figure 1).

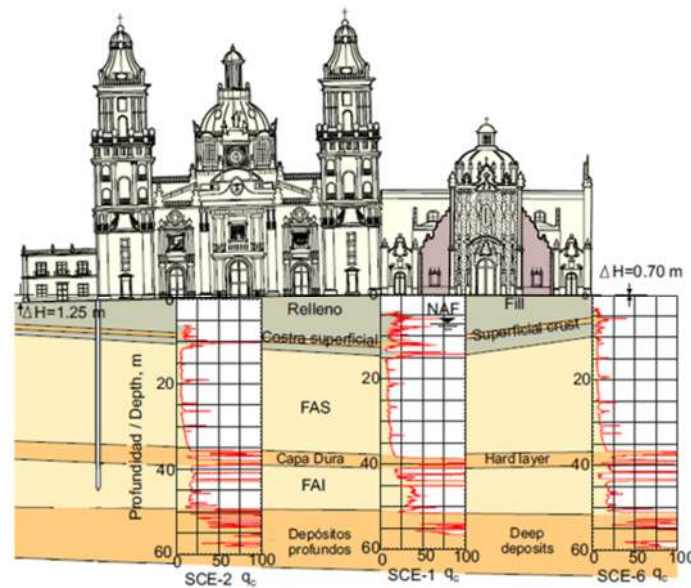
**Figure 2.** Stratigraphic profile of the front portion of the religious complex (Santoyo Villa & Ovando Shelley, 2008)

The subsoil underlying the Cathedral complex consists predominantly of lacustrine deposits formed by highly compressible soft clays, resulting from the deposition and physicochemical alteration of alluvial materials and volcanic ash (Figure 2). These deposits are interbedded with layers of volcanic ash, pumice beds, and soils derived from the weathering of volcanic, fluvial, alluvial, and glacial deposits. This stratigraphy yields an ordered sequence of soft-clay strata separated by stiff lenses of clayey-sandy silt, desiccation crusts, and basaltic or pumiceous sands.

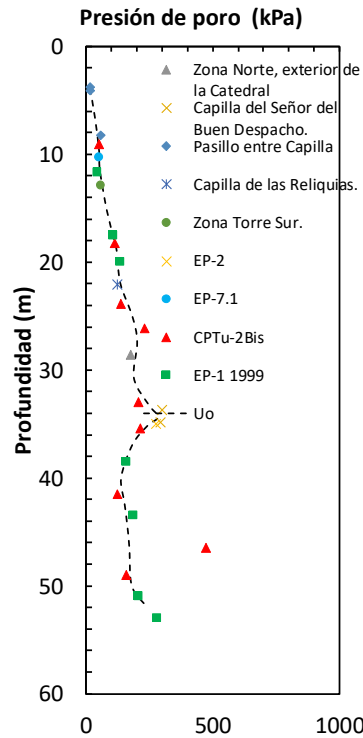
**Figure 3.** Pore-water pressure records from 1999 and July 2021.

In July 2021, a CPTu test was performed, and pore-pressure dissipation tests were conducted; readings were also taken at the piezometer stations and in the observation standpipe. Figure 3 presents these results and compares them with piezometric records from 1999. The comparison indicates that over the last 21 years, the depth to the groundwater level (GWL) has not changed significantly and that, from approximately 7.5 m (the current GWL) down to 38 m (the depth of the hard layer), pore pressures remain essentially hydrostatic. Although pore pressures between 38 m and 49 m show drawdown relative to hydrostatic conditions, they have not changed appreciably during the past two decades. This observation is consistent with the interpretation that the main drawdown driving regional subsidence in the Historic Center occurs at greater depths (>50 m), as documented in prior hydrogeological assessments.

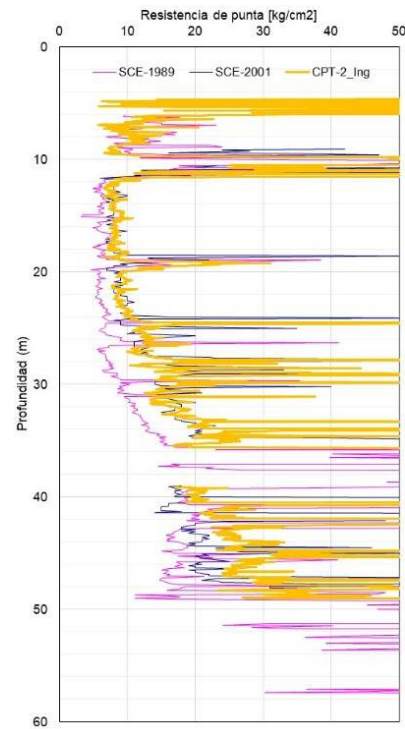
**Figure 4.** Comparison of the CPT- 2Ing, SCE-1989, and SCE TP-2001 records

A comparison of the CPT-2\_Ing (2021) sounding with earlier CPTs performed at the base of the West Tower of the Cathedral in 1989 (SCE-1989) and 2001 (SCE-2001) shows higher  $q_c$  values in 2021, attributable to soil stiffening induced by subsidence associated with groundwater withdrawal (see Figure 4).

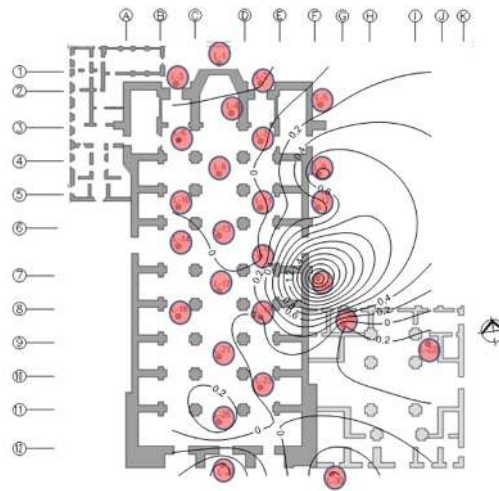
**Figure 5.** Water-level contours in shafts, referenced to the elevation of Shaft L06.

The results in Figure 5 indicate that, overall, the shafts exhibit minimal fluctuations in water level, consistent with the site's geotechnical conditions. However, the water levels in shafts L-09, L-12, and L-16 differ by up to 2 m, warranting a detailed site review to rule out possible leakage in the piezometer tubing.

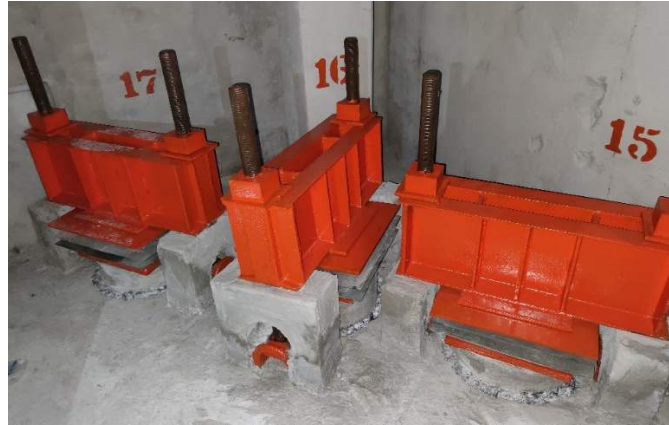
**Figure 6.** Pile load frames 17, 16 and 15.

The works carried out on the foundations of the Cathedral and the *Sagrario* comprised: maintenance of the pile load frames (reaction frames) (Figure 6); trimming of pile heads that exhibited a significant apparent protrusion; replacement of the hardwood (*caobilla*) blocks used to maintain a constant load on the pile head; application of pile loads in accordance with the calculated values; and load testing on selected piles.

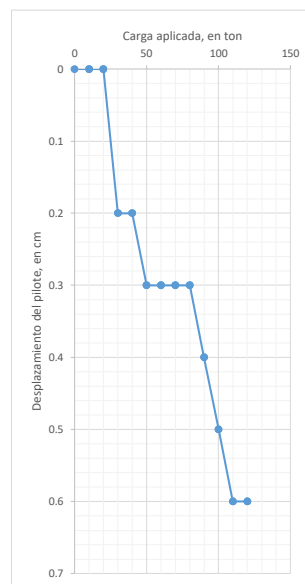
**Figure 7.** Example of load test of pile 54/205B

Initially, the Institute of Engineering (II-UNAM) designed and supervised the load testing of six piles along the south façade, each initially carrying 25 t (~245 kN). The piles were loaded in 10 t (~98 kN) increments up to 120 t (~1.18 MN), and the resulting displacements were recorded at each increment (Figure 7). They were then unloaded and set to the operating load specified by design. The tests verified shaft and toe-load transfer responses, enabling assessment of whether each pile was socketed into a hard layer or fully embedded in the clay strata. Load levels referenced in this paper are distinguished as follows: (i) proof-load test levels (up to 120 t) used to verify axial response; (ii) operational loads re-established after maintenance (e.g., 10–90 t) to control differential settlements; and (iii) analytical verification load cases (e.g., 50–95 t) used for limit-state checks.

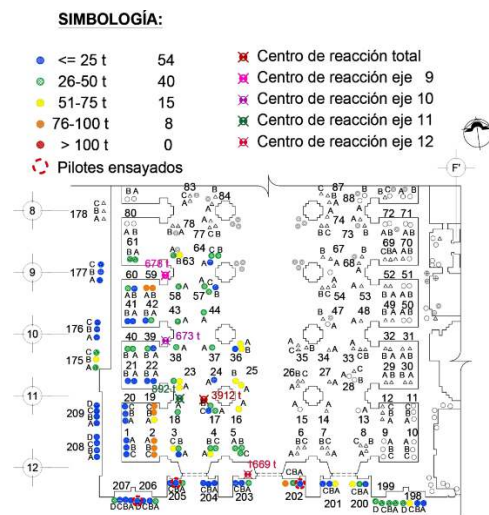
**Figure 8.** Load on the control piles before maintenance

The Cathedral has the highest number of piles within the religious complex; however, among the 417 control piles, only 28% have load-carrying capacity. In this context, control piles are foundation piles equipped with load frames and deformation cells that apply and maintain controlled axial loads to mitigate differential settlement. An initial review was conducted to determine the loads on the piles, from which it is known that the total load carried by these piles is 3,912 t (~38.4 MN), i.e., 3% of the structure's total load. As shown in Figure 8, 80% of the piles do not carry more than 50 t (~490 kN).

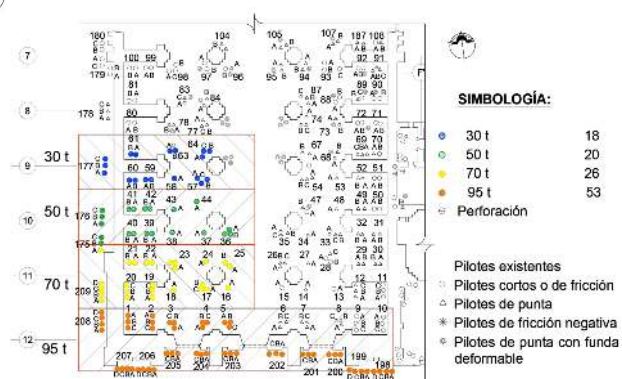
**Figure 9.** Loading protocol designed for control piles

To reduce the settlement rate in the southern zone, a loading protocol was designed. This protocol accounted for the load capacity identified in the initial review, the recorded pile emersions, and the mechanical characteristics of the wooden blocks to be used.

However, during field inspections, the installed blocks exhibited inferior mechanical properties (indicated by the red dashed line). In those cases, and in subsequent maintenance, the issue was remedied, as evidenced by the solid green lines in the figure. Final pile loads after maintenance were determined based on calculations of column and façade out-of-plumbness (tilt) to mitigate these effects. The applied loads were 10 t (~98 kN), 30 t (~294 kN), 40 t (~392 kN), and 90 t (~883 kN), as appropriate (Figures 9 and 10).

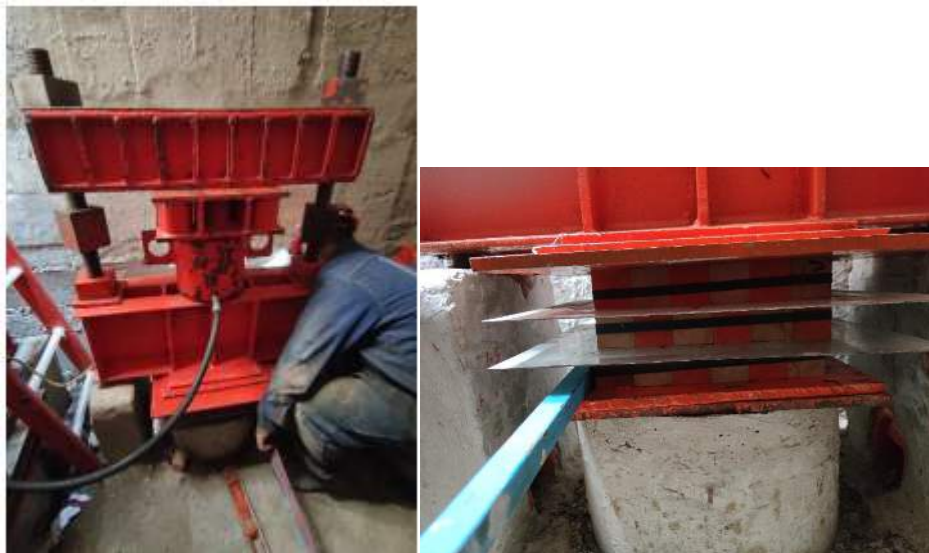
**Figure 10.** Load application at 90 t. Pile 54/205B.
