Study on Early Warning of Slope Failure by Using Tilt Sensors Installed at Slope Surface

L. Wang Lin and I. Seko

Technology Center, Chuo Kaihatsu Corporation, Japan

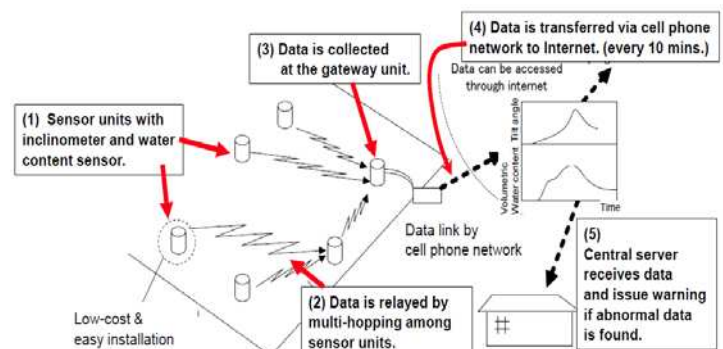
Fig. 1 Outline of wireless monitoring and early warning system

easily by themselves, even in developing countries. Fig. 1 show the basic concept of the wireless monitoring and early warning system.

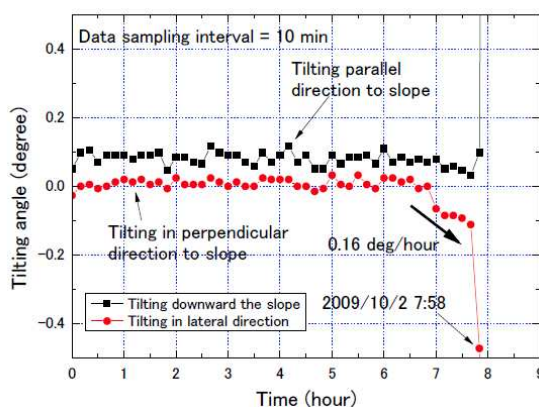
Fig. 4 Tilting angle deformation on the slope site

Fig. 4 shows the records of tilt sensor of the unit, in directions toward and laterals to the slope,

respectively. Specially, the tilting in Y-axis (lateral direction) showed extraordinary behaviors 50 minutes before the second failure. Its tilting rate

was around 3 degrees per day (0.12 degrees per hour).

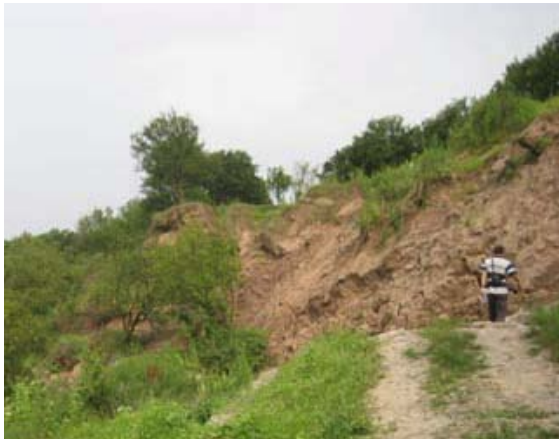
Fig. 6, new landslide on June 7, 2009

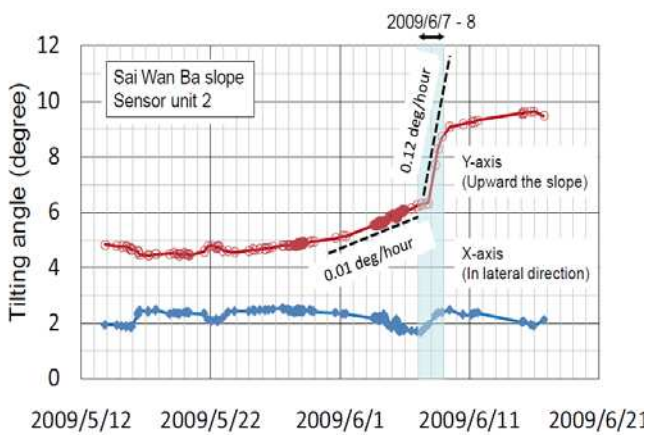
Fig. 7 Time histories of tilting angle obtained by Sensor unit 2

in X-axis and Y-axis, the volumetric water content at a depth of 30 cm on the ground surface. While receiving frequent rainfall events, the tilting angles showed gradual progress, and the tilting angle in Y-axis reached around 5 degrees at the beginning of June 2009. A quick increase in the tilting angle in Y-axis, and a small increase in the X-axis are recorded on June 7 and 8. The precipitation for

these 2 days was 65 mm, while the criteria for heavy rain warning was decided to be 30 mm per day in this area. The increasing rate of the tilting angle in Y-axis was 3 degrees per day during this event, while the rate just before this event was around 0.2 degrees per day. This quick behavior should be corresponding to the landslide event in this period. The slope failure near the sensor unit 2 took place at noon of June 8 shown in Fig. 7.

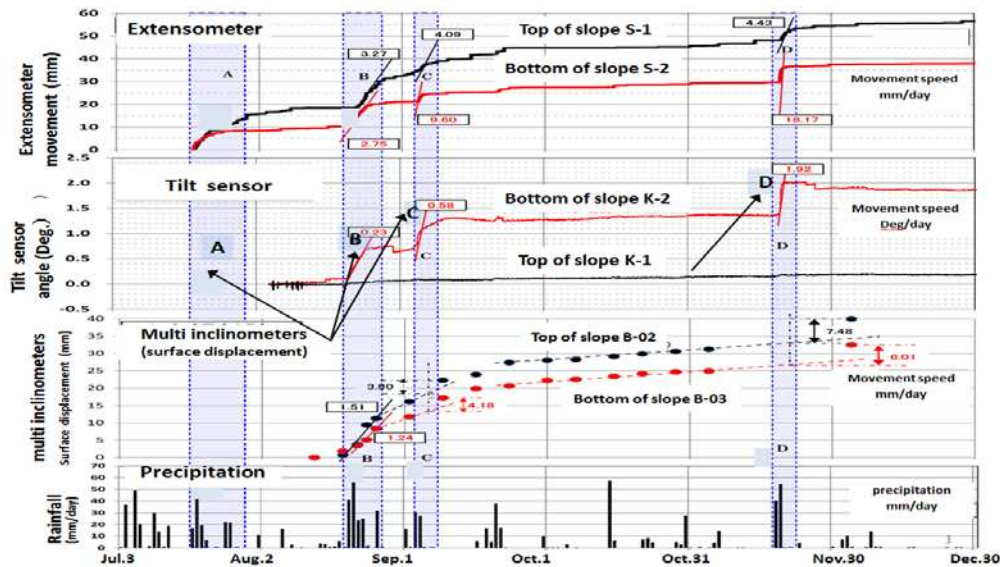
Fig. 9, the relationship of extensometers, tilt sensors, multi inclinometers and rainfall vs. time

Fig. 9 shows the relationship of extensometers, tilt sensors, multi inclinometers and rainfall vs. time. During the monitoring, the four times warning issues were send out for a period of time A to D, the results could be concluded as following:

(1) At the first stage of 'A' period, the behavior of each type of instruments showed the same movement, the warning issue was send out based on rainfall value what the threshold was exceeded only. (2)The extensometer of S-1 installed at top of slope position showed a large movement compared with the extensometer S-2 at bottom of slope in whole period, it is means that the installation of extensometer is better effective at top of surface. (3) For tilt sensors, because of parallel motion, the sensor (K-1) installed in the top of slope was not reasonable to catch the phenomenon of slope failure. But, the tilting degree change of sensor (K-2) was very clearly and the result of K-2 showed a same change tendency like extensometer (S-1) installed at top of slope.
