Landslip Remediation for Hilly Road Infrastructure Using a Simple Engineering Solution

J. Thanapalasingam and V. Tandjiria
Jacobs Group (Australia) Pty Lt, Brisbane, Australia

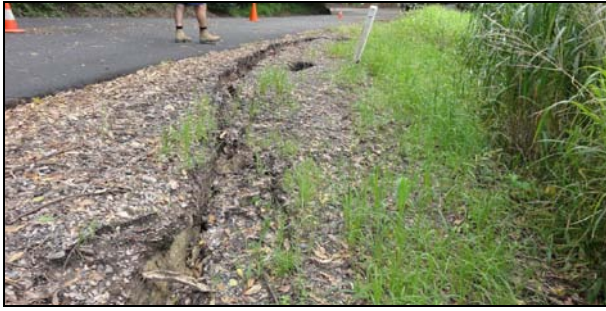
Fig. 1 Site failure by 2010-2011 rain event

The landslide (as shown in Fig. 1) at the site discussed in this paper was firstly occurred by the natural disaster event in 2011 and road was closed

for public considering the safety of road users as the inspection indicated road subsidence, longitudinal cracks and lateral movement. Subsequently short term remediation works were undertaken during the emergent period immediately after the natural disaster event in order to minimise the risk to road users and public and keep the road opened. This short-term remediation works undertaken comprised constructing a 2m high gabion retaining wall near the shoulder of the road.

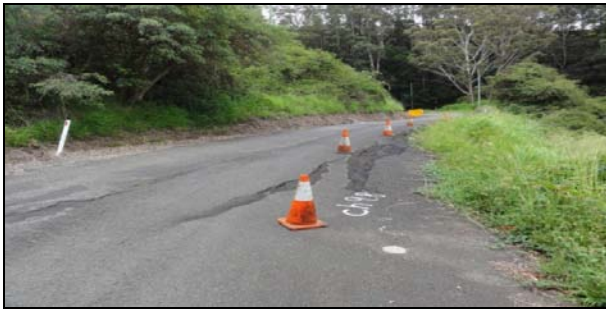
Fig. 2 Landslide re-activated by 2013 rain event

The heavy rain event in 2013 re-activated the landslip due to the failure of undertaking long-term remediation works. An approximate 35 m long section of this road has been affected by this landslip during the 2013 rain event.

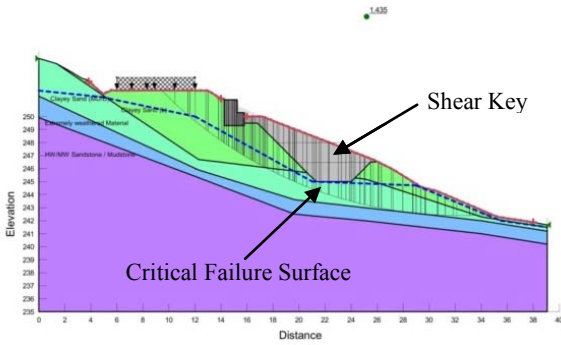
Fig. 4 Slope stability analysis results (without soil nails)

The results of the slope stability analyses are given in Table 4 and the graphical representation for the long terms condition is given in Fig. 4.

The factors of safety (FoS) calculated for the long term condition with no temporary soil nails is 1.45. The above results show that the calculated

FoS is slightly below the minimum design criteria (i.e. FoS = 1.5). However, such a FoS value was considered acceptable to protect the road embankment slope from any further (future) instability. In addition, it should be noted that the presence of temporary soils nails installed and left behind the shear key mass improve the overall factor of safety to 1.7.
