# Investigation of the relationship between fluvial topography and factors associated with the occurrence of liquefaction

**ABSTRACT:** In April 2016, an epicentral earthquake occurred beneath Kumamoto City in Japan. The earthquake caused widespread liquefaction across the city. In particular, the liquefaction was characterized by its continuous linear occurrence along the natural levees. In Japan, the topography formed by rivers is regarded as an important source of basic information for predicting liquefaction. To clarify differences in liquefaction occurrence characteristics is important to improve the accuracy with which the topographical classification can be used to predict liquefaction.

**Keywords:** liquefaction; Kumamoto earthquake; natural levee; portable dynamic cone penetration test

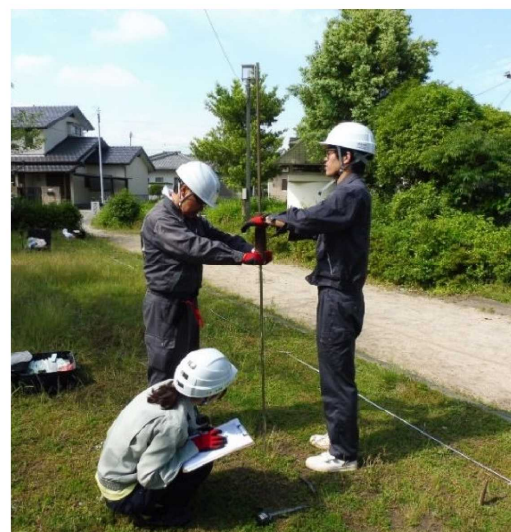
Figure 7. The status of field survey for PDCP.

The PDCP apparatus is shown in Figure 6. The status of field survey is shown in Figure 7. The test apparatus consists of a cone, a rod, an anvil, a guidance rod, and a hammer.

The test procedure was as follows: First, the cone was attached to the tip of the rod, and the anvil, guidance rod, and hammer were attached on top. Next, the test apparatus is maintained in a vertical position above the survey

point allowing the hammer to freely fall. The hammer is dropped freely from a height of  $500 \pm 10$  mm, and the number of blows required to penetrate 100 mm is recorded as the  $N_d$  value. If the penetration amount exceeds 100 mm by a blows  $N_d$  can be calculated using (1).

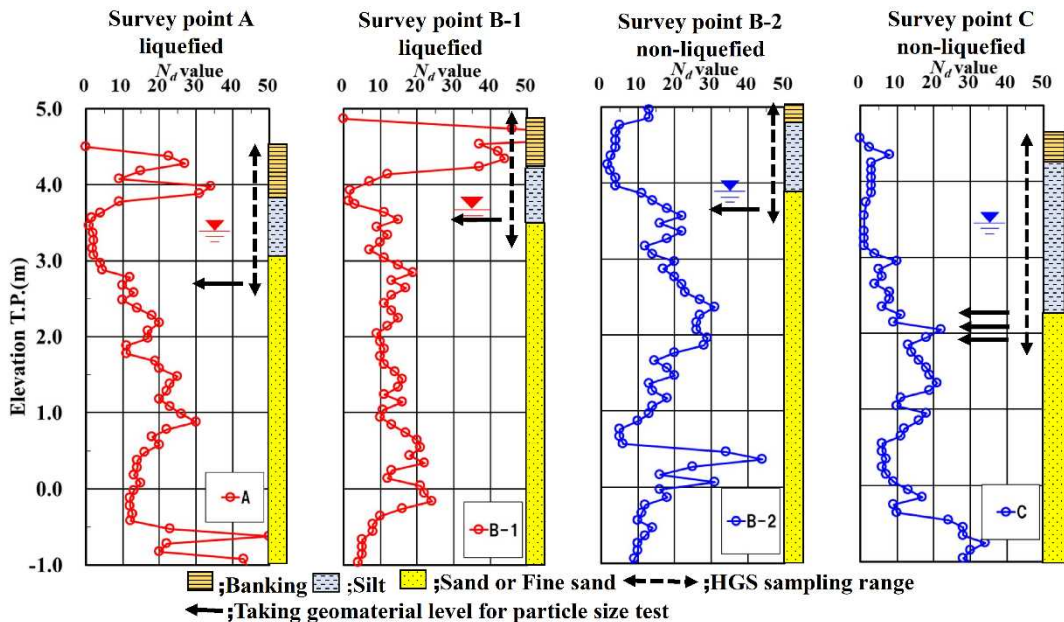
Figure 8 shows the results of the PDCP at each survey point. The soil was classified based on the HGS sampling result for the surface layer, and based on the PDCP penetration resistance  $N_d$  value and existing boring survey results from the surrounding area for the deeper soil.[14]

Figures 8. Soil properties assumed based on PDCP and sampling results for the survey points.

Point A, a liquefied point, was located 30 m from the channel with nearby liquefaction. The soil property at this point was fine sand from the ground surface to 1.3 m deep. The  $N_d$  value of the sand layer within the range of 1.3 m in depth to T.P. 0.5 m, where the  $N_d$  value suddenly increases, ranged from 10 to 30 with a mean of 15.7. The groundwater level during the PDCP survey was 1.0 m from the ground surface.

Point B-1, a liquefied point, was located 14 m from the channel, and 18 m from point B-2, a non-liquefied point. The soil structure was the same for both points, where it was fine sand from the ground surface to 1.0 m. The  $N_d$  value for the range of T.P. 3.8 to -0.4 m at point B-1 ranged from 10 to 20 with a mean of 14.0. The  $N_d$  values of this range show relatively little variation. At B-2, the

$N_d$  values for the range of T.P. 3.8 to 0.5 m, where the  $N_d$  value rapidly increased, ranged from 10 to 30 with a mean of 19.3. Within this range, the penetration resistance was higher than at point B-1.

Point C, a non-liquefied point, was located at approximately 200 m from the channel. The silt layer with an  $N_d$  value of less than 10 was thicker than that at other survey points, distributed within a range of up to 2 m from the ground surface. The  $N_d$  values within the range of T.P. 3.0 m to -0.25 m ranged from 5 to 20 with a mean of 11.4, which was the lowest  $N_d$  value among the survey points. The groundwater level during the survey was the same as that in the other survey points at 1 m from the ground surface.

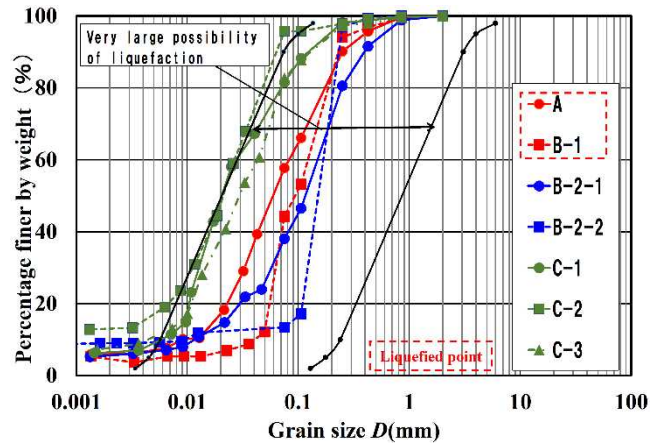
At each survey point, we selected representative samples from the sampled range, and conducted a density test of the soil particles and a grain size analysis. Figure 10 shows the particle size composition of samples from each survey point, and Table 1 shows the results of the laboratory soil test.

Figure 10. The particle size composition of samples from each survey point.

The Technical Standard and Commentaries for Port and Harbour Facilities in Japan by the Ports & Harbour Association of Japan [15], which is the design standard for ports and harbors in Japan, stipulates the range of grain size with potential for liquefaction based on the existing survey results of liquefaction. We showed that this grain size range has potential for liquefaction as based on the Technical Standard for Port and Harbour (range A) within the particle size composition, and compared the range with potential for liquefaction with particle sizes of the present samples. Points A, B-1, and B-2 have the same fine sands from the ground surface to a depth of 1.5 to 2.0 m. Their particle size composition shows some variations in the fine fraction content ( $F_c$ ), although the average particle size ( $D_{50}$ ) and uniformity coefficient ( $U_c$ ) were similar. The particle size composition of these three points is near the center of range A. The soil layer from the ground surface to a depth of 2.5 m at point C, a non-liquefied point, was silt with  $F_c$  of 80% or higher, and its particle size composition was near the smaller limit of range A.

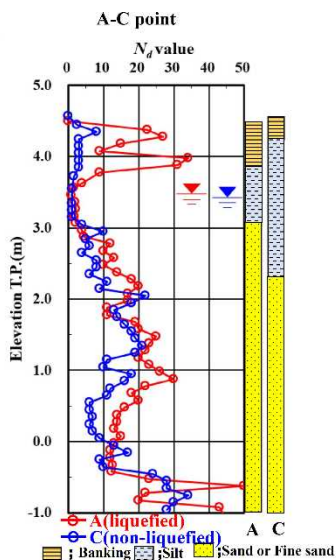
Figure 17 shows the comparison of the PDCP results at Point C, which is at a distance from point A, a liquefied point. When compared in the range of T.P. 3.0 to 0.0 m, the  $N_d$  value of point A was 20% higher overall. The particle size composition at point C was silt with  $N_d$  values of 10 to 20 and  $F_c$  of 80% or higher around T.P. equal to 2.0 m. At point C, the  $N_d$  value from the survey result alone cannot provide an estimate for fine sand and silt as geomaterials, making particle size composition information necessary. Silt at point C shows a  $N_d$  value close to fine sands; thus, this is considered a firm fine-grained soil. The reason for the lack of liquefaction in the areas far from the channel was that the geomaterial is firm fine-grained soil.

Figure 17. PDCP results at points A and C.
