# Combined geophysical-geotechnical investigation of a landslide surface of a recultivated open-pit mine

**ABSTRACT:** Properly planned and executed recultivation of open-pit mines is critical for safe re-use of the land. Erosion, surface cracks or even landslides may appear on steep slopes of not properly recultivated mine surfaces. Detailed documentation of near-surface geology and recultivation technology applied are often missing for mines closed several decades ago. Drilling or penetration tests are difficult or impossible to execute on unstable, steep slopes, therefore alternative data acquisition techniques have to be applied in addition to geotechnical measurements. Geophysical surveys can provide useful information for understanding subsurface geology and identifying critical layers/areas.

Case study of an open-pit coal mine closed in late 60ies exhibiting surface movements along an unstable slope will be presented. Slope stability calculations based on information from limited number of borehole locations and geophysical electrical tomography and seismic survey were completed and identified the critical subsurface layers.

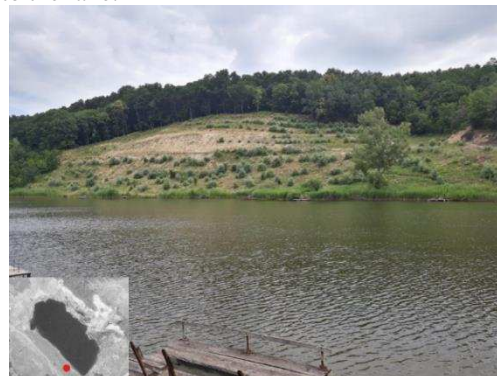
**Figure 1.** Surface conditions of the survey area in 2018. (Red dot indicates point of view of the photo)

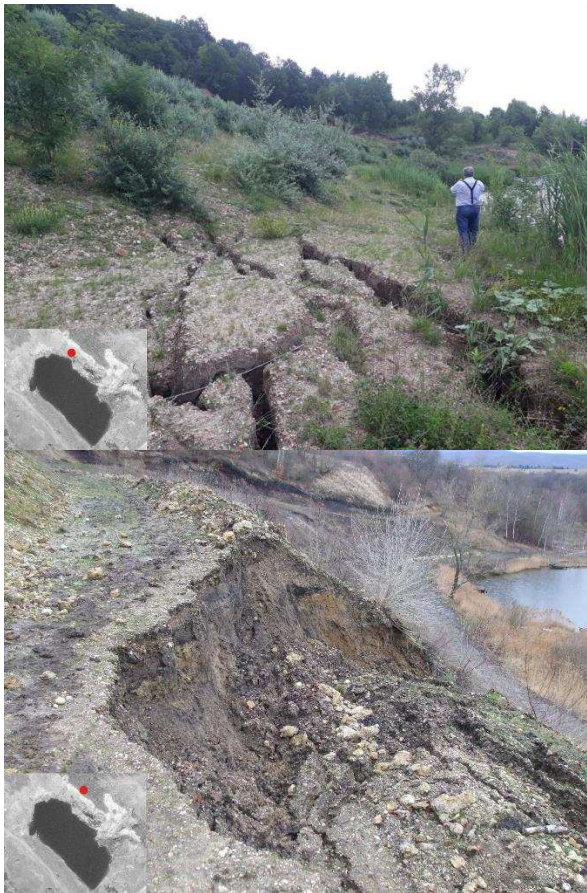
**Figure 2.** Surface cracks and landslide on the slope NE to the lake. (Red dot indicates point of view of the photos)

Mining activity lasted only for a short period of time during late 60ies. As soon as mining activity was terminated the excavated brown coal layer was covered with water in order to prevent self-ignition. The artificial lake is still present today and is used for fishing and recreational purposes. Recultivation of the slope on the NE side of the lake was not completed due to the danger of working on the steep slope. It was assumed, that natural processes will create a stable slope surface within a reasonable time. Unfortunately, this was not the case, landslides, collapses and movement of the slope continued, therefore a 30-35° slope was designed and prepared a few years ago. During this recultivation work, the surface coverage and the previously existing vegetation was removed, the surface was straightened, and the depressions were filled up with the removed material (Figure 1). These interventions, the erosion and near surface differences along layer boundaries and/or fault surfaces resulted in surface movements along the unstable slope. Surface ruptures, slides, ongoing erosion and slope movement are characteristic of the area (Figure 2). As the

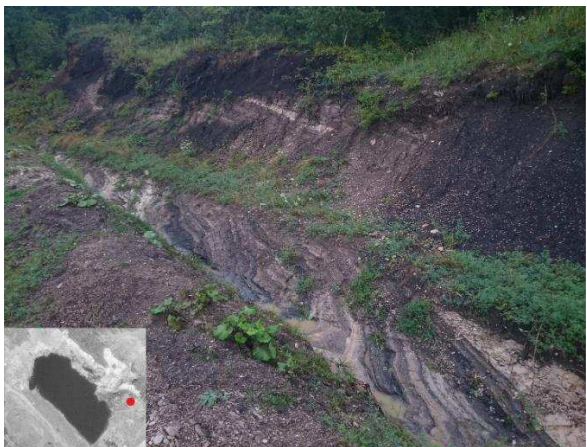
**Figure 3.** Clay layer outcropping as a result of recent erosion. (Red dot indicates point of view of the photo)

As a first step, core and borehole information from historical boreholes were collected, surface observations of clay layers exposed by recent erosion (Figure 3) were made. Since present slope conditions were not suitable for drilling, geotechnical surveys could only be performed at a few locations. Geophysical surveys were planned and completed in order to map the subsurface between drilling points and in areas not accessible for drilling.

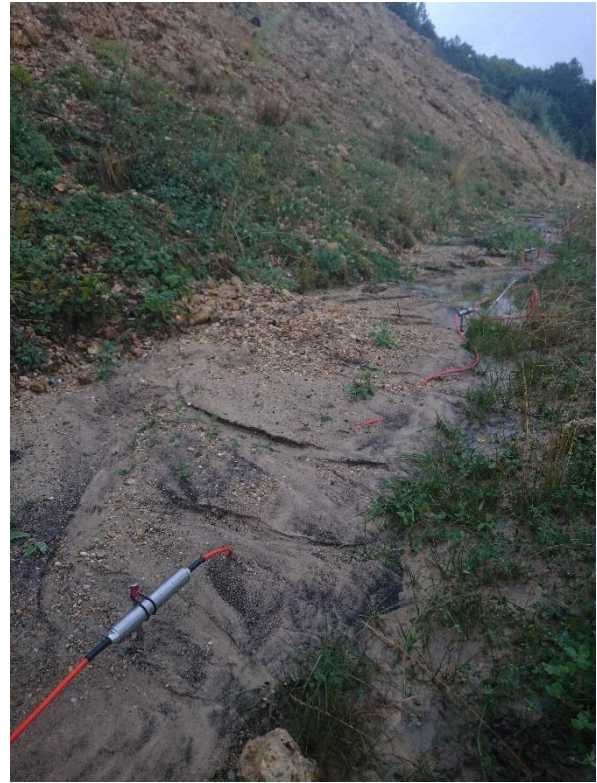
**Figure 4.** Electrical tomography profile measured in strike direction on the slope. Please note the amount of eroded sediment caused by a heavy rainfall during the measurement.

7 geoelectrical tomography profiles were carried out with variable length (min. 82.5 m, maximum 172.5 m). 4 of them in strike (Figure 4), 3 in dip direction on the slope. The separation between the electrodes was 2.5 m for the strike direction and 1.5 m for the dip lines. The

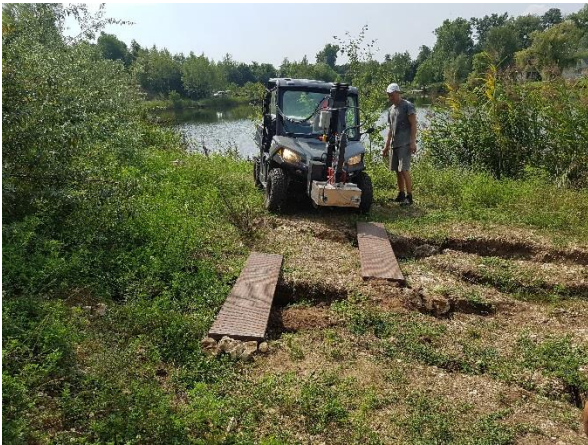
**Figure 5.** Lightning™ seismic source in the survey area crossing a surface crack zone

During land seismic surveys compressional and/or shear waves are used to image the subsurface layers. Elastic waves are generated by impulsive or vibroseis sources and the signal is sensed by one- or three-component geophones planted in the ground. The vibroseis source used for the survey was an electromechanical vibroseis source, Lightning™ manufactured by Seismic Mechatronics. This vibroseis source is a unique electromechanical vibrator capable of generating low distortion source signal in the 1-1000 Hz frequency range (Figure 5).
