The paper was published in the proceedings of the 6th International Conference on Geotechnical and Geophysical Site Characterization and was edited by Tamás Huszák, András Mahler and Edina Koch. The conference was originally scheduled to be held in Budapest, Hungary in 2020, but due to the COVID-19 pandemic, it was held online from September 26th to September 29th 2021.

Post-liquefaction behavior determined by in-situ investigations after earthquakes

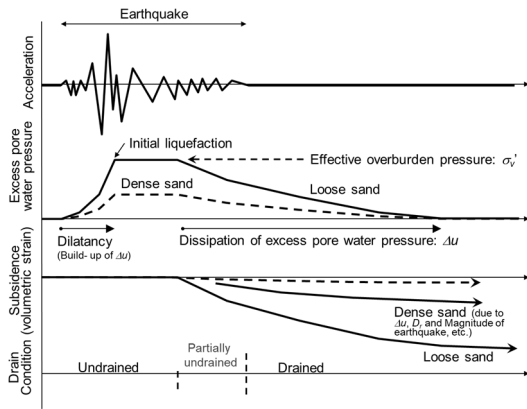
Figure 1. Typical in-situ behavior of soil layer liquefied by an earthquake.

Generally, when a large earthquake occurs, an increase in excess pore water pressure due to liquefaction in loose sand leads to a simultaneous decrease in the undrained shear strength and shear modulus. Then, as shown in Fig. 1, it is thought that liquefied sand recovers to the state that existed before the earthquake as excess pore water pressure dissipates and the liquefied soil layer densifies. These recovery tendencies are considered to depend on various factors, such as deposition conditions in the liquefied soil layer, relative density, effective overburden pressure, amount of excess pore water pressure and its drainage conditions, and the initial conditions that lead to liquefaction susceptibility.

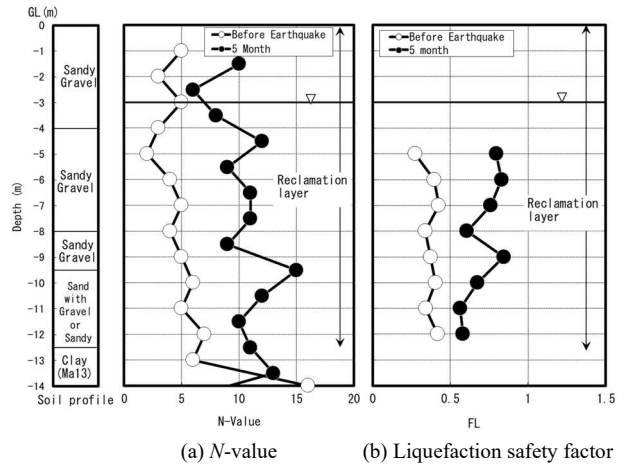
Figure 3. Comparison before and after the 1995 Hyogo-ken Nanbu Earthquake [7].

It is well known that gravel deposits in reclaimed land were heavily liquefied during the 1995 Hyogo-ken Nanbu earthquake. Kobe City [7] reported the investigation results for the seismic array observation site on Port Island before and after the earthquake. In the investigation about 5 months after the earthquake, as shown in Fig. 3, it is difficult to grasp the process of N -value changes after liquefaction from the N -values before the earthquake.

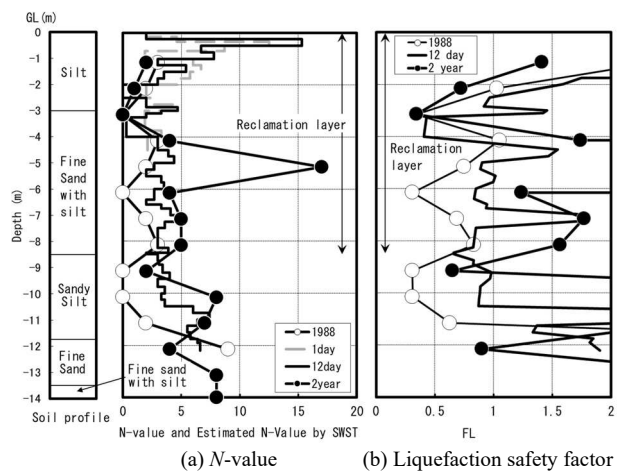
Figure 4. Comparison before and after the 2000 Tottori-ken Seibu Earthquake [9, 10].

In the 2000 Tottori-ken Seibu Earthquake, liquefaction occurred over a wide area. Especially in the Takenouchi Industrial Park, liquefaction in a reclaimed layer of dredged non-plastic silt was confirmed [8]. In this site, Yamamoto et al. [9] conducted SWSTs at 1 and 12 days, and the recovery of N -values estimated from N_{sw} in the liquefied silt layer was reported. N -values obtained 2 years after the earthquake by Nakazawa et al. [10] are also shown in Fig. 4(a).

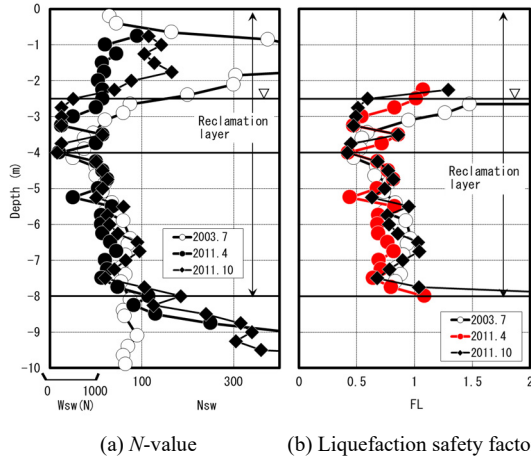
Figure 5. Comparison before and after the 2011 Great Tohoku Earthquake [11].

SWSTs 1 and 6 months after this earthquake to estimate the liquefied characteristics at four points in a housing site and described the long-term recovery tendency of liquefied soil layer by comparing the distribution of N_{sw} obtained by SWST. Fig. 5(a) shows typical data indicating the recovery tendency of properties in a liquefied layer. The F_L distribution in Fig. 5(b) was obtained based on estimated N -values calculated from SWSTs performed by Inada [12].

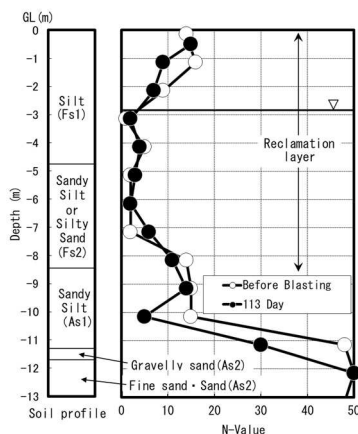
Figure 6. Comparison before and after the experiment at Soma Port [5].

Fig. 6 indicates the N -value distribution at Soma Port. Though blasting was carried out at a depth of 4 m below ground level (GL-4m) and GL-8m in Fs1 and Fs2 layers equivalent to reclaimed deposits, no significant change in N -value distribution occurred 113 days after blasting.

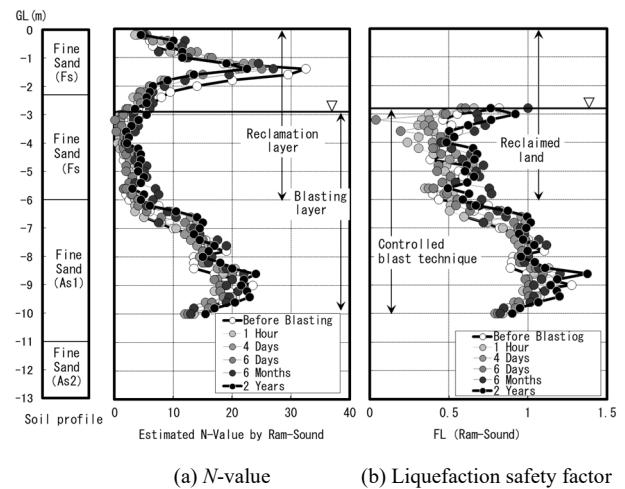
Figure 7. Comparison before and after experiment at Ishikari Bay New Port [5].

Fig. 7 shows the results obtained from mini-ram sounding. This test is a simple method to acquire data related to the N -values by driving a rod equipped with a cone which top angle is 90 degrees and 36.6 mm in diameter with a 30 kg hammer from a height of 350 mm automatically. Blow counts, N_m , is usually measured every 20 cm. Finally, the N -values are calculated as half of N_m .

According to this figure, the N -value distribution decreased slightly 1 hour after blasting because of remarkable liquefaction from blasting, and recovery of N -values was recognized after 1 day, when excess pore water pressure dissipated completely. The recovery tendency of the blasting layer can be confirmed more clearly in the F_L distribution.

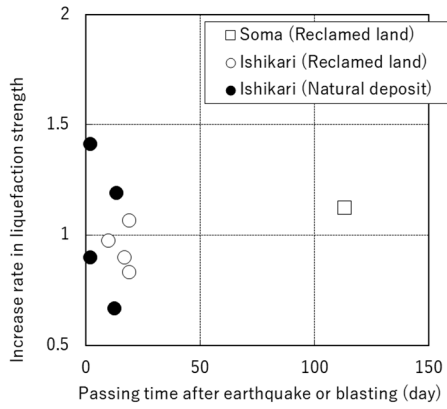
Figure 8. Increase rate in R_L after passage of time.

As shown in Fig. 9, it is difficult to confirm the tendency of the increase rate in liquefaction strength with respect to F_c . However, after a certain amount of time passes, it can be seen that rate exceeds 1.0, and R_L becomes larger than the original liquefaction strength in Fig. 8.

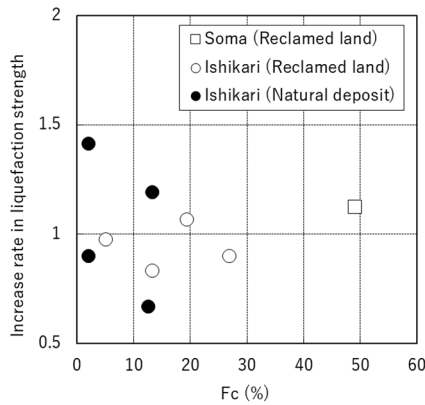
Figure 9. Relationship between F_c and increase rate in R_L .

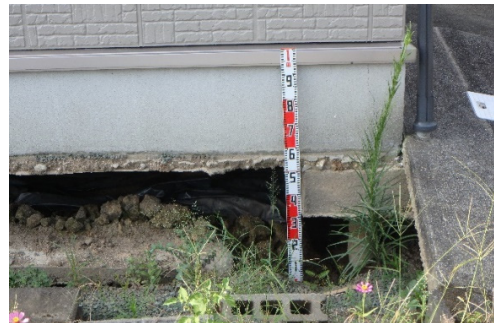
Figure 11. Exposure of pile-supported foundation due to liquefaction.

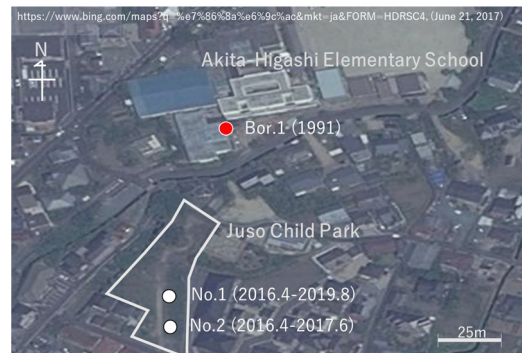
Figure 12. Investigation site in Kumamoto City [10].

A total of five on-site liquefaction investigations were conducted on May 5, 2016; July 26, 2016; January 21, 2017; June 9, 2017; and August 16, 2019, at Juso Child Park (Fig. 12). On May 5, 2016, Hara et al. investigated the site and provided an overview of the liquefied ground [15]. The liquefaction characteristics of the investigation site are described below with reference to the previous results shown in Fig. 13.

The survey method typically used in this study was the Variable Energy Dynamic Cone Penetrometer (VEDCP), also called as PANDA, as shown in Fig. 14. The locations of test points were No. 1 at distance of 10 m from the starting point and No. 2 at 28.5 m along the surface wave exploration line shown in Figs. 12 and 13.

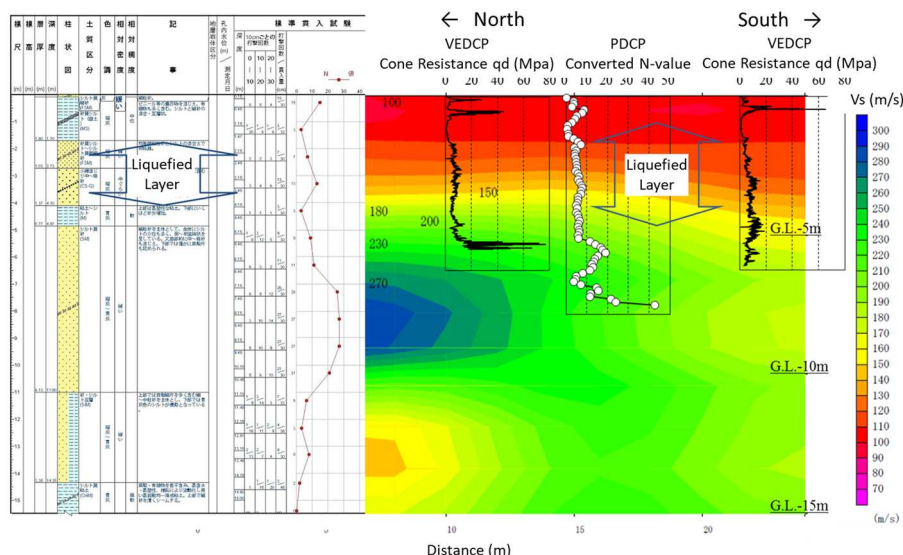
Figure 13. Summary of ground investigation results from a previous study [15].

In the previous study, surface wave exploration and sounding tests were conducted. Among these, the results of a portable dynamic cone penetration test show that a loose layer had an N -value converted to less than 10 and this low N -value distribution continued near GL-5m, below the groundwater surface of GL-1m. Moreover, it was confirmed that the post-liquefaction N -value distribution increased deeper than GL-5m.

Additionally, according to the results of surface wave exploration, a soil layer with a low S-wave velocity equivalent to 100 m/s existed from the surface down to GL-2m, and the V_s distribution was about 200 m/s deeper than GL-5m. The boring log [16] displayed on the left side of the same figure shows the results obtained before the earthquake at Akita-Higashi Elementary School, located about 50 m north of the investigation site (Fig. 12). Hara et al. [15] reported that the main strata where liquefaction occurred consisted of fine sand deposits from GL-1 to -5m.

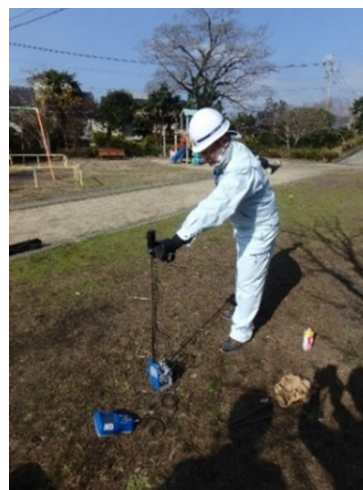
Figure 14. Variable Energy Dynamic Cone Penetrometer.

VEDCP is sounding equipment developed in France, and it has been widely used for evaluation of compacted ground, such as embankments. However, the applicability to natural sediments is unknown because there are few examples of this implementation. The results obtained from VEDCP were the dynamic penetration resistance values represented as q_d (MPa). Therefore, to evaluate the state of the liquefied layer as an N -value, correlation with the mini-ram sounding conducted separately at position No. 1 was obtained on July 26, 2016, and the q_d values at this site were converted to N -values with Eq. (1), as proposed by Nakazawa et al. [4].

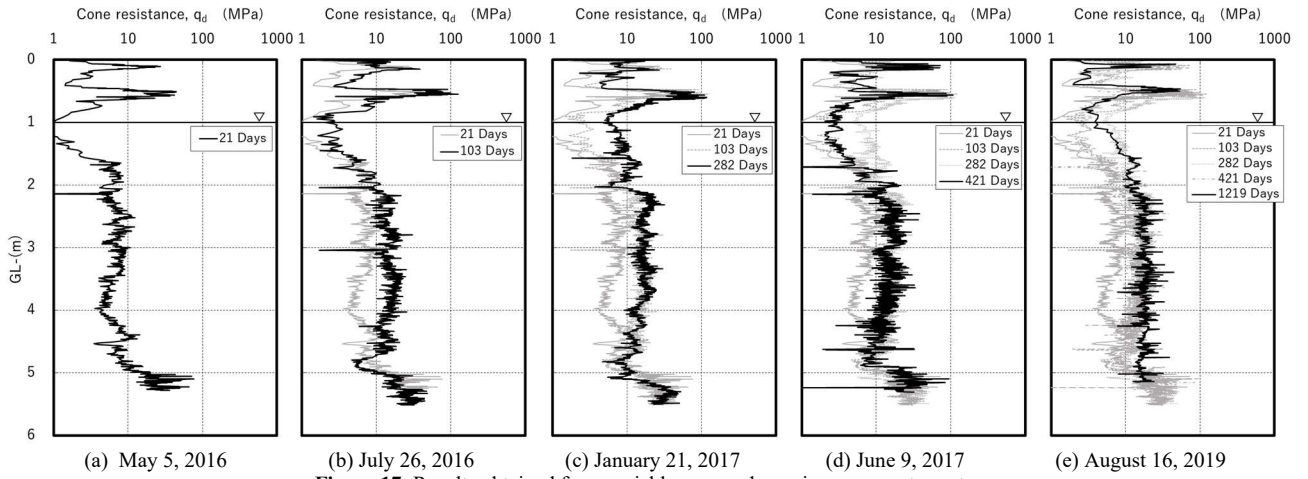
Figure 17. Results obtained from variable energy dynamic cone penetrometer.

In previous studies, VEDCP was performed four times on June 9, 2017 at each location (No. 1 and No. 2), and the results were reported [11]. This paper adds the results for the survey conducted at No. 1 on August 16, 2019, to the previous data. Fig. 17 shows the q_d distribution obtained from all five investigations. Each VEDCP result seems to indicate almost no change in the q_d distribution, but the result of the investigation conducted on May 5, 2016, soon after the earthquake, showed the lowest q_d distribution overall. Subsequent investigations show a tendency for q_d distribution recovery.

The results of the Kumamoto Earthquake shown in Figs. 17 and 18 indicate that decreased N -values continued during the dissipation of excess pore water pressure after liquefaction, and that N -values began to recover later. However, because the decrease and recovery tendency of N -values differ depending on the type of ground and the liquefaction state during the earthquake, Fig. 20 shows the relationship between the initial N -values before an earthquake and the N -value change, ΔN , after liquefaction. In this figure, though all data are plotted, the passage of time is not considered. It is confirmed that the distribution trends of plots for each site were different. Especially, it can be seen that values at Port Island and Takenouchi Industrial Park were increasing, but values at reclaimed ground in Urayasu City were decreasing. Also, Ishikari Bay New Port and Juso Child Park have plots ranging from negative to positive, and it can be confirmed that these trends differ depending on the elapsed time.

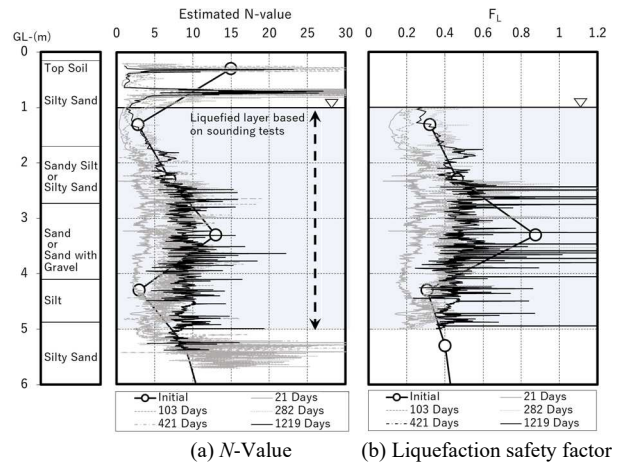
Figure 18. Comparison before and after the 2016 Kumamoto Earthquake.

Figure 18(a) shows the converted N -value distribution obtained by adding existing boring data giving an initial N -value before the earthquake to the depth distribution of N -values estimated by VEDCP at position No. 1. Compared to the initial N -value, the q_d distribution 21 days after the earthquake on May 5, 2016, is clearly decreasing, but it can be seen that it closely approaches the initial N -value afterward.

According to the depth of the initial N -value shown in Fig. 18(a), the average of the estimated N -values for each meter at GL-1.3m, -2.3m, -3.3m, and -4.3m in the liquefied layer was calculated and Fig. 19 shows these time histories. In the figure, (a) is the change in the estimated N -value; (b) is the increase in N -value, ΔN ; and (c) shows the increase rate in N -value, $\Delta N/N$, with respect to the initial N -value before the earthquake. Though the plot at GL-4.3m does not show a tendency of clear decrease in N -value, a decrease in N -value and a subsequent recovery trend regardless of the depth were observed 21 days after the earthquake on May 5, 2016.

Based on these estimated N -values, Fig. 18(b) shows the F_L distribution by liquefaction susceptibility assessment assuming that the earthquake condition was Level 2 and Type II quake motion, as shown in Table 1 according to the road bridge specification [6]. This liquefaction susceptibility assessment allows interpretation of changes in ground properties, as obtained by previous studies (Section 2). Therefore, the liquefaction susceptibility assessment does not necessarily reflect the actual phenomena in the Kumamoto Earthquake. The F_L distribution 282 days after the earthquake, obtained on January 21, 2017, shows that most of the distribution has returned to the initial state before the earthquake.

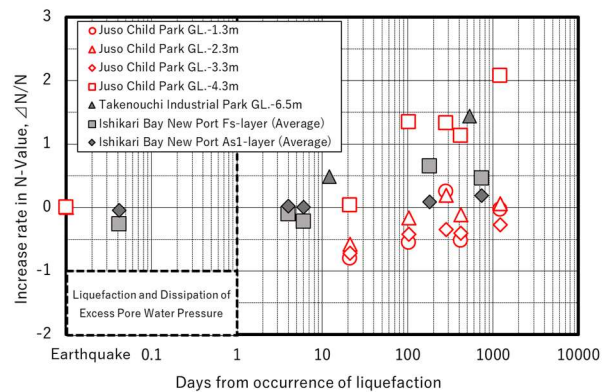
Figure 21. Time history for increase rate in N -values.

behavior, the time histories from the new investigation are added to the $\Delta N/N$ values from Fig. 19(c) in Fig. 21. After the liquefaction occurred, the N -values remained flat or decreased for about 1 month, and thereafter increased to their former level as a post-liquefaction behavior.

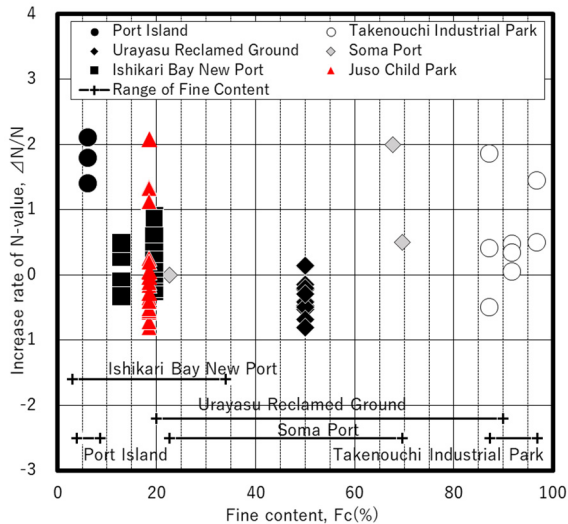
Figure 22. Relationship between fine content and increase rate of N -values.

It was confirmed that the decrease and recovery tendency of N -values after liquefaction were almost the same, but the degree of liquefaction and the timing of recovery differed. It is thought that major factors include the intensity of liquefaction and the F_c . The former can be estimated to some extent from the F_L calculated in advance, but in Figs. 3-7 and 17, there was little difference between the external force during the actual earthquake and the external force set during the F_L calculation. Therefore, because it is difficult to compare sites using F_c in the liquefied layer, the relationship between F_c and $\Delta N/N$ is shown in Fig. 22 to investigate the influence of F_c on post-liquefaction behavior. However, the reclaimed layer at Port Island consists of Masado soil with high gravel content, making it difficult to compare the effects of F_c . However, after excluding plots for Port Island, it can be confirmed that $\Delta N/N$ increases between -1 and 2 as F_c increases. In addition, Fig. 21 shows that Takenouchi Industrial Park with high F_c , Ishikari Bay New Port, and Juso Child Park had an early recovery trend except for GL-4.3m at Juso Child Park.

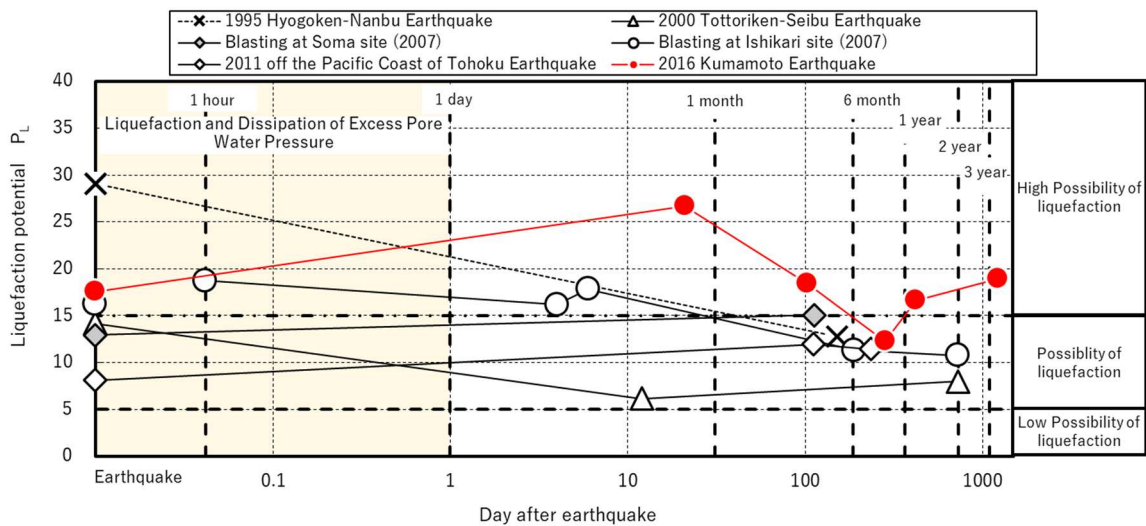
Figure 23. Changes in liquefaction potential.

At Ishikari Bay New Port, the initial value of P_L was 16.2 before liquefaction, increased to 18.7 immediately after liquefaction, and returned to the initial value of 16.2 1 day after the excess pore water pressure had dissipated completely. At this stage, although the possibility of liquefaction is “extremely high”, identical to the initial condition, it seems that P_L gradually decreased and the evaluation improved to a state where the possibility of liquefaction is “high”. Conversely, in the case of Juso Child Park in the Kumamoto Earthquake, the initial value of P_L was 17.6 and it rose to 26.7 21 days after the earthquake. Then, the P_L showed a recovery trend and reached 18.9 after 1,219 days. At Takenouchi Industrial Park after the Tottori-ken Seibu Earthquake, 10 days after the earthquake, the initial value of P_L decreased from 14.2 to 6.1. After the 2011 Great Tohoku Earthquake, the P_L value was slightly increased 3 months after the earthquake, indicating an increased potential for liquefaction.

Based on the results of each evaluation, we focused on changes in the P_L at Ishikari Bay New Port and Juso Child Park, which have sufficient data for discussion. The former is reclaimed ground and the latter is a natural deposit. Differences at these sites suggest that the recovery behavior of ground after liquefaction depends on conditions such as sedimentation.
