*The paper was published in the proceedings of the 6th International Conference on Geotechnical and Geophysical Site Characterization and was edited by Tamás Huszák, András Mahler and Edina Koch. The conference was originally scheduled to be held in Budapest, Hungary in 2020, but due to the COVID-19 pandemic, it was held online from September 26<sup>th</sup> to September 29<sup>th</sup> 2021.*

# Engineering application of smart slope stability in-situ and remote monitoring methods in lignite opencast mine

*Z. Bednarczyk, Poltegor-Institute, Institute of Opencast Mining, Wroclaw, Poland, zbyszbed@gmail.com*

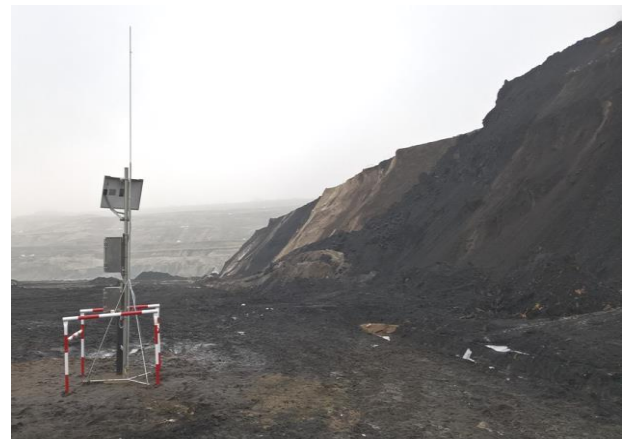
The monitoring instrumentation included two hundred 3D displacements sensors located every 0.5 m, 3 magnetometers for control of rotation and ground temperature sensors every 4 meters. The continuous inclinometer SAA system is 100 m depth, built from rigid segments. Segments could be tilted in any direction but not twisted. One segment is 0.5 m length. One segment includes 3 tilt sensors measuring range  $\pm 45$  degrees, accuracy 0.02 mm/m, the mistake of joints  $\pm 0.250$ . Every octet (4 segments) is equipped with a ground temperature sensor for the correction of temperature effects. The maximum range of equipment depends on the speed and depth of movements (usually not more than 500 mm). The system is waterproof up to 980 kPa. System powered by a solar panel was additionally equipped with a VW pore pressure sensor located at a depth of 30 m. The GPRS data are registered every 6 hours and available online from 19 December 2016 till now. Data were recorded every 6 hours. Connection with field station was realized every day between 11 AM-1 PM. Recorded data were interpreted and analyzed in SAA3D software as plots of magnitude, cumulative, incremental displacements and pore pressure plots (Figs. 16-18). For an early warning, the limit of 30 mm per day was selected in the software.

**Figure 15.** The on-line monitoring station in Belchatow mine.

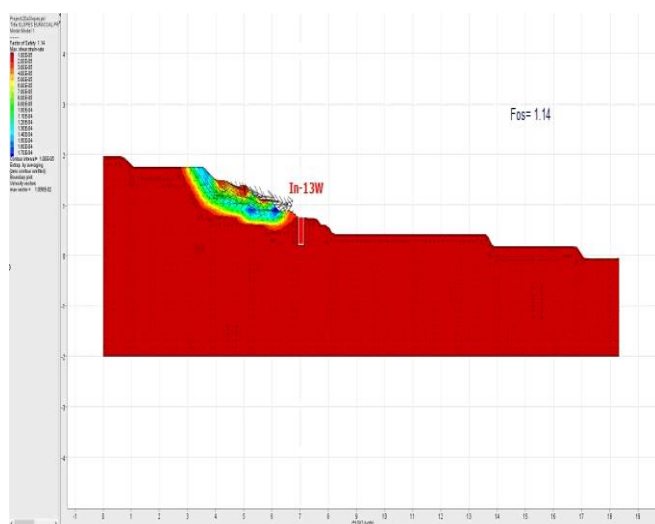
The stability coefficients obtained in the Flac program were unfavorable and ranged from 0.85 in section 18 WE (near a landslide) to 1.14 in section 20 WE (Figs. 22-24). In complex geological-engineering conditions, the reliability of numerical modeling may depend on many factors related to the uncertainty of calculation parameters, simplified geometric model, strength parameters introduced, length of analyzed cross-sections, and the applied calculation grid. The analyses of western slope stability were also performed with the LEM border equilibrium methods using the Bishop and Janbu methods (Fig. 25). The results of all the analyses are presented in Table 3. The result of the local analysis and the field inspection indicates that it is a high landslide risk on the west slope of the mine (Fig. 27). The movements were caused by multiple factors as mining influence, the slope height and strength parameters, and salt dome influence. The salt structure influence was not included in these preliminary local analyses due to the relatively high distance to the salt dome and lack of representative data but it should be implemented in future analysis. It should take into account the rheological properties of salt in the salt dome and surrounding layers. However, in such complex geotechnical conditions, its credibility depends on several factors. The errors of interpretation may be of a different origin. These are usually associated with the uncertainty of calculation parameters and the simplified geometric model. Errors can arise mainly from the approximations of geometrical models for the analysis, usage of simplified strength parameters, length of the analyzed cross-sections, and applied computing grid.

Figure 23. Slope stability analysis 20WE, SSR method, Fos = 1.14.

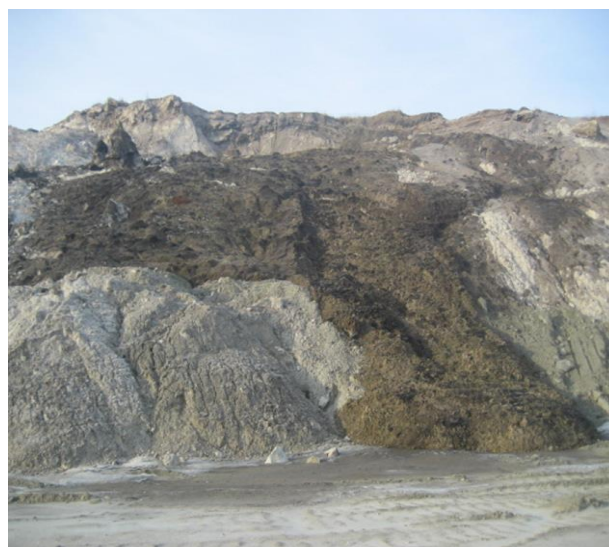
Figure 26. Landslide near the cross-section 20 WE, west slope of the Belchatow field.
