Permeability profile of a planosol based on in situ falling head permeability tests

C.A.B. Bastos & D.F. Fagundes

ABSTRACT: The present paper show the results of in situ falling head permeability tests conducted in a planosol formed above the coastal quaternary deposits in south of Brazil. An excavation was planned to be performed to drainage of a road constructed nearby. The influence of this excavation on the seepage behavior of the marshy ground of this region was important to be considered in order to protect the habitat of endangered fish species. Results showed that for the depth up to 2.0 m, the value of permeability coefficient decreased (from 2.4×10^{-5} to 4.1×10^{-6} cm/s) and then it increased to 4.4×10^{-5} cm/s. The results are in agreement with the concentration of clay in subsurface, resultant of the pedogenesis of the planosol. This study will subsidize a numerical analysis of the flow resulting from excavation and therefore an indication of the best solution to minimize the project impacts on the surrounding environment.

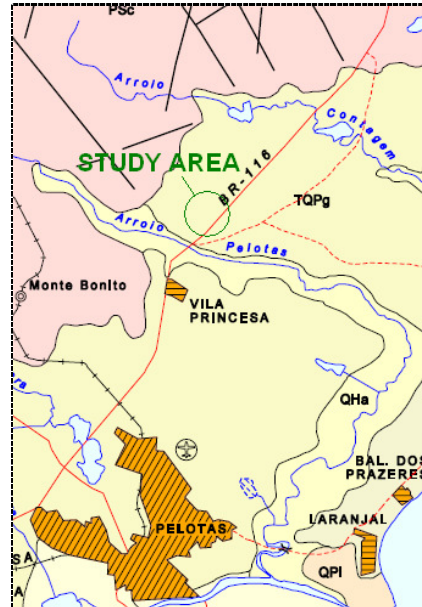
Figure 4. Geological map of the study area

The geology and pedology of the study area have great importance to the interpretation of the geotechnical characterization and the permeability profile. According to segment of the Geological Map of the Sheet Pelotas/Mostardas - SH.22-Y-D / Z-C (IBGE 2003) presented in Figure 4, the study area has the geological substrate TQPg unit, characterized by arkose sandstones weakly consolidated that constitute alluvial fans deposits. The soil formed from this substrate belongs to the class of eutrophic Planosols with texture medium/clay (unit PLe3 in Figure 5) or Subdystric Paraquic Ochric Planosol obtained by the Soil Taxonomy American System. The soil profile is inserted in the geomorphologic unit Lagoon High Plain (Cunha & Silveira 1996).

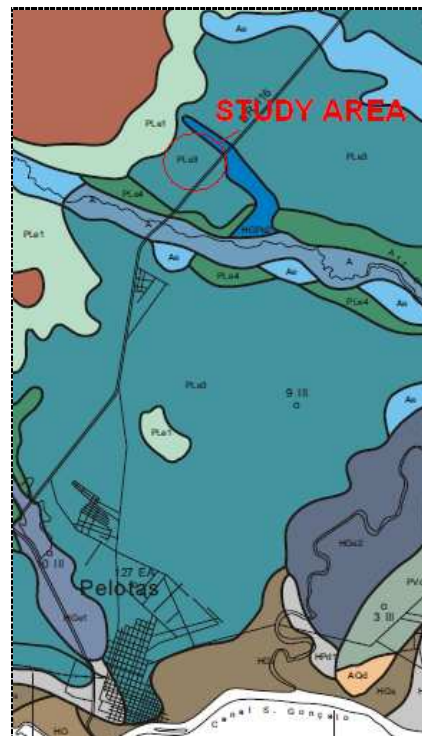
Figure 5: Soil map of the study area

Cunha & Silveira (1996) describe this planosol as a deep soil with imperfect drainage. The superficial horizon has 30-80 cm thick, texture medium (with 6-10% clay), poor structure (massive), strong acidity, color brown to dark grayish. The profile shows an abrupt and flat textural transition to the subsuperficial horizon B, with texture clay (25-40% clay), weak structure (angular or prismatic blocks) and consistency very firm when moist and very hard when dry. The authors indicate in this horizon the presence of a clay-pan, which difficult water penetration, and also reddish and yellowish brown mottled, indicating imperfect drainage. Therefore, the pedological records already indicate poor

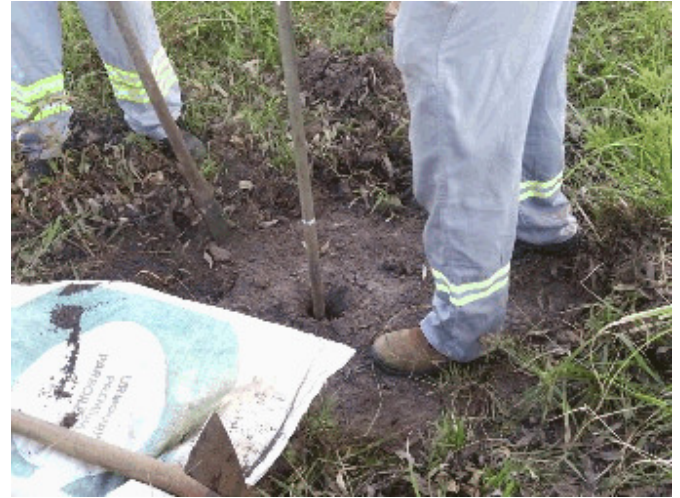
Figure 6. Sampling auger for geotechnical characterization of materials

For geotechnical characterization of the soils with depth, the auger samples were collected (Figure 6) at five different depths around 0.5, 1.0, 2.0, 3.0 and 4.0 m (in an amount sufficient for geotechnical characterization in the laboratory tests). The samples packaged and identified were sent to the Laboratory of the Geotechnics and Concrete of the Federal University of Rio Grande - FURG to the geotechnical characterization according the Brazilian standards: NBR 6457/1986 (Soil Samples - Preparation for Compaction and Characterization Tests); NBR 7181/1984 (Soil - Grain Size Analysis); NBR 6459/84 (Soil - Determination of Liquid Limit); NBR 7180/84 (Soil - Determination of Plastic Limit). These results allowed obtain the HRB-AASHTO and USCS classifications.

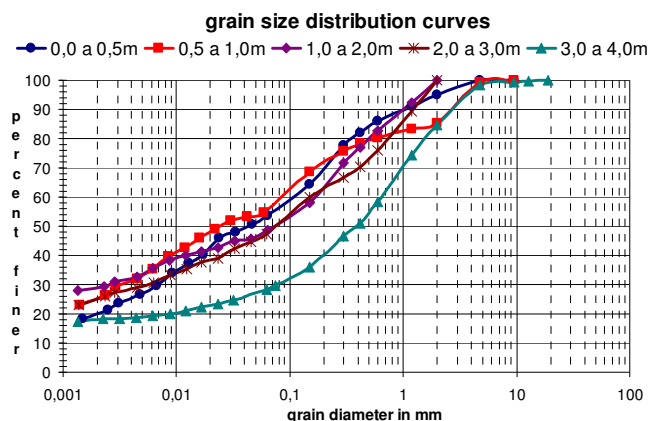
Figure 10. Grain size distribution curves

The parameters obtained from the grain size analysis tests and Atterberg limits are shown in Table 1. The consequent geotechnical classification of the soils is presented in Table 2. The grain size distribution curves are shown in Figure 10.
