Integrated use of terrestrial laser scanning and thermal imagery for characterization of hydrothermally altered granites

J.S. Coggan, D.M. Pascoe, & M.L. Eyre
University of Exeter, Cornwall, UK

ABSTRACT: The assessment of material properties is a fundamental component of geotechnical characterization of slopes in hydrothermally altered granite, as potential slope failure mechanisms are controlled by kaolinization intensity, discontinuity characteristics (such as orientation, persistence and spacing) and the detrimental effects of groundwater. In order to assess the potential advantages of remote mapping technologies for improved spatial cover both laser scanning and photogrammetry have been evaluated within the china clay operations for use in rock mass characterization. The results presented also focus on application of the remotely captured data for use in design of china clay slopes in southwest England. A key benefit of the detailed geo-referenced point cloud data is the ability to measure and evaluate discontinuity characteristics such as orientation, spacing, persistence and volumetric data which are key factors that dictate the size of any potential failure. In addition to

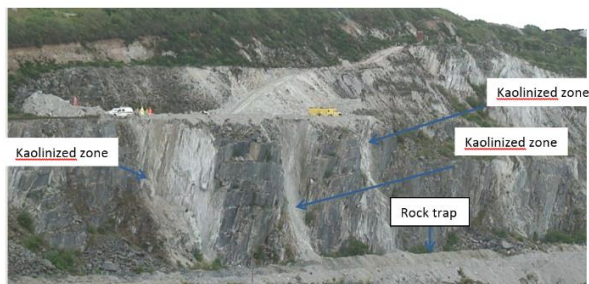
Figure 1. Photograph of a section of historical bench face (striking N-S) with several sub-vertical kaolinized zones, found within poorly kaolinized rock. Discontinuities sets of high angle joints striking sub parallel to the face subject to possible toppling failure.

In less kaolinized zones, individual benches can be near vertical as demonstrated in Figure 1, where the slope of this historic bench face is approximately 26 m high at an inclination of 80+/-5 degrees with significant rock traps constructed to manage risk. Also shown in the photograph is the presence of several narrow highly kaolinized zones within this mostly poorly kaolinized bench face which have been oriented using remote methods, as described in this paper.

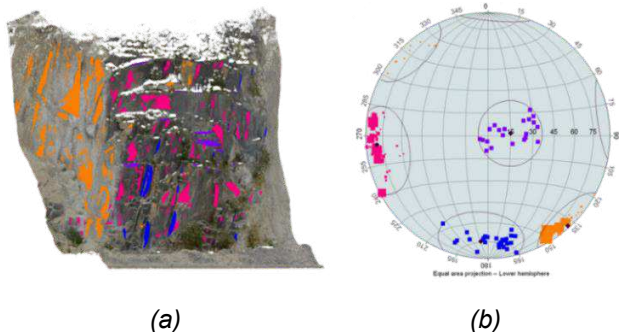
Figure 3. a) 3-D laser scan of section of pit benches indicating patches (angular) and traces (ovoid) added b) Stereoplot of section of NE face pit bench indicating poles of patches (angular) and traces (ovoid) with each joint set colour-coded.

corresponded mostly with highly altered zones where the joints have been obscured by the process of kaolinization. Where discontinuities were striking almost perpendicular to the bench face it was not always possible to fit patches to the surface of the discontinuity and ‘traces’ were fitted, enabling orientation of these joints to be determined as demonstrated in Figure 3.

3. Major sub-vertical discontinuities striking perpendicular to the face are indicated by dark blue features in the infrared images. These correspond to Set 2 (blue) shown in Figure 3. From the mean pole of this set indicated in the major plane plot in Figure 6 and data in Table 3 the mean pole of this set is orientated at 77°/348°.

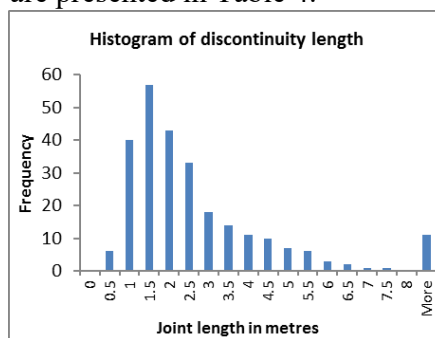
Figure 5. Histogram of discontinuity length.

It is also possible to determine estimates of the true spacing and persistence of discontinuities using Split-FX, achieved by measuring the perpendicular distance between fitted traces and patches. The probability density distributions of both total discontinuity lengths and spacings are shown in Figure 5. Individual joint set spacings from sections 2, 3 and 4 are presented in Table 4.

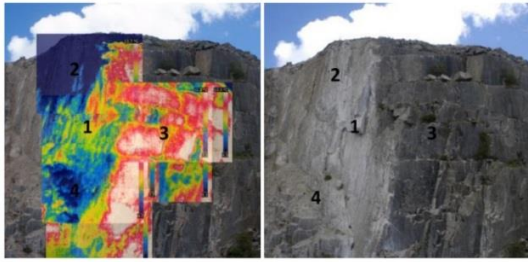
Figure 8. (a) Thermal images draped over point cloud of same position depicted in figures 6 and 10 (b) Raw format digital image of same exposure aids identification of specific features.

Figure 7 also demonstrates that surfaces of discontinuities that have been subject to alteration have a different thermal response to unaltered rock faces. The highly kaolinized zone to the left hand side of the thermograms in Figure 8(a), indicated by numbers 2 and 4, is characterized by dark blue coloured thermographic imaging indicating the lowest temperatures equating to approximately 8°C. The orientation of this particular highly kaolinized discontinuity surface corresponds to Set 4 (orange) in Figure 3. In Table 2 the mean orientation of this major joint set in this section of the bench is seen to be 86°/310°.
