Using Multi-Channel Analysis of Surface Waves and Cone Penetrometer Tests to delineate an in-filled palaeochannel during routine investigations – A Christchurch Earthquake Case Study

R. Kamuhangire & T. Plunket
Aurecon, Christchurch, New Zealand

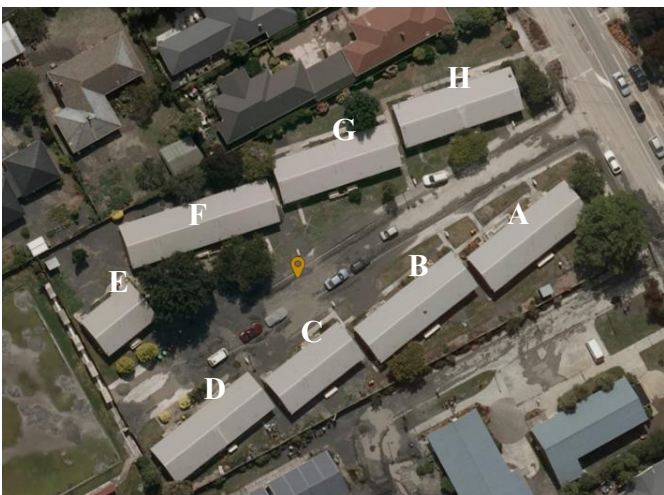
Figure 2 – Site detail (note building locations). Image background from LINZ Crown Copyright Reserved.

The site is located at Cresselly Place, St Martins Christchurch, within a ‘point bar’ of the Heathcote River (see Figs 1 & 2 below).

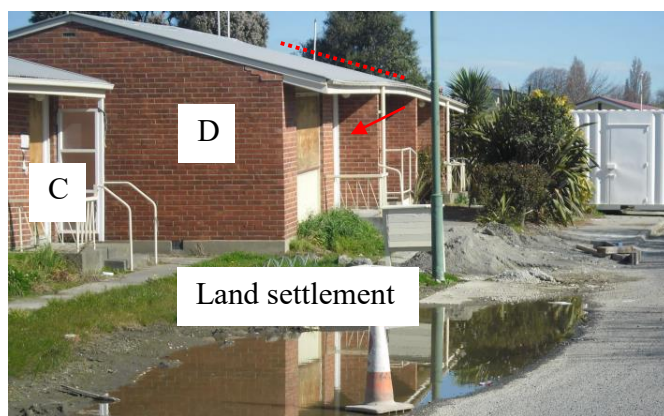
Figure 5 – Building D differential settlement (view roof line). Building ‘broken’ around dotted line.

Building D, which appeared to straddle the edge of the channel, showed significant hogging (Fig 5). Building C sagged towards the middle, which correlates with its location near the centre of the in-filled channel. There was also up to 40 mm lateral stretch across Building D foundations and veneer around the inferred channel boundaries. Damage observed around other buildings also supported the hypothesis of the in-filled channel shown on Figure 4.

- Building damage can be explained based on building locations in the inferred channel profile. Building D straddled the low V_s part of the channel profile and transition zones while Building C was in the middle where larger magnitudes of settlement could be expected based on ground stratigraphy.
- Ground cracks recorded at the site appear to coincide with areas of sudden changes in ground stratigraphy based on MASW plots.

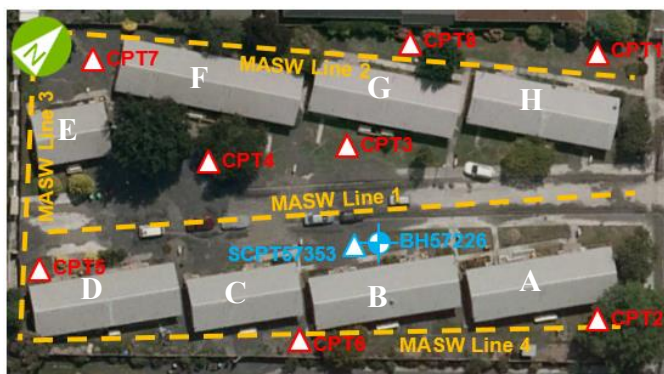
Figure 6 – Extent of investigations undertaken.

A combination of eight CPTs and four MASW survey lines were undertaken in 2013 to delineate the extents of the in-filled channel and soil stratigraphy across the site. The investigation locations are shown on Figure 6, and include an additional seismic CPT and machine drilled borehole undertaken by others in 2015 (CGD, 2016).

The orientation of the MASW survey lines (Fig 6) was planned to optimise coverage across the site and to identify any abrupt changes in V_s .

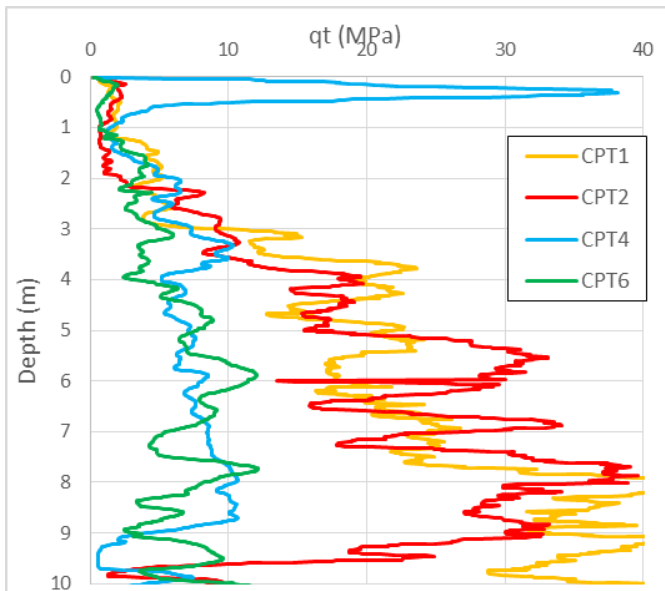
Figure 7 – Normalised cone resistance Vs depth (upper 10m profile and only CPTs 1, 2, 4, 6 shown for clarity).

A summary of the CPTs is presented on Figures 7 and 8 indicating normalized cone penetration resistance (Q_t) and Soil Behavior Type Index (I_c) with depth. The results indicate the following:

- The logs of CPT1 and CPT2, at the eastern end of the site with less observed settlement, show dense sands and gravelly sands from 3m to 4m depth extending to at least 10m depth. This relatively thick dense layer is generally absent in all other CPTs at shallow depth.
- The logs of CPT4 and CPT6 located in the 'middle' of the inferred channel, show soils with relatively low Q_t cone resistance to minimum 14m depth. Organic layers are also interpreted between 11m and 13m depth in CPT6.
- Other CPTs show varying ground conditions, with the medium dense to dense layer only encountered in thin layers and generally not as strong as in CPT1 and CPT2.

Based on the CPT results, it can be inferred that CPT1 and CPT2 are outside the infilled channel, CPT4 and CPT6 are in the channel, and the rest are probably in transition zones. The CPT results therefore support the hypothesis that there is a historical channel and the nature of land and building damage is directly related to variability in ground conditions.

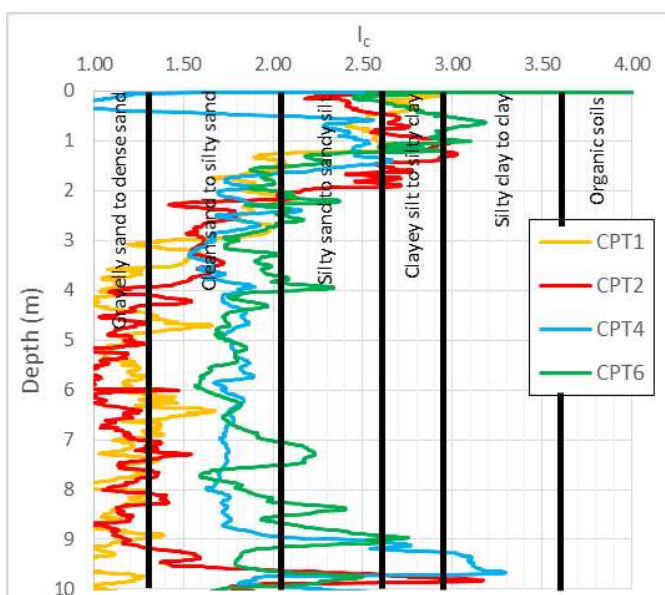
Figure 8 – Soil Behaviour Type Index (I_c) Vs depth (upper 10m profile and only CPTs 1, 2, 4, 6 shown for clarity).

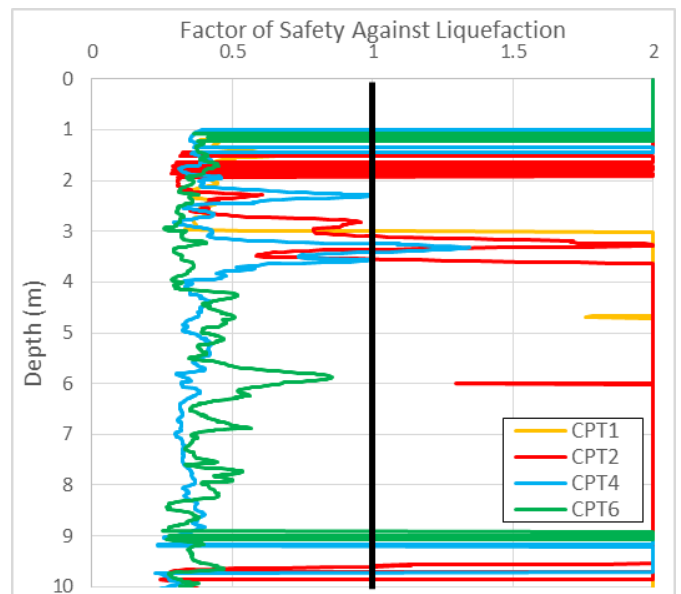
Figure 9 – Factor of Safety Against Liquefaction Vs depth (upper 10m profile and only CPTs 1, 2, 4, 6 shown for clarity).

The liquefaction assessment results for CPTs 1, 2, 4, and 6 are presented in Figures 9 and 10 for the upper 10m profile. The results show the following:

- CPTs 1 and 2, at the eastern end of the site with less settlement, show no liquefiable layer below 3m depth to at least 10m. The assessed liquefaction settlement is generally less than 50mm.
- CPTs 4 and 6, located in the middle of the inferred channel, have potentially liquefiable layers

from below the groundwater table to at least 10m depth. The assessed liquefaction induced settlement is generally more than 150mm.

The results of the liquefaction assessment were consistent with site observations. Areas where more liquefaction induced settlement was observed were assessed to have thicker calculated liquefaction layers and larger magnitudes of calculated free field settlement. The liquefaction assessment also supports the hypothesis of a historical channel and that the nature of observed damage is directly related to variability in ground conditions.

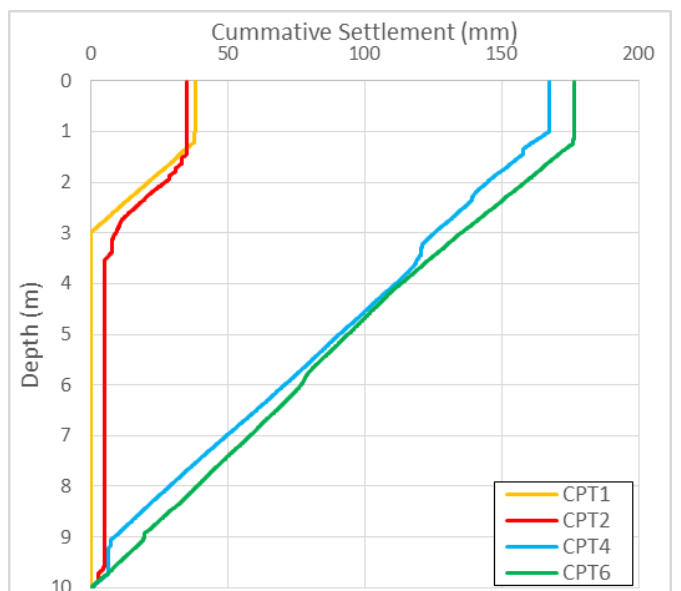
Figure 10 – Liquefaction Induced Reconsolidation Settlement Vs depth (upper 10m profile and only CPTs 1, 2, 4, 6 shown for clarity).
