# Interpretation of shear strength data for construction on mine tailings deposits

D.J. Williams

**ABSTRACT:** The safety of an upstream embankment raise or final capping for a conventional surface slurried tailings storage requires that the existing tailings be desiccated and a geotechnical investigation to demonstrate adequate bearing capacity. Typical geotechnical investigation methods include in situ shear vane testing and cone penetration testing. Heavily desiccated tailings may allow direct access using a conventional rig. Otherwise, a rig with wide tracks may be required, or access roadways may have to be constructed over the tailings. The data from these tests are then interpreted to determine the shear strength profile for the desiccated tailings, to enable bearing capacity, geotechnical slope stability and settlement analyses of a proposed upstream embankment raise or capping. The paper describes two case studies of such geotechnical investigations, test data interpretation, and geotechnical analyses; one for an upstream embankment raise on heavily desiccated tailings and the other for the capping of variably desiccated tailings.

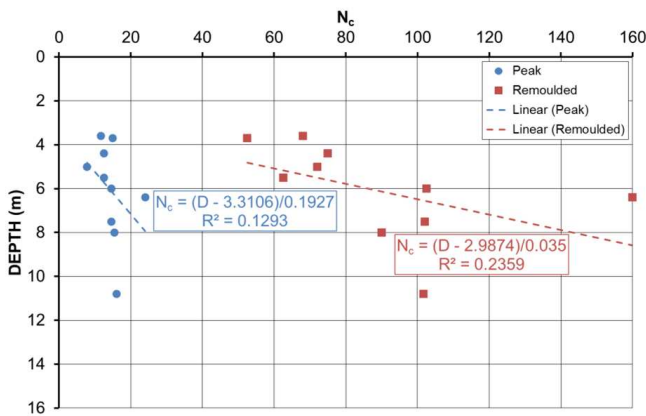
Figure 5. Calculated peak and remoulded bearing capacity factors with depth in Cell 1 tailings.

Values for the peak and remoulded bearing capacity factors are plotted in Figure 5. The reported vane shear strength data and the calculated bearing capacity factors are very scattered. The range of peak bearing capacity factors is 7.8 to 24.0, with an average value of 14.4, while the range of remoulded bearing capacity factors is 53 to 160, with an average value of 88.6.

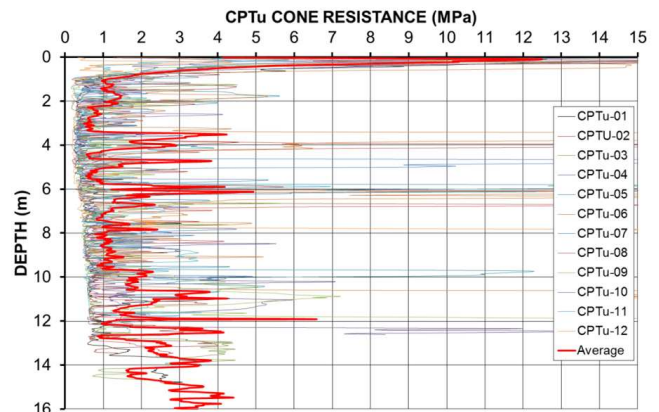
Figure 6. CPTu cone resistance versus depth profiles.

All 12 CPTu cone resistance profiles are plotted in Figure 6, together with the average profile. In Figure 7, the CPTu cone resistance data have been divided by the average peak bearing capacity factor of 14.4 to provide the estimated profiles of peak shear strength with depth, again including the average profile, plus the “smoothed” lower bound of the average profile, ignoring the peaks caused by the sandy lenses.

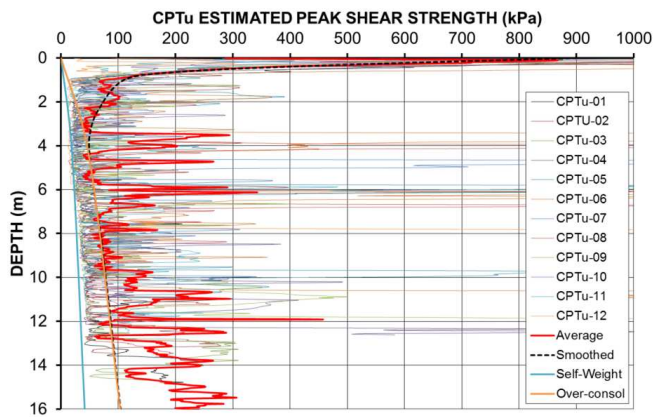
Figure 7. Estimated peak shear strength versus depth profiles.

Also shown in Figure 7 are the approximate normally-consolidated, self-weight profile and the approximate over-consolidated profile, the latter made to match the smoothed average profile below the water table (from about 4.6 m depth). The average OCR is approximately 3.15 and, using Equation (3),  $(s_u / \sigma_v')_{oc}$  is approximately 0.63, 2.5 times the adopted normally-consolidated value of 0.25. The

remoulded values are approximately 0.4 times these values, but will only be realised if remoulding is initiated.

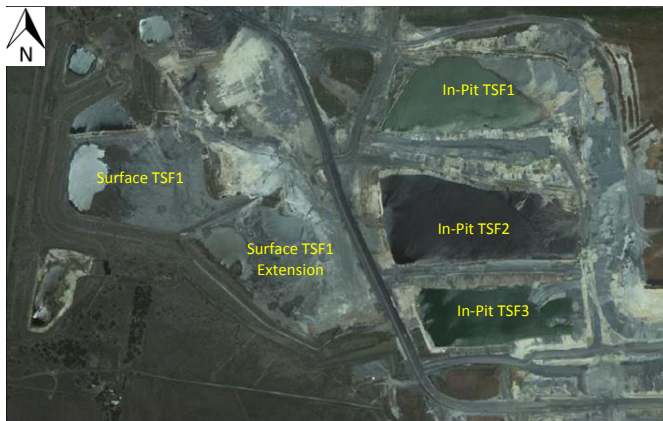
Figure 8. New Acland surface and in-pit TSFs (aerial photograph taken on 12 March 2013).

New Acland Coal Mine in the Clarence Moreton Basin within the lower Walloon Coal Measures, is located north-west of Oakey in South East Queensland, Australia. Initially, New Acland discharged slurried tailings generated by their coal processing plant to a surface tailings storage facility (TSF1 and TSF1 Extension), before establishing in-pit TSFs (see Figure 8).

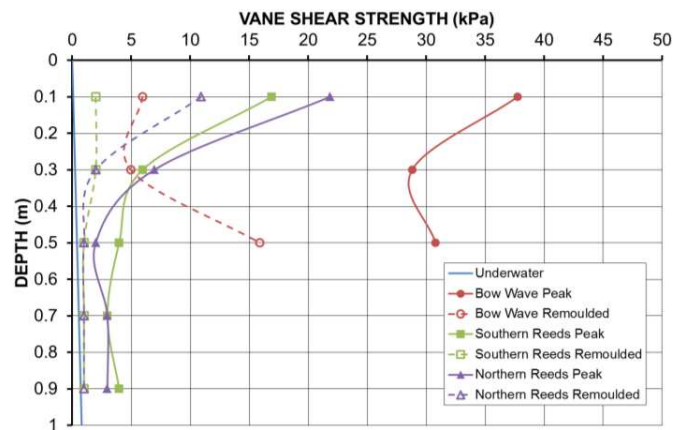
Figure 9. Selected peak and remoulded vane shear strength profiles with depth.

Selected peak and remoulded vane shear strength profiles with depth for TSF1 tailings are shown in Figure 9. Included in Figure 9 is the shear strength profile expected for coal tailings maintained 'underwater', due to its self-weight alone. The tailings at the bow-wave induced by the previous placement of spoil is capable of safely supporting a fill height of up to 6 m, while the surface of the tailings towards the reeds can only support a maximum of 2 to 3 m of fill, from Equation (6). The average ratio of the remoulded:peak vane shear strength for TSF1 tailings is about 0.4, implying a corresponding drop in the fill height that can safely be supported on remoulding.

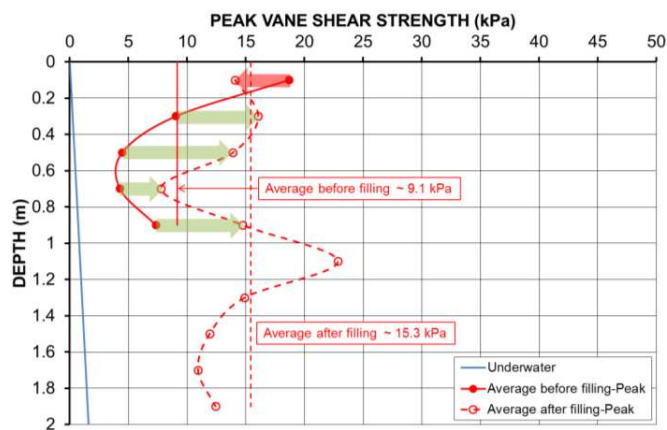
Figure 11. Increase in peak vane shear strength due to dissipation of excess pore water pressures.

On the placement of the initial capping layer (typically about 1 m high in an effort to avoid bow wave failure), excess pore water pressures are induced in the tailings, raising the water table (often to the surface). These excess pore water pressures dissipate through drainage to the surface, resulting in a general increase and greater uniformity of the peak vane shear strength profile with depth, as shown in Figure 11. The increased peak shear strength, averaging 15.3 kPa in Figure 11, corresponding to Equation (8), would allow an additional fill height of almost 2 m to be safely placed using the D6 Swamp Dozer.
