# A comparative analysis of the stability of a slope in an overconsolidated clay pit based on CPT and DMT measurements

H. Peiffer

**ABSTRACT:** In Belgium the Boom Clay is a well known overconsolidated tertiary clay formation. In the period 2011-2014 small slidings occurred in the slopes of a pit with a depth of 30 m. Because more slidings could be expected, a monitoring was started including a series of DMT-tests and CPT-tests around the pit. In June 2014 a very large sliding (an area about 100 m by 50 m) occurred. In the present paper the results of the DMT-tests and the CPT-tests were discussed at different stages, before the sliding and after the remediation works. Although both CPT and DMT gives a clear image of the sliding surface, the measurement with the DMT gives a more pronounced result.

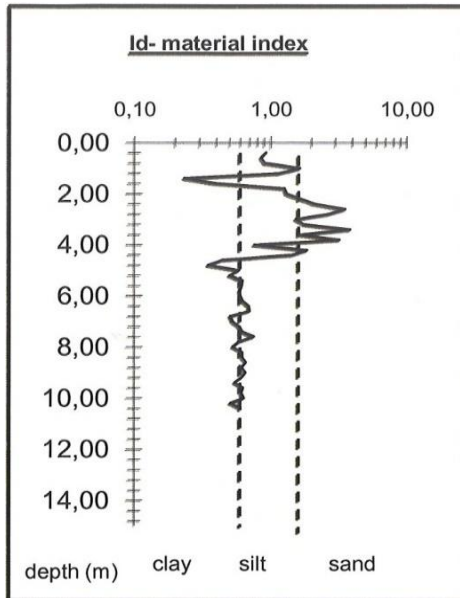
Figure 1.  $I_D$  (DMT1)

Based on the geological investigations and data maps, the upper layer consists out of a sandy silt (quaternary deposit). Under this layer the tertiary overconsolidated Boom Clay can be found. This can be seen also on the  $I_p$ -diagram as presented below. The profile confirms the results of the undisturbed sampling of the soil.

As discussed in 4.1., after the more pronounced sliding in 2013, a monitoring program was elaborated for different points at the top of the slope around the pit. Besides topographic surveys and the measurement of the phreatic waterlevel, DMT-tests were carried out. In this article the top of the slope in section AA' is discussed. The section itself is given in the figure 9. The reference level in the figures 1 and 9 corresponds with the national reference (TAW)  $\pm 8$  m TAW.

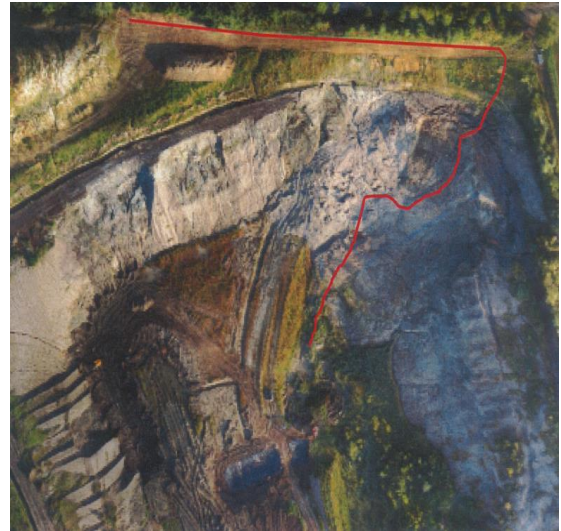
Figure 2. Photographic impression of the sliding

In the figures 2 and 3 a general impression of the sliding and the soil movement is presented. A zone of 100 m by 50 m started to move resulting in a downward movement of about 9 m in the corner of the pit. After the first sliding in the northwestern part of the pit a monitoring program was set up. The monitoring consisted out of the execution of CPT-tests and DMT-test. Besides these tests, also the water pressures were measured on a regular base

The analysis resulted in a design where a deep drain has to be installed at a depth of 5 m., as shown in the Fig. 2. This drain was installed in November 2015. The red line in figure 2 is the position of the drain in plan view. After the installation of this drain, there was an immediate effect on the depth of the groundwater. The original depth of 1,5 m increased to a depth of about 4.5 m. The safety of the slope stability increased from 0,9 to 1.31.

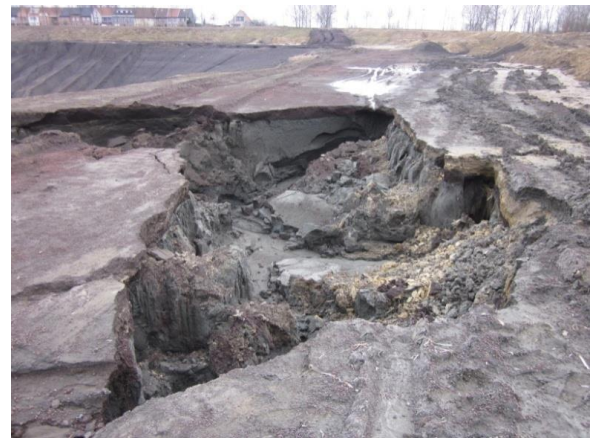
Figure 3. Detailed impression of the instable slope

In the next figures a general view of the main sliding is presented. After excavation of the clay pit till a depth of about 30 meters, in the Northern part of the pit instability (small slidings) of the walls started to occur after some years. The main reason for this was the lack of a sufficient resistance against horizontal stability. During the period of excavation the pit became the central dewatering point for the region. Unfortunately the surface between the upper quaternary layer and the underlying Boom clay was slightly declining towards the pit. The upper part (quaternary layer), with a thickness of about 4 to 5 m moved towards the pit, resulting in instability. Also the underlying Boom Clay was affected by this slide.

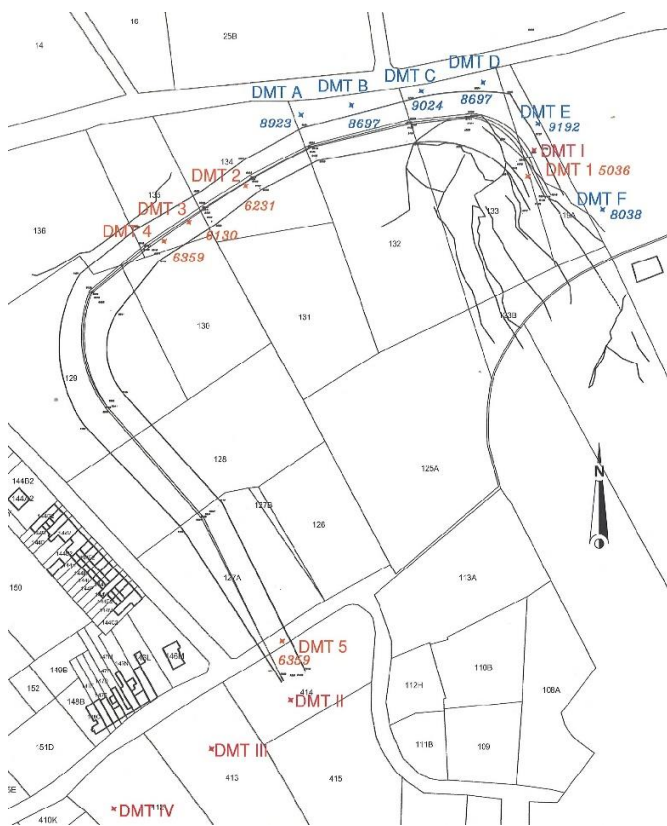
Figure 5. Overview in-situ tests

An overview of the monitoring points is presented in figure 5.

Until now four campaigns were organized :

January 2014 – DMT 1 to 5 (before the important sliding)

July 2014 – DMTA to F (about 1 month after the sliding)

January 2015 – DMT I to IV (after stabilizing)

March 2016 - DMT1' to 5'

In the second half of 2013 a more important slide occurred in the neighborhood of point 5 on figure 5. The number 5 refers to DMT 5 executed in the beginning of 2014 at a distance of 5 m from the top of the slope.

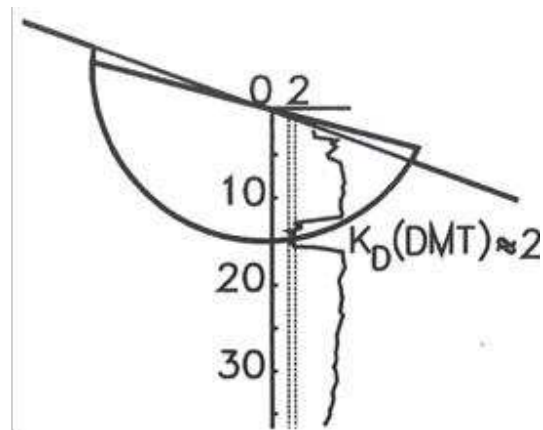
Figure 6. Principle of the DMT- $K_D$ -method

The principle of the DMT- $K_D$ -method for the detection of slip surfaces can be shown as follows. (Marchetti, 1997). In many OC clay landslides, the sequence of sliding, remoulding and reconsolidation, leaves the clay in the slip zone in a normally consolidated (NC) or nearly NC state, with loss of structure, ageing or cementation effects.

In genuinely NC clays (no structure, ageing or cementation) the horizontal stress index  $K_D$  from the DMT is approximately equal to 2, while  $K_D$  values in OC clays are considerably higher (for the Boom Clay about 8).

Therefore it is known that, if an OC clay slope contains clay layers with  $K_D \approx 2$ , these layers are highly likely to be part of a slip surface (active or quiescent).

The DMT- $K_D$ -method consists on identifying zones of NC-clay in a slope, using  $K_D \approx 2$  as the identifier of the NC zones.

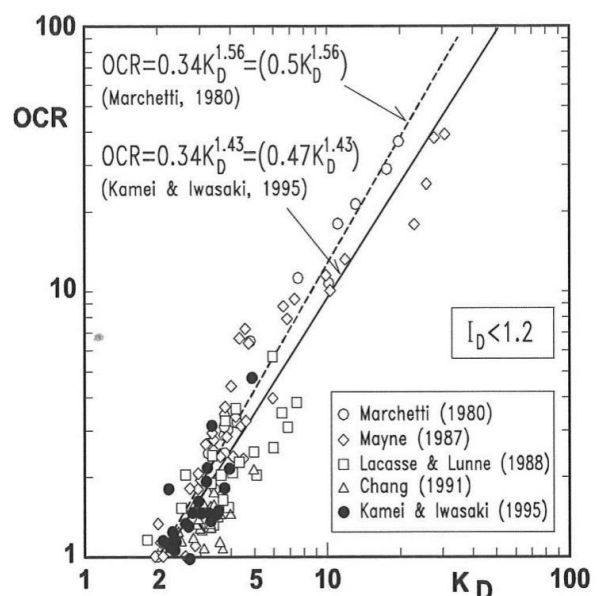
Figure 7. Correlation  $K_D$  – OCR for cohesive soils (after Kamei & Iwasaki, 1995)

Based on field data from different clay sites in various geographical areas correlations could be established (G. Totani et al., 1997, Lacasse & Lunne, 1988).

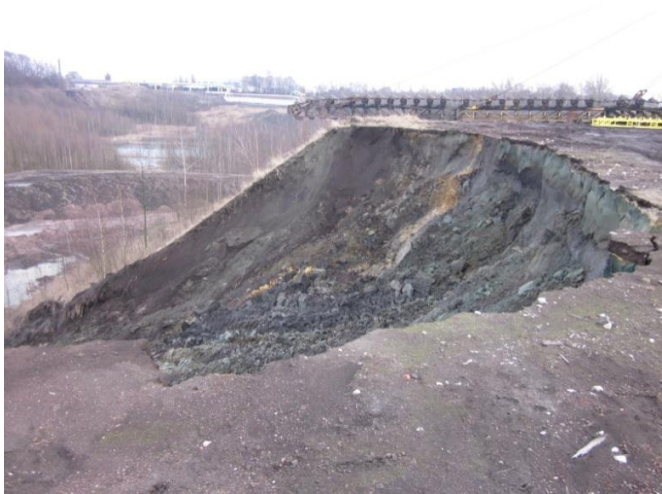
Figure 8. Photo of the unstable zone after sliding

In the figure 8 a photo of the slide is presented. The sliding occurred in the quaternary layer until a depth of about 1.5 m in the Boom clay.

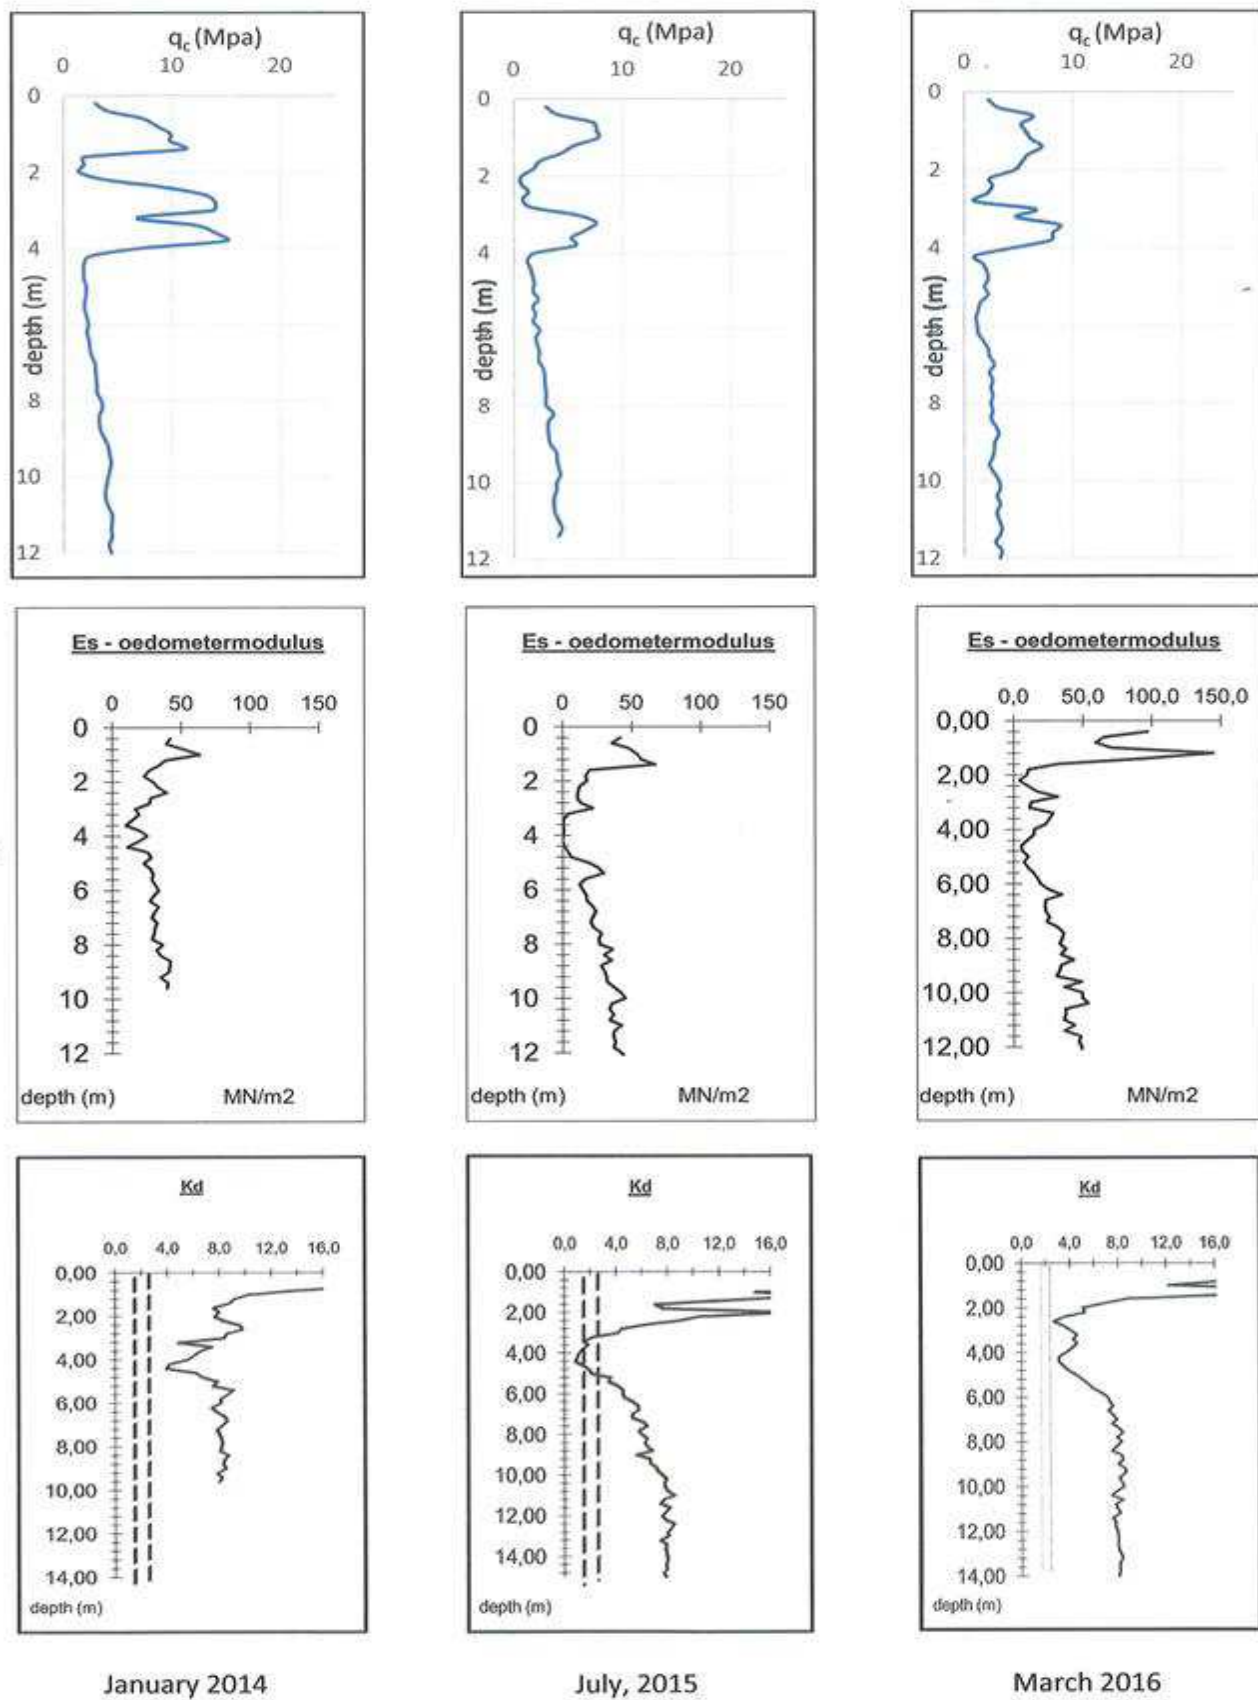
Figure 10. Results of CPT and DMT

In the figure 10, the results are presented for the tests before (January 2014), immediately after (July 2014)

and about two years after the sliding in point of section AA', corresponding with DMT1 in the figure 5.

In the test diagrams one can distinguish the upper quaternary sandy silt layer. In the  $K_D$ -graph one can see that two points (one in a weaker point in the quaternary deposit and one at the interface between the quaternary layer) show a lower value of  $K_D$ . The CPT diagram shows also the presence of a weaker layer at depth of about 2m. The DMT-results show a decrease in horizontal stress at these point.

The layer between these two points became unstable in June 2014, resulting in an important sliding. One can see on the diagrams of figure 10 (July 2014) that the  $K_D$ -value became lower than 1.8, referring to unstable soil conditions. The failure occurred in this zone and affected a slip layer with a thickness of about 1.5 m. Although the cone resistance decreased with a factor about 2, and a significant decrease of  $q_c$  between 2 and 4 meter can be seen in this layer, the CPT-diagram doesn't give a clear reflection of the sliding. It is also important to notice that the  $K_D$ -values below the sliding zone decreased till a depth of about 5 m below the sliding surface. It is interesting to see which way the stresses changed after the sliding. In the last column of figure 10, the results are presented for the measurements carried out in March 2016. Remediation works were done in October-November 2014 (see 6.).

The  $q_c$ -value did not change in an important way. Out of the  $K_D$ -diagram it become clear that the  $K_D$ -values exceeded the critical value 1.8. For the clayey layer the measurement reflects actually a normally consolidated soil. For the intermediate sandy silt layer, one can see a slightly overconsolidated soil condition. The difference between the measurements of July 2014 and March 2016 can be explained by the presence of excessive pore pressures, resulting in lower values of  $K_D$  in the sandy silt layer in the sliding layer.

After consolidation a residual part of the original overconsolidation did appear again. The soil conditions after sliding and reconsolidation can be measured more clearly using the dilatometer.

This way the stability of the slope could be evaluated before, during and after sliding. Comparison between the DMT-test before and after the sliding shows clearly an important reduction of  $K_D$  (factor about 4) and  $E_D$  in the sliding zone (resulting in lower values of  $E_s$ ). It is important to notice that the  $K_D$ -value also were reduced in the layer immediately below the sliding zone. The CPT-measurements showed a decreased strength ( $q_c$  reduced with a factor about 2) and stiffness in the soil, but the sliding zone could not be indicated that pronounced. After a period of about two years, the  $K_D$ -value in the sliding zone increased towards values corresponding with the state of normal consolidation. The CPT-diagram didn't show a remarkable change of  $q_c$ .

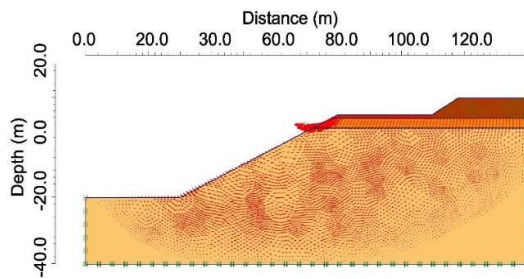
Figure 11 – PLAXIS-analysis

In order to get a better understanding of the effects resulting in this instability and in order to design an appropriate remediation, additional investigation was done to determine the design soil characteristics (CPT-tests and laboratory tests (triaxial tests, oedometer tests)). This analytical and numerical analysis is not discussed in detail in this article. Out of the theoretical analysis it became clear that the effect of the groundwater pressures on the horizontal equilibrium was dominant.

The Fig. 11 presents the calculated critical horizontal disequilibrium due to the presence of the groundwater out of an equilibrium analysis the zone within the most critical global sliding surface. But in the upper part of this zone the equilibrium is broken in the upper layer (lower part of the quaternary deposit and top layer of the Boom clay (big red arrows)). In reality it could be seen that the sliding in the upper part of the Boom clay was more pronounced than in the analysis made with Plaxis.
