Lessons Learned From Field Instrumentation and Remote Sensing Studies of Instrumented Pavement and Bridge Infrastructure

Anand J. Puppala¹, Ujwalkumar D. Patil² and Tejovikash Bheemasetti³

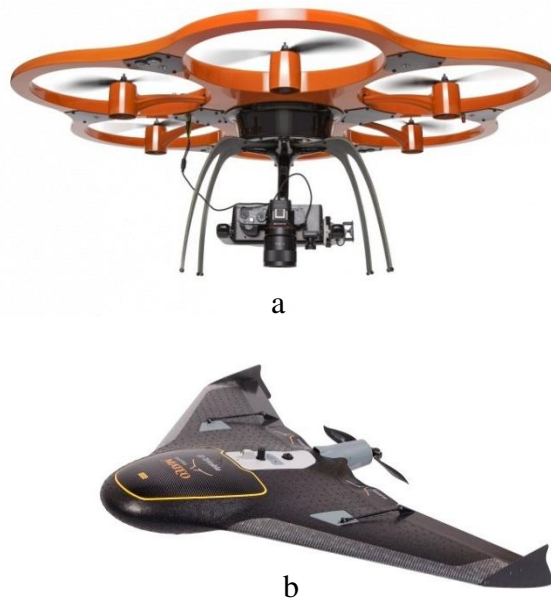
Fig. 1 a) Aibotix X6 rotary-type UAS; b) UX 5 fixed wing UAS (Leica Geosystems)

Fig. 1 shows commercially-available rotary-type UAV (Aibotix X6 multi-rotor) and fixed wing (UX 5) type UAV, both of which are available from Leica Geosystems. Aibotix X6 is a versatile UAS, best suited for acquiring data over relatively small areas. The hovering capability of the aircraft provides a unique data collection platform that can be applied to many areas. The Aibotix X6 multi-rotor UAS can be adopted for small-scale investigations, and the UX5 fixed wing UAS can be adopted for large-scale environments. The Aibotix X6, with an on-board RTK GPS receiver, allows the UAS to communicate and use real-time kinematic positioning provided by the existing TxDOT VRS network.

Fixed wing aircraft systems are better suited for collecting data in remote areas far from roadways with limited access. UX5 is a high-performance system with 50 minutes of flight time per battery charge and a 50 mile per hour cruise speed. This allows rapid collection of data over large areas. At a 2-inch pixel resolution, the UAS can cover 541 acres per charge; at a 4-inch resolution it can cover over 1200 acres per charge.

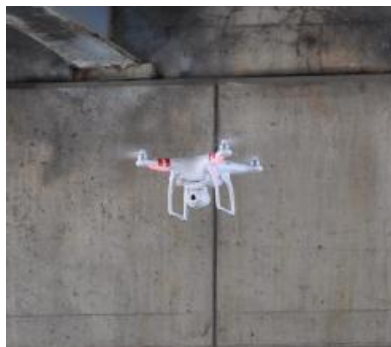
Fig. 4. DJI Phantom Vision 2 quadcopter UAS performing under-bridge inspection (Brooks et al., 2015; www.mtri.org).

Recently, the DJI Phantom 2 UAV (quadcopter), which can fly in relatively challenging areas such as beneath bridges and inside confined spaces, was employed for aerial surveys during a research program conducted jointly by the Michigan Tech Research Institute and Michigan Tech Transportation Institute (Brooks et al., 2015). The camera, which has the capacity to take pictures and record video to micro SD cards with a real-time video link of up to 900 feet, was mounted on the DJI Phantom Vision 2 UAS. It was used to create photographic inventories of study sites, such as bridges with hard-to-reach areas, and to look for damage on the inside of a pump station. Fig. 4 shows the same DJI Phantom Vision 2 UAS, with a small (GoPro) camera mounted on its top to shoot photos of the underside of bridges.

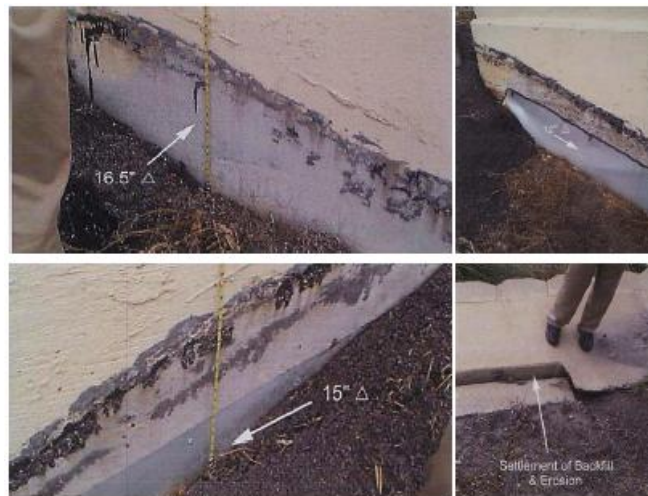
Fig. 5 Bridge approach slab settlement in Johnson County, Texas, USA

construction, the approach slab has experienced more than 16 in. of settlement, as shown in Fig. 5. One of the primary causes of the settlement is the self-weight of the 40-ft high embankment fill material which undergoes self-consolidation, inducing large stresses and settlement to the underlying foundation subgrade. To mitigate the settlement, several treatment methods were applied, including hot mix overlays, grout injections, soil nailing, and others; however, they were not effective.

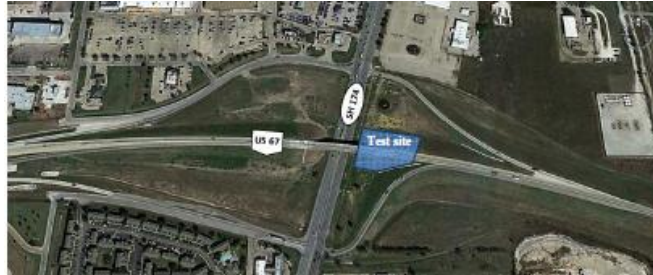
Fig. 6 Test site location

The test site was located at the intersection of US 67 and State Highway 174 in Johnson County, Texas USA, as illustrated in Fig. 6. The bridge was designed for two-lane traffic, and both ends

of the bridge were placed on abutments supported by drilled shaft foundations. Approach embankments were built adjacent to the bridge abutments to support the interfacing bridge approach slabs and roadways. The embankment fill soils were classified as clayey sand (SC), and the foundation soils were classified as clays of low plasticity (CL), as per the USCS classification.

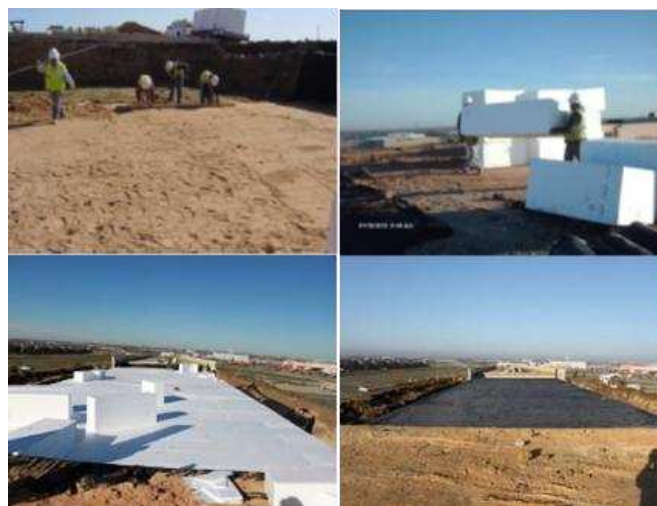
Fig. 7 Construction of EPS Geofoam

The rehabilitation of the test site began in January 2012. The test site was constructed with EPS 22 geofoam, which has unit weight of 24.35 kg/m^3 (1.52 pcf) and unconfined compressive strength of 152 kPa (3174 psf). The embankment soils were first excavated to a depth of about 2.74 to 3.04 m (8 to 10 ft.).

A sand layer was put in place to provide a proper leveling base before the installation of the EPS geofoam. The geofoam blocks were then placed on top of the sand layer to a height of 1.83 m (6 ft.) and were connected, using a barbed plate, and encapsulated in a geotextile membrane, which protected the geofoam blocks from the infiltration of any fluids and termite infestations. Fig. 7 illustrates the construction process of the EPS geofoam. Different sizes of the geofoam blocks were used in this construction to fill all the narrow spaces. A pavement structure of 0.61 m (2 ft.) was placed on top of the geofoam blocks, using a flex base and hot mix asphalt concrete (HMAC) pavement surface.

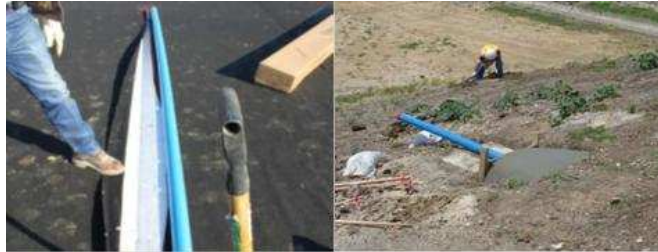
Fig. 8 Horizontal inclinometers installation

The test site was instrumented to monitor the settlement and pressure that was exerted on the structure. Horizontal inclinometers, which measured the displacement of the subsurface layers in a direction perpendicular to the axis of a flexible plastic casing, were used to monitor the settlement. Four small trenches were excavated in the top geofoam blocks in accordance with the size of the inclinometer casing, as shown in Fig. 8.

Long PVC casing pipes of about 7.9 m (24 ft.) were installed in the trenches, and the extended ends of the casings were fastened with cast-in-place concrete bases. Four earth pressure cells, made of two circular stainless steel plates welded together to form a sealed cavity, were installed in the embankment to monitor the pressures exerted on the structure. The cavity was filled with a non-compressible fluid, and a pressure transducer was connected to the cell. Fig. 9 depicts the installation of the pressure cells in the embankment. A Quattro Logger, a compact data logger, was used to monitor the four installed pressure cells. The logger was automated to record the pressures at 15-minute intervals. The recorded data was retrieved after every site visit.

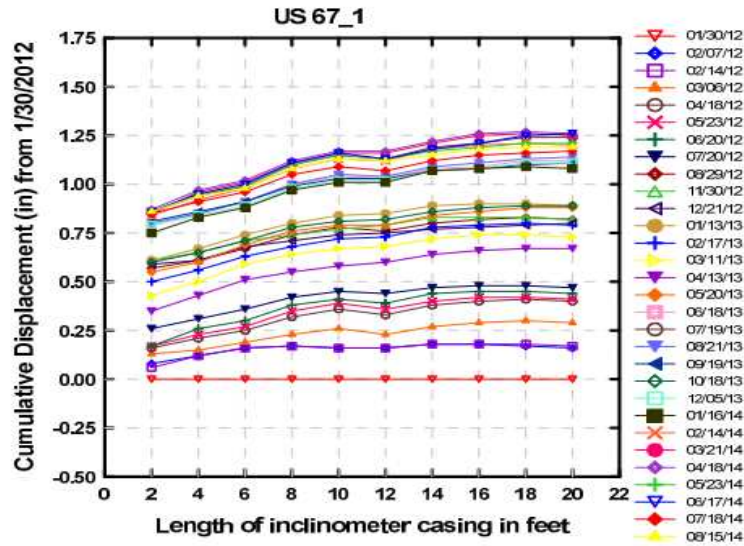
Fig. 10 Horizontal Inclinometer readings

The horizontal inclinometer and pressure cell readings were taken monthly to evaluate the performance of the geofoam block structure. Fig. 10 presents the plot of the cumulative settlement of the embankment along the inclinometer casing at one station.

The data was collected in January 2012, immediately after the installation. From the plots, it can be observed that the maximum displacement was less than 33 mm (1.5 in.). This means that the geofoam blocks can sustain the traffic load effectively and can mitigate the settlements (Ruttanaporamakul 2014), thus assuring the quality of the geofoam blocks' performance in the bridge approach slabs.
