# CASE STUDY AND FORENSIC INVESTIGATION OF LANDSLIDE AT MARDOL IN GOA

Leonardo Souza,<sup>1</sup> Aviraj Naik,<sup>1</sup> Praveen Mhaddolkar,<sup>1</sup> and Nisha Naik<sup>2</sup>

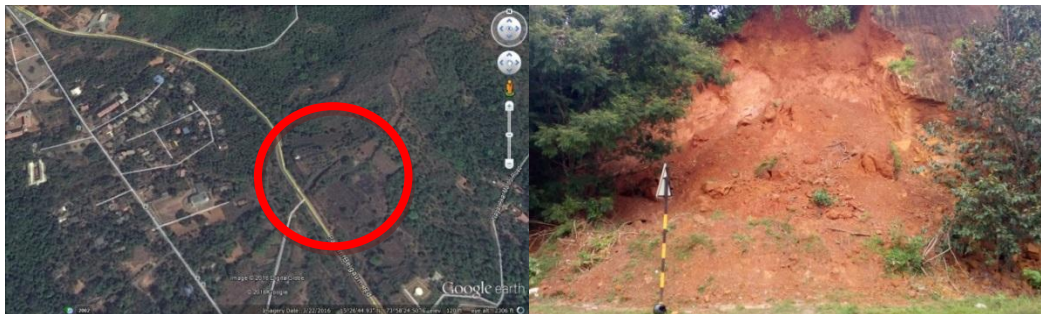
**Figure 1: (a) Location of site, (b) Landslide at site.**

A landslide occurred in the village of Mardol, in south Goa district at the foot of a hill adjacent to NH4A highway. The proximity of the site to a highway caused a concern and hence was the motivation behind this study. This paper presents a forensic analysis of the landslide at Mardol, Goa. Figure 1(a) shows a google earth image of the location of the site and a photograph taken at the site is shown in Figure 1(b). A forensic investigation of the site includes the following:-

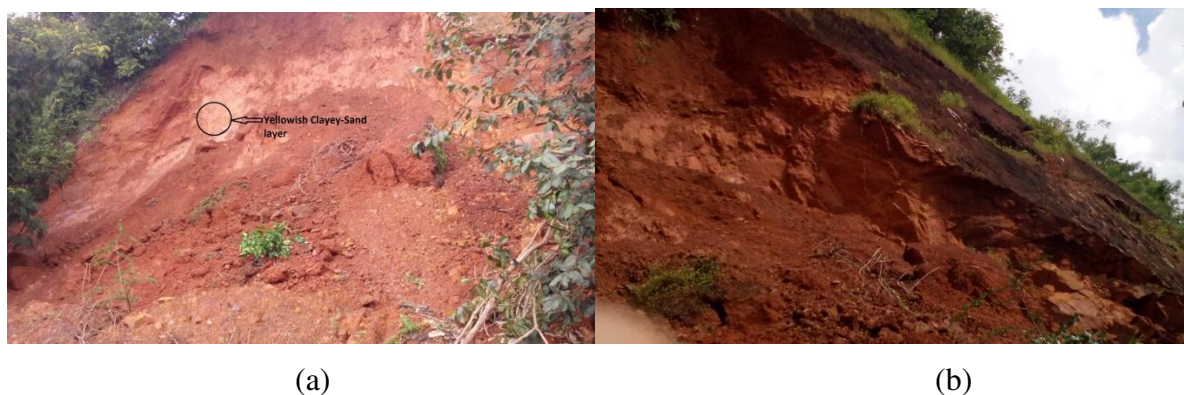
Site conditions play an important part in stability and failure of slope. Slope face and slope angle and height play an important role in governing the stability of slopes. As they increase, chances of failure also increase. The degree of saturation of the slope material is also a major factor. The soil at site was poorly graded clayey sand. Patches of yellowish clayey-sand layers were observed. As the landslide was fresh, the soil was moist and lumps of it could be easily squeezed in hand. Figure 4(a) shows the yellowish clayey sandy layer and Figure 4(b) shows the failure of slope.

**Figure 4: (a) Photo showing yellowish clayey sandy layer, (b) Photo showing failure of slope.**

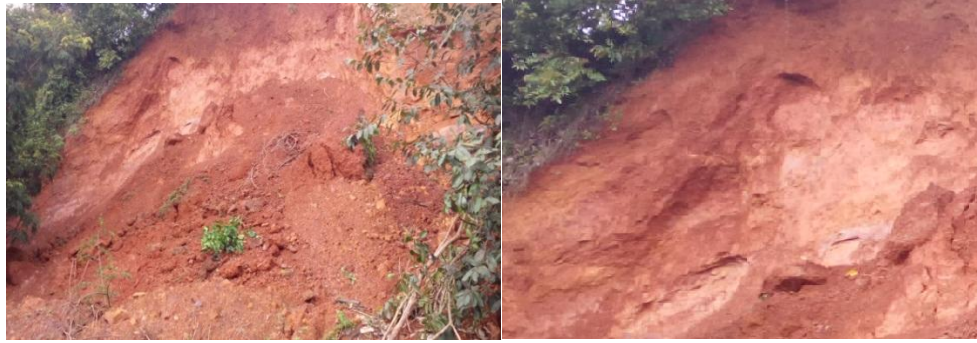
The soil is basically formed of thin layers of red clayey sand interspersed with thick layers of yellowish clayey soil both of which have very weak shear strength. Figure 6, shows the photos resembling regional geology.

**Figure 6: photograph of soil layers resembling regional geology.**

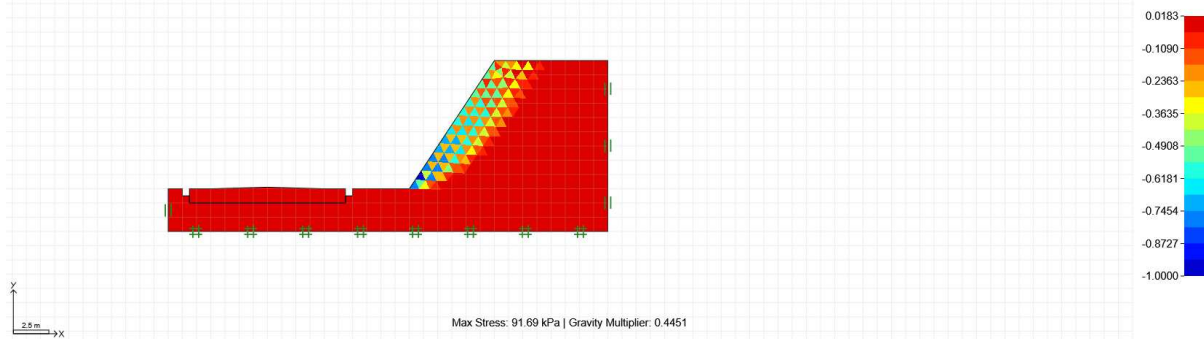
**Figure 8 : Slope failure (F.O.S = 0.45)**

As known from stability analysis that the slope is highly vulnerable to further loading or increase of pore pressure, the only possible cause for this landslide can be the continuous heavy rainfall experienced in this region during monsoons. The destruction of natural vegetation along this area has also added to its instability. The slope must have been saturated during rains and thereby increasing its self-weight and eventually leading to collapse.
