Investigation on Causes of Failure and Design of Remedial Measures of Pile Foundation Supporting Transmission Line Tower.

Manojit Samanta¹, Ajay Dwivedi², Piyush Mohanty³, Anindya Pain⁴ & Mahesh Sharma⁵

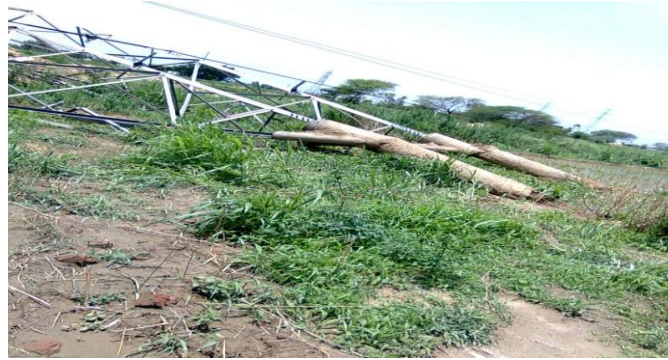
Figure 1. Uprooted pile foundation with tower

A failure in foundation system of Mahilpur-Jamsher transmission line in Punjab was occurred in the year of 2013. One of the towers of this line was uprooted in storm, causing total disruption of power supply of Punjab (Figure 1). The transmission line is about 47 km in length

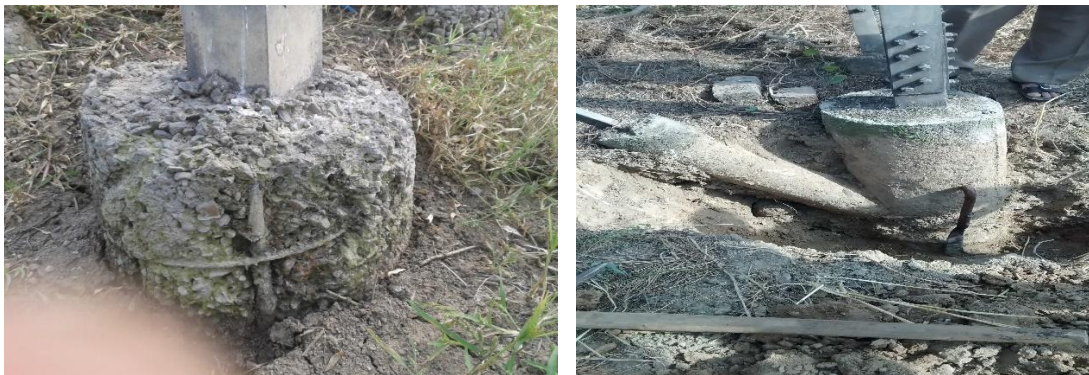
Figure 3. Present condition of the in-service piles

Visual inspection of individual transmission tower foundation was carried out before the low strain integrity test for examining the present conditions and simultaneously, the diameter of the piles with surrounding conditions were also recorded (Figure3). The visual inspection of the physical conditions were then used to decide the stress wave velocity of the pile foundation.

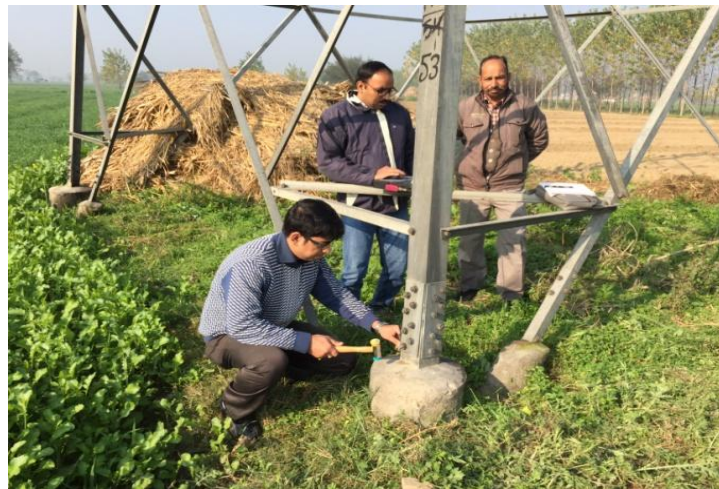
Figure 4. Pile integrity test in progress

The low strain integrity tests have been conducted on the pile heads (about 300 mm above NGL) under each individual leg of all the towers. Each pile head was cleaned of any earth, loose particles of concrete and dust. The integrity test was conducted by striking the pile head with a small manual hammer in the axial direction. The wave response consisting of reflections from the locations in variation of pile section such as increase or decrease in the cross-section, cracks,

necking or inclusion from the pile toe are picked up by an accelerometer placed on pile head close to the hammer blow. At each pile, at least a set of 3 signals were taken to obtain repetitive and good representative signals. Impact of hammer blow was given at two to three locations on pile head to assess the overall condition. To arrive at the most appropriate stress wave velocity and corresponding lengths for proper assessment of structural condition of piles, the maximum stress wave velocity has been taken as 3600 m/s considering grade of concrete, its method of mixing along with its placement and aging. The lower limit for the same was considered as 2400 m/s. These records are stored on the computer for subsequent processing and analysis.
