# **The Cause of the Collapse of Yeager Airport Extended Runway**

**A. S. S. Raghuram<sup>1</sup>, S.M. ASCE, B. Munwar Basha<sup>2</sup>, M. ASCE**

## **ABSTRACT**

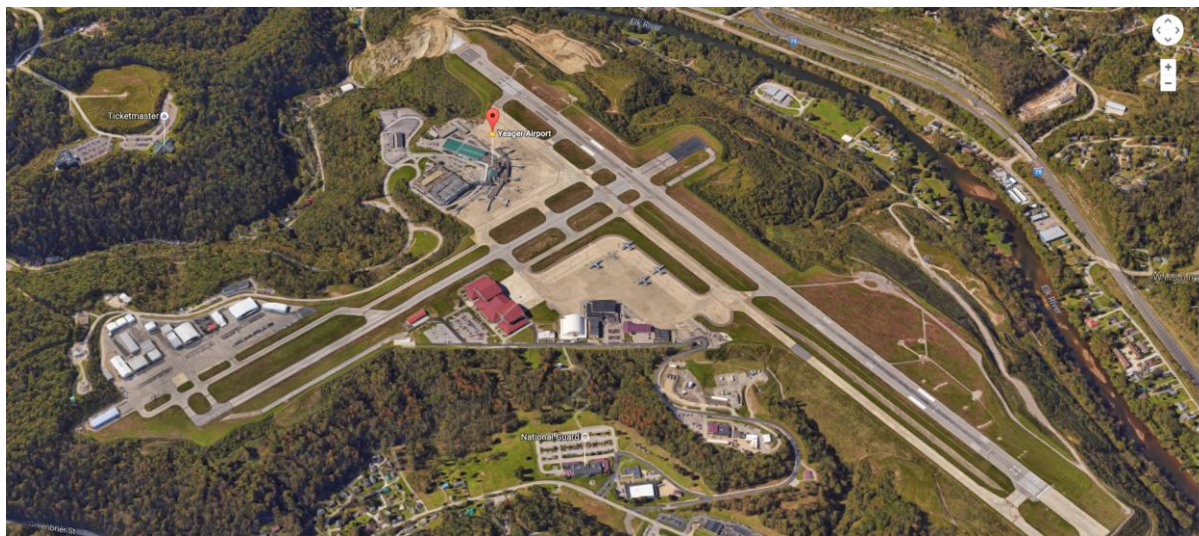
**Figure 1. Yeager Airport situated on series of semi-connected hill tops know as “Coonskin Ridge. (Courtesy Google Earth, downloaded on Sep 20, 2016)**

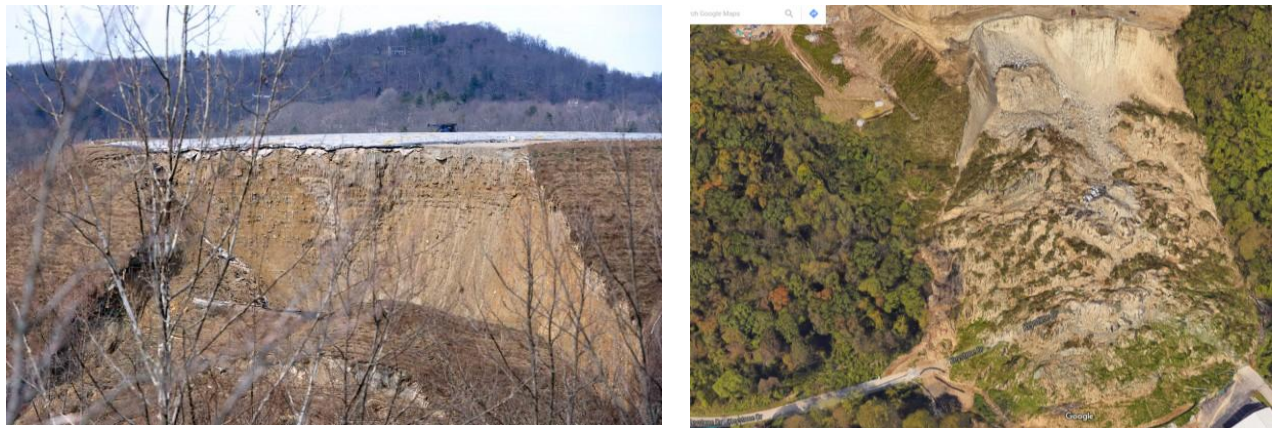
**Figure 2. The failure of Yeager airport expansion runway as reported by Charleston Gazette-Mail on 12 Mar 2015**

An important conclusion that can be made from this section that the reduction in friction angle from  $36^\circ$  to  $26^\circ$  could have made the GRS critical to tension and pullout failures. However, the failure images as shown in **Figs. 2, 3** and **4** do not show any signs of either overstressing or pullout failures. Therefore, a significant reduction in friction angle is highly unlikely.

**Figs. 2** and **3** shows that the reinforced soil zone sheared where the reinforcement ended, and the reinforced soil as a whole is sliding down the hillside. The reinforcement is visible in the top layers, but not at the bottom. The fact is that it is at the base where the initial failure might have occurred, as this looks to be a rotational slide. The road embankment at the base of the slope as shown in **Fig. 3(a)** appears to be quite soft, with electricity poles leaning down the hill. Further,

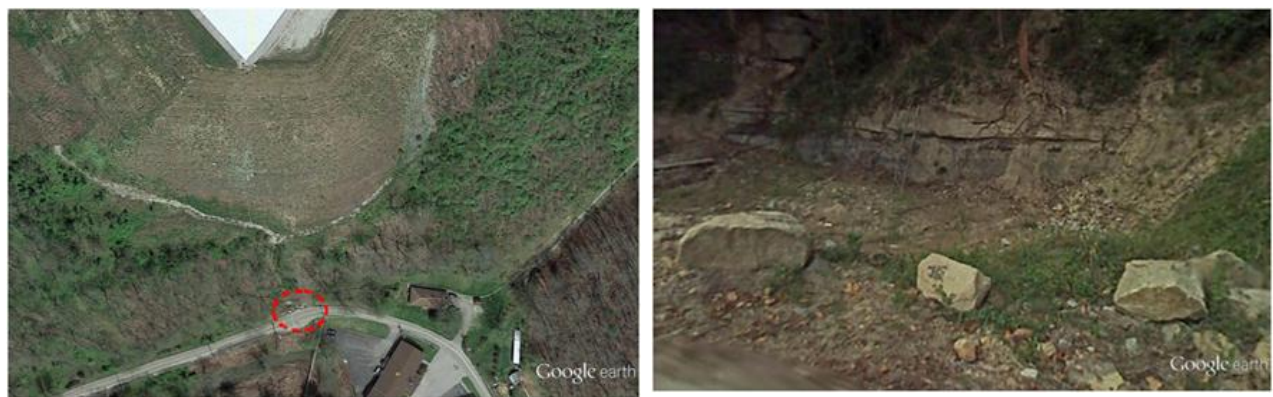
(a) At the base of the slope

(b) Close view of the fissures

**Figure 3. Formation of fissures at the bottom of the slope**

Due to the dramatic slopes of 91 m height around the airport, they could not meet with the Federal Aviation Administration (FAA) safety regulations and a few concessions were made. Finally, the airport was completed in 1947 and came into operational on December 01. Moreover, the committee decided to upgrade the Yeager airport facilities in order to meet the FAA safety regulations. For this upgradation to meet FAA safety regulations, Runway 5 required a 150 m extension as the previous runway did not include the emergency stopping area. Lostumbo (2010) reported that reinforced steepened slope was determined to be the best option for the project as it offered an economical solution. In addition, Lostumbo (2010) reported that the construction of the 1:1 reinforced slope was completed in just under 2 years, starting in the late summer of 2005 and finishing in spring 2007. On, 11<sup>th</sup> Mar 2015, the Charleston Daily Mail reported that six residents were moved out of their houses below the slope as the movement of the slope was detected. On, 12<sup>th</sup> Mar 2015, this quickly developed into a very large-scale landslide as shown in **Figs. 2, 3 and 4**. Formation of fissures before failure was shown in **Fig. 3(a) and 3(b)**.

it can also be noted that the area of bedrock exposure as shown in **Fig. 3(b)** shows flat lying sedimentary rock. It appears to include a competent pale sandstone over a greyish shale.

Another interesting observation that can be made from **Figs. 3(a)** and **3(b)** that the excavation and foundation of the GRS did not go to the base of the hill. The bedrock is visible in the back and presence of some moisture can be observed at somewhat higher in the slope. Lostumbo (2010) reported that foundation soil below the base of the GRS consists of “sandstone and some shale”. The small intercalations of shale material can produce enormous bearing capacity problems. The low value of bearing capacity of shale can be attributed to lower compressive strength but more importantly significantly lower friction angle. Finally, an important conclusion that can be drawn from the study is that the founding bedrock failure is the most likely the cause of the collapse.

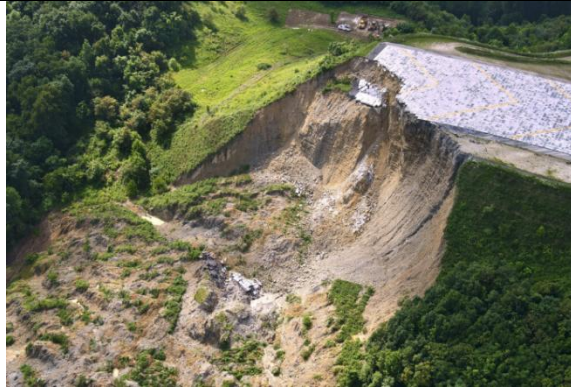
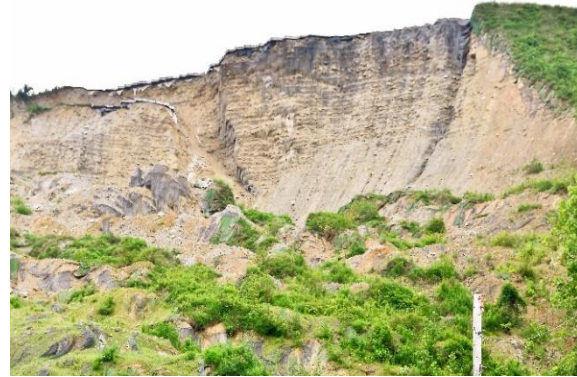
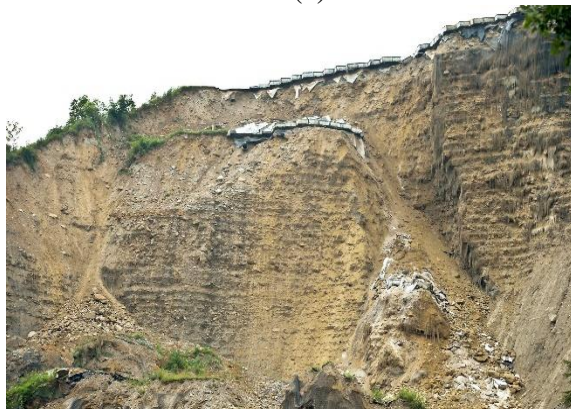
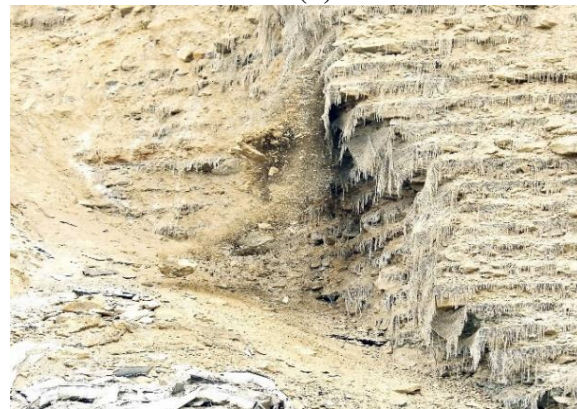
**Figure 4. Collapse of extended runway (a) View from top, (b) Long front view, (c) Close front view, (d) Failure of reinforcement**
